The Apollo 1 Fire

Course No: LE1-011

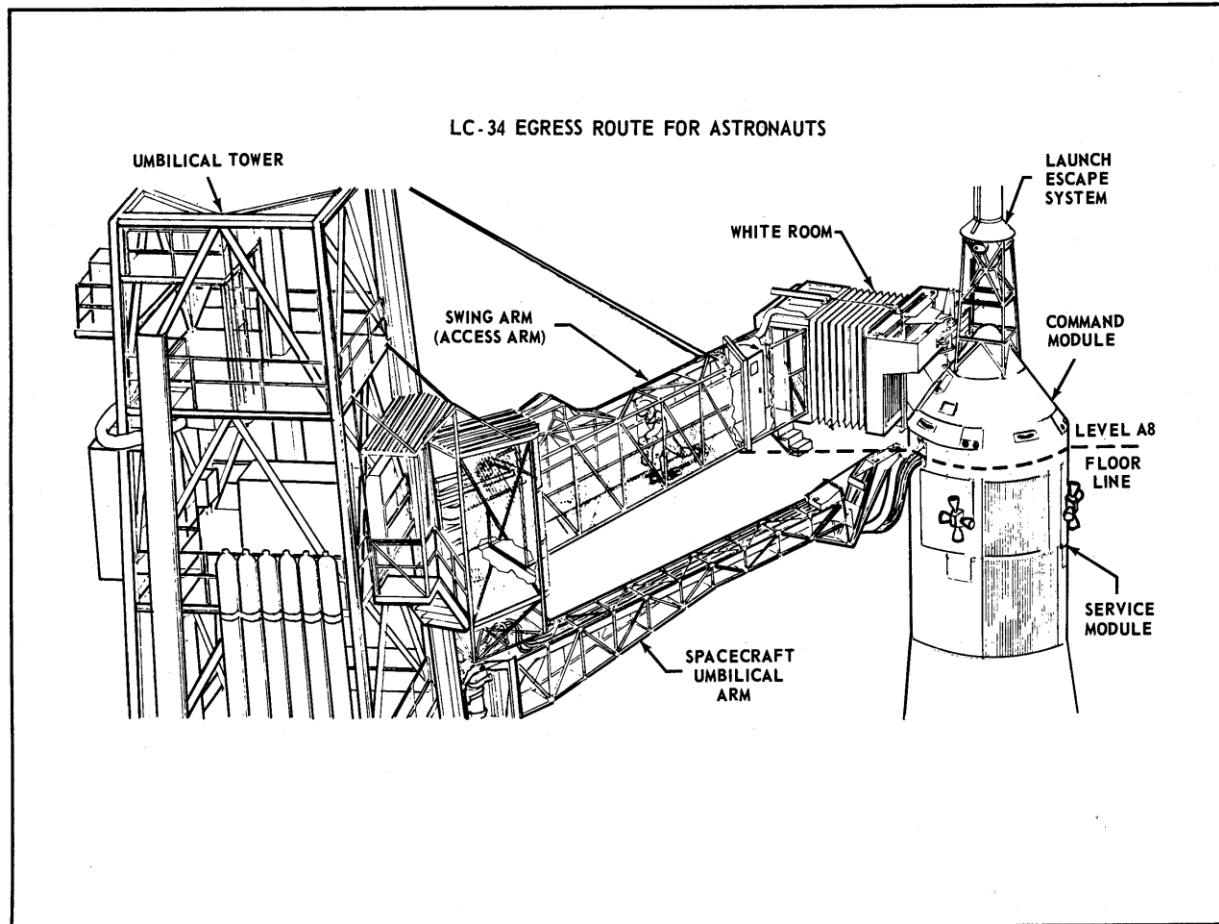
Figure 5 Sketch of the egress route

The egress route for the astronauts was attached to the umbilical tower. This was to provide an escape route for the astronauts in the case of an emergency before launch. The egress route is shown in the NASA sketch below. The “White Room” surrounds the hatch and is where the crew would step immediately upon egress (exit).

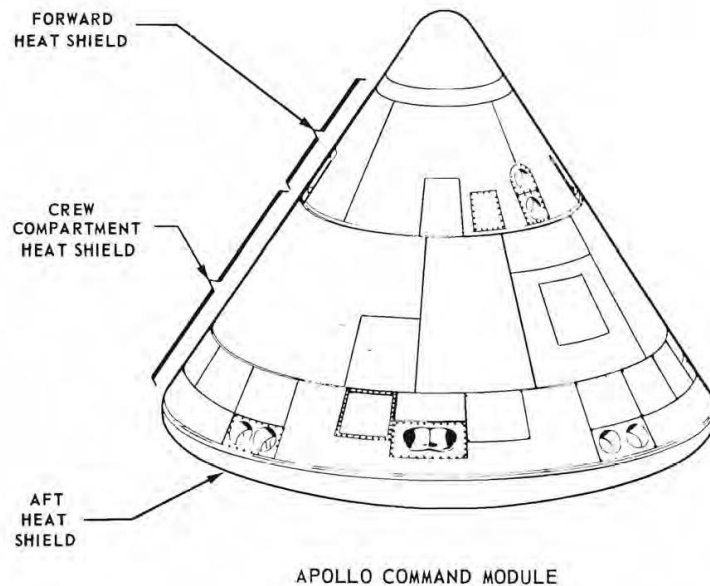
The Command Module had three hatches installed. The outermost hatch was called the boost protective cover (BPC). It was part of the cover that shielded the Command Module during launch. This hatch is jettisoned before reaching orbit. This hatch was not fully latched due to the test requirements, but difficulty opening it occurred during rescue attempts. The thick smoke that filled the White Room further complicated opening the hatch.

The middle hatch is called the ablative hatch and becomes the outermost hatch after the boost protective cover is jettisoned. The inner hatch seals the pressure vessel wall of the Command Module and is the first opened by the crew when they egress unaided. These hatches were in place and latched after crew ingress (entry).

The rescue attempts were able to remove the middle hatch. The inner hatch opening revealed intense heat and smoke coming from inside the Command Module. The two outer hatches were opened approximately five minutes of the first report of the fire or at 23:36 GMT. The visibility inside the Command Module was poor.

It should be noted that the inner hatch was held shut with the pressure higher inside the Command Module. During Project Mercury, explosive bolts were added to the escape hatch for egress during an emergency. These were added at the insistence of Grissom. They were removed after Grissom's Project Mercury flight where the spacecraft was lost after splashdown.

The investigation determined that the Command Pilot left his couch (left hand couch) to avoid the initial fire. The Senior Pilot remained on his couch (center couch) as for a planned emergency egress and attempted to open the hatch for an emergency egress. The Pilot, Chaffee, remained on his couch (right hand couch) to maintain communications until the hatch could be opened by the Senior Pilot. A slightly higher pressure inside the Command Module than outside made the inner hatch impossible to open due to the resulting force on the hatch.

The fire did lead to changes to make space flight safe enough for the United States to land on the moon in 1969 with the Apollo 11 flight. The hatch was replaced with a hatch that would open outward quickly, to facilitate an emergency egress.

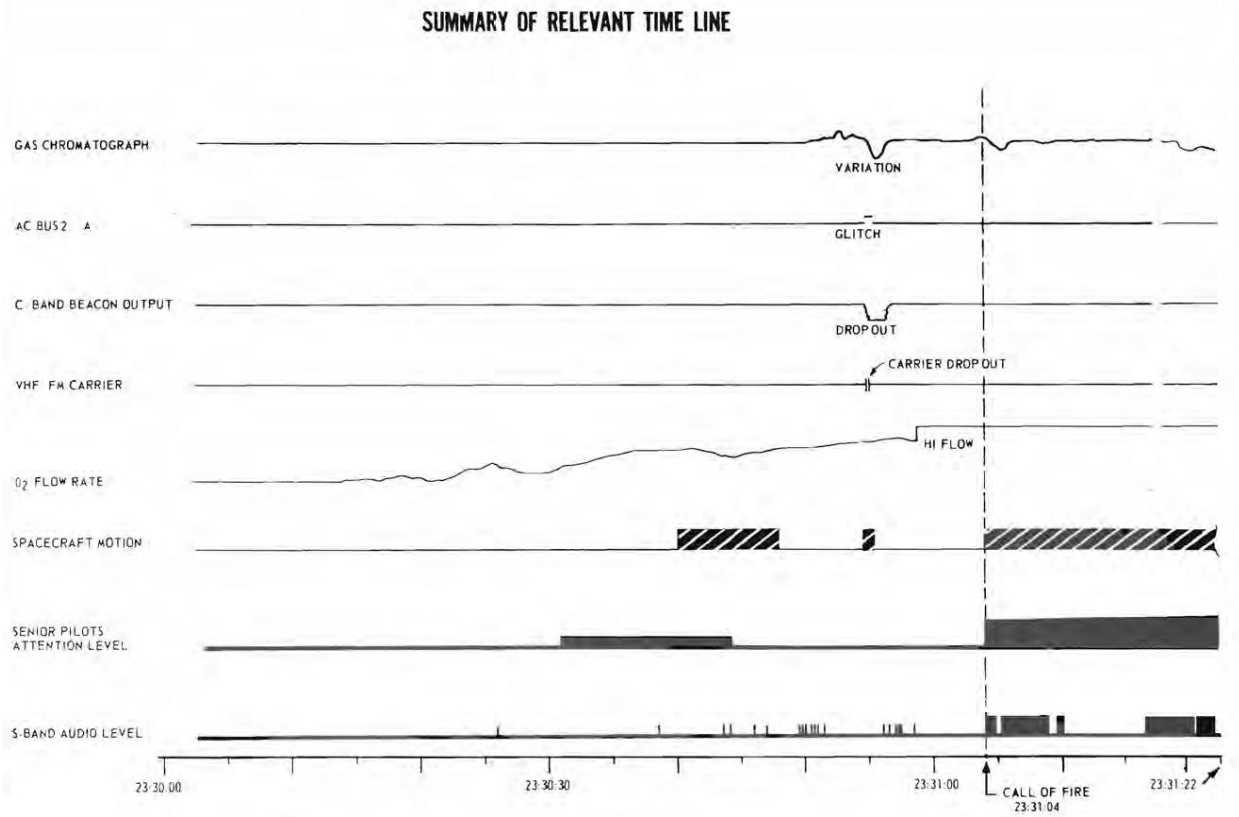
Figure 8 NASA summary timeline

All transmissions of voice and data stopped by 23:31.22.4 GMT, which was approximately three seconds after the Command Module ruptured. The witnesses monitoring the television screen showing the hatch window reported that the flame spread from the left to right side of the Command Module, and then covered the entire area of visibility. A NASA summary timeline is shown below.
