Ethical Issues from the Kansas City Hyatt Hotel Collapse

Course No: LE2-001
Credit: 2 PDH

J. Paul Guyer, P.E., R.A., Fellow ASCE, Fellow AEI

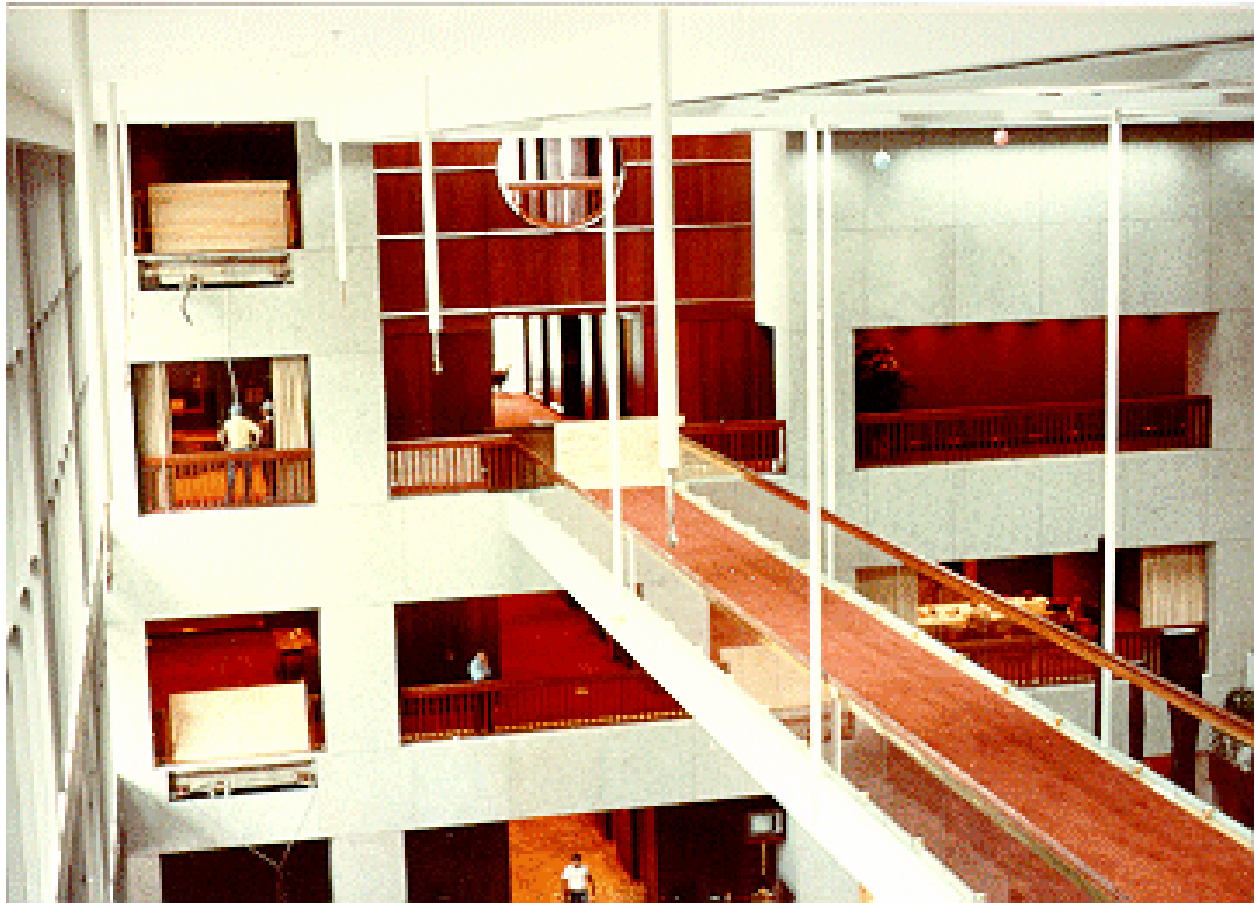
The structural failure occurred at two of the three suspended walkways that traversed from one side to the other of the atrium lobby. Walkways that failed were directly in line with each other and crossed from one side to the other at the second and fourth floors. The third walkway, at the third floor, was offset from the other two and was not involved in the failure.

Figure 10
Surviving 3rd Floor Walkway

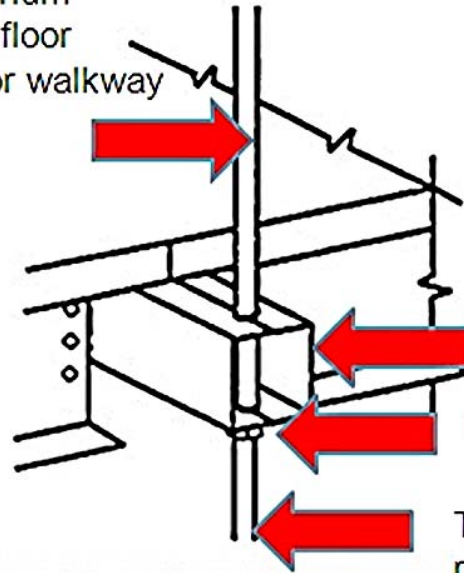
Figure 13
The Structural Engineer's Original Design

1-1/4" continuous suspension rod from 4th floor atrium ceiling, through 4th floor walkway, to 2nd floor walkway

Box beam fabricated of two 8x8.5 MC channels welded toe-to-toe

Box beam rests on nut

Threading of rod required from 2nd to 4th floor walkways

THE NBS specifically concluded that “Under the original hanger rod arrangement (continuous rod) the box beam-hanger rod connections as shown on the contract drawings *would have had the capacity to resist the loads estimated to have been acting at the time of collapse.*”

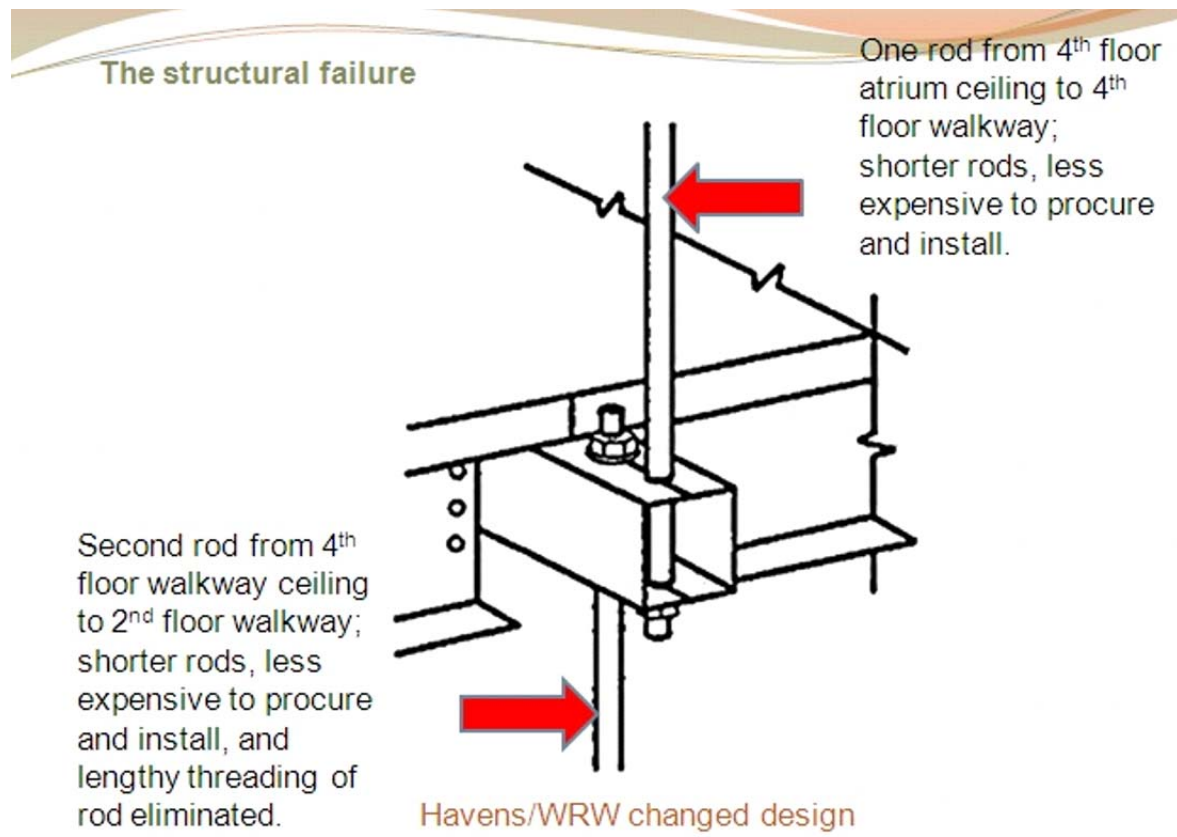
The cause of the failure was a change made by the steel detailer (WRW, a sub-contractor to Havens, which in turn was a sub-contractor to Eldridge) to the suspension rods design shown on the structural engineer Gillum's drawings.

4.2 THE IMPETUS FOR THE DESIGN CHANGE. Why did WRW, at Haven's instigation, make this change? Because of two *constructability* issues....

First, the Gillum design required continuous suspension rods approximately 40-feet long. Havens determined these would be unacceptably expensive to procure and install.

Second, the suspension rods would have to be threaded for approximately 30-feet of their length in order to install the nut on the rod that supported the fourth floor walkway. This was determined by Havens to be unacceptably expensive to fabricate and install.

Figure 14
The change made by the Steel Fabricator-Erector/Detailer

- **the design change which led to the failure at the box beam-nut-suspension rod connection**

6.1.1 Havens/WRW had properly designed the changed detail

6.1.2 The improperly changed detail had been noted and corrected by Gillum

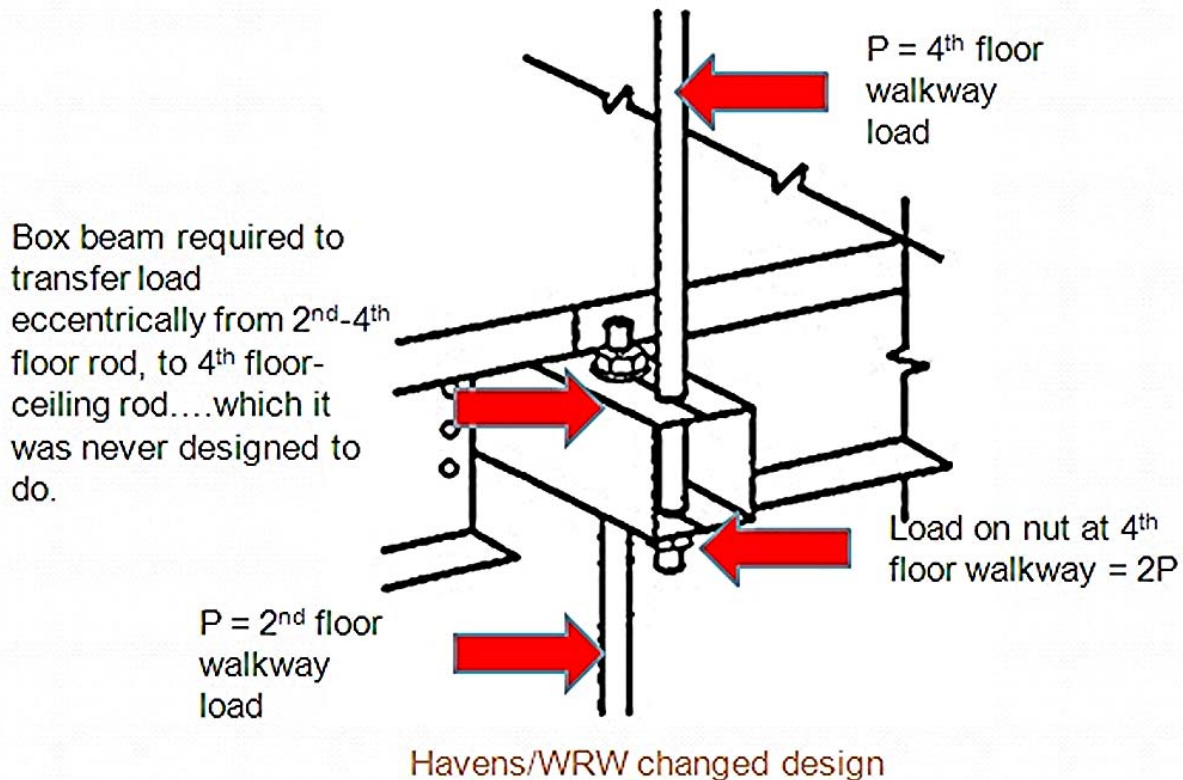
Figure 16
The change made by the Steel Fabricator-Erector/Detailer

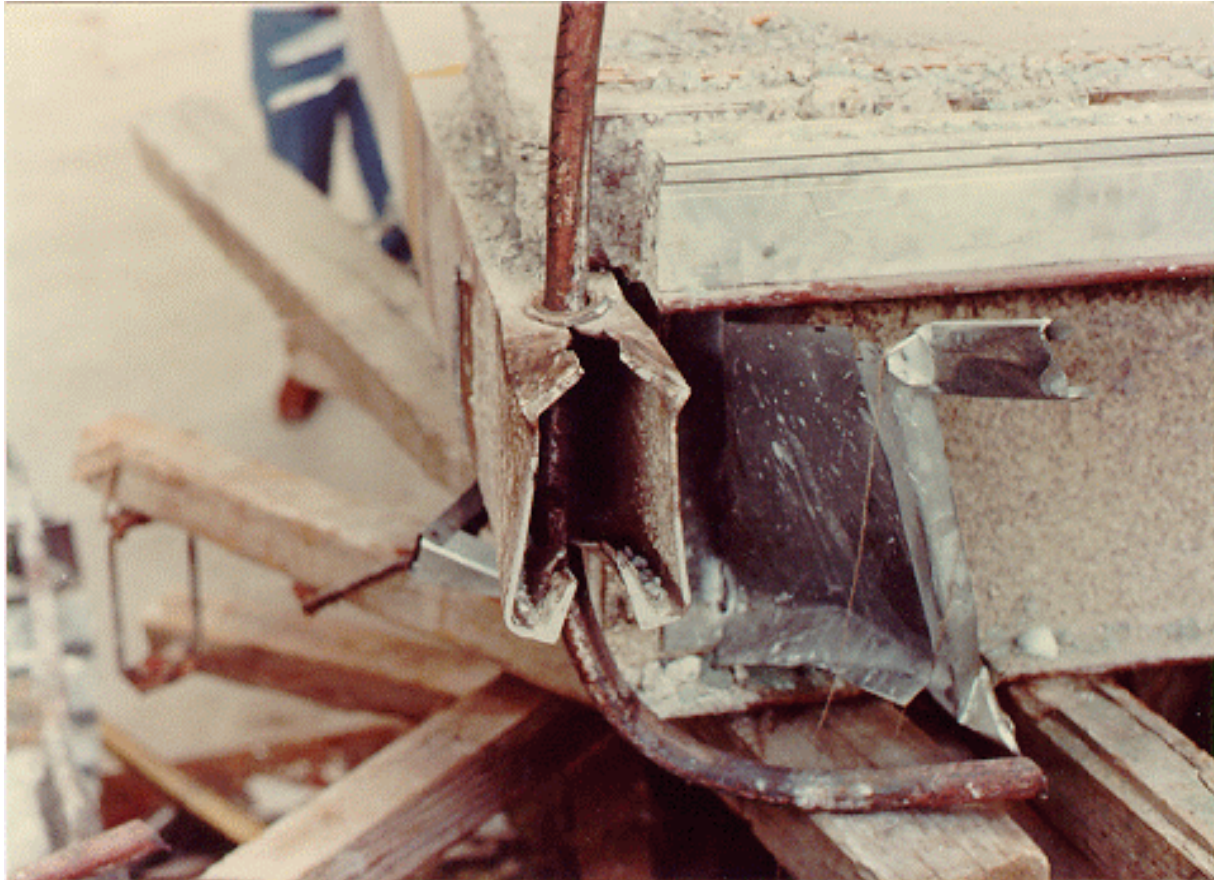
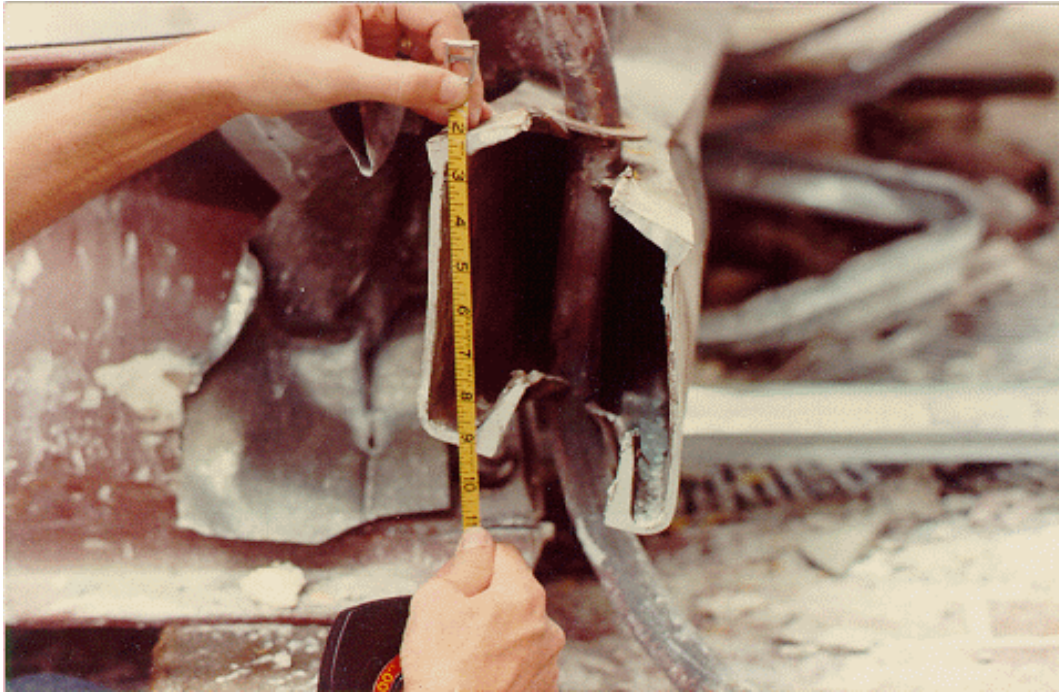
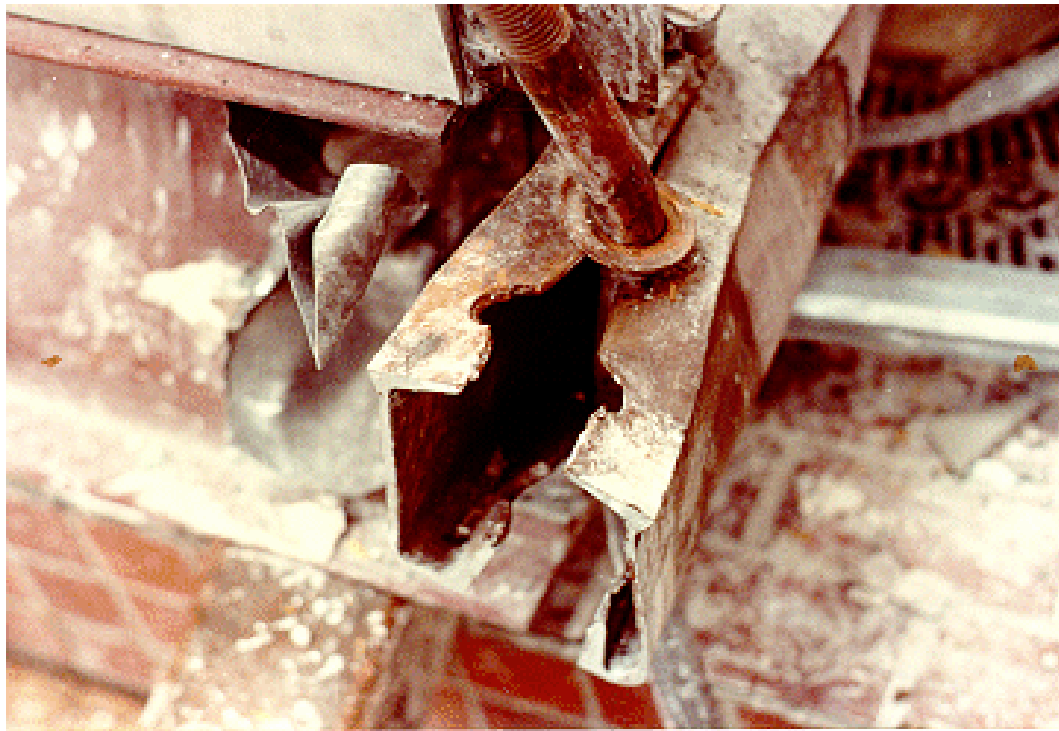
4.5 AND HERE IS WHAT HAPPENED....
