Underwater Inspection of Bridge Substructures Using Imaging

Course No: S12-001
Credit: 12 PDH

This course was adapted from the Department of Transportation, Publication No. DOT-FHWA-HIF-18-049, “Underwater Inspection of Bridge Substructures Using Imaging Technology”, which is in the public domain.

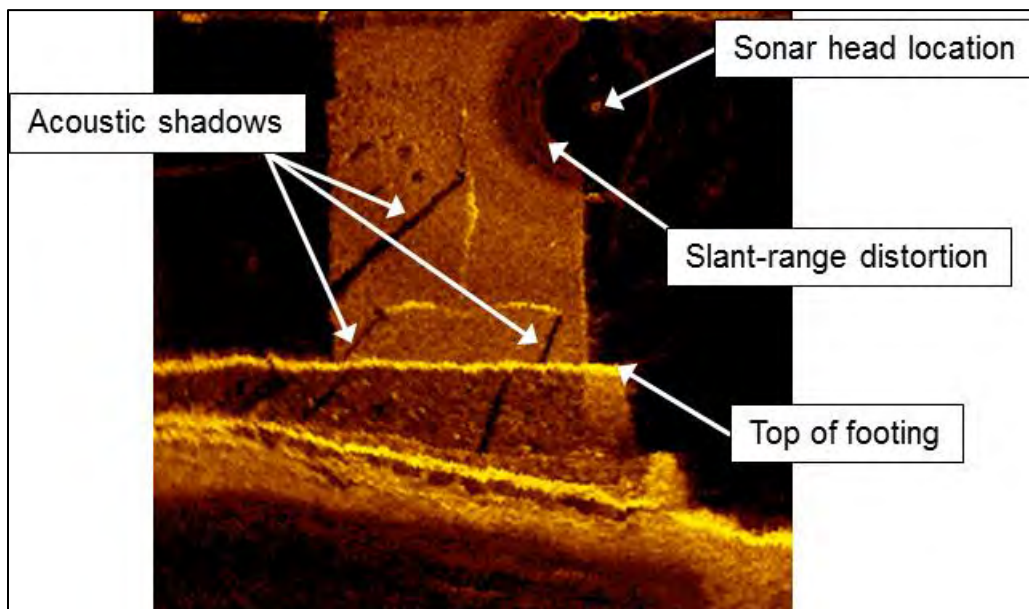
Shadows can easily be misinterpreted as defects in a bridge substructure. For example, an inverted T-shape is apparent on the face of the concrete pier in figure 18. An inspector unfamiliar with sonar may misinterpret this image as concrete deterioration or cracking. However, as shown in the bridge plans for this location in figure 19, the shape is actually a steel frame designed to mount a fixed scour monitoring device to the pier. The acoustic shadow connects to the target that formed it at the location where the steel frame is connected to the pier face.

Figure 18. Image. Sector-scanning sonar image with shadows on the face of a concrete pier.

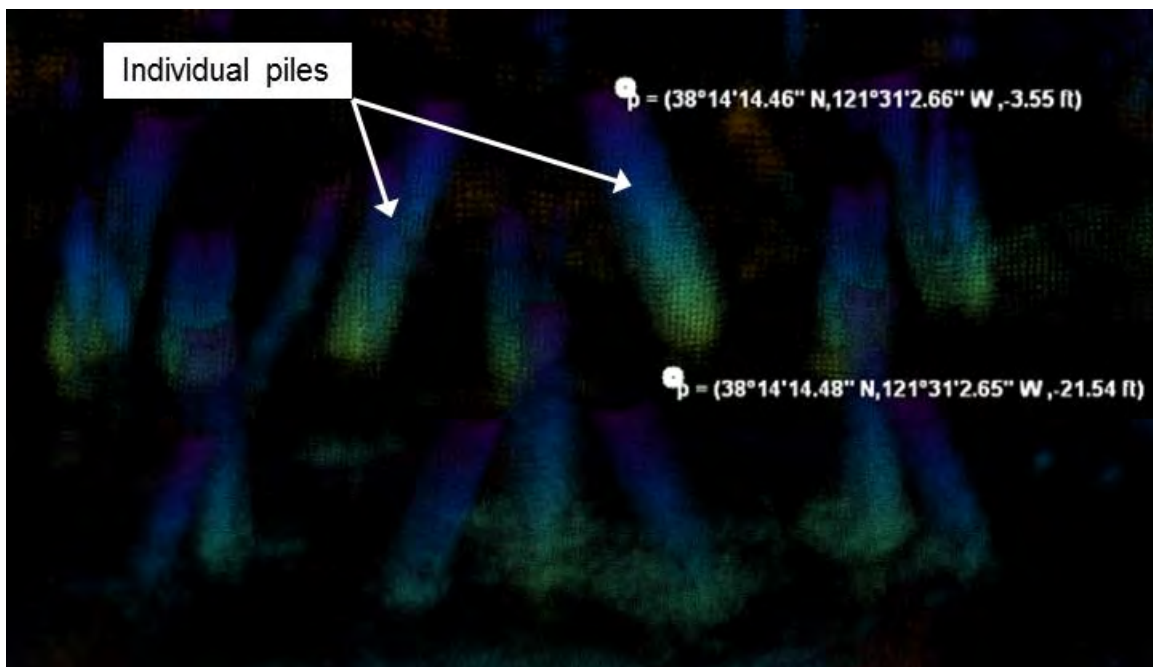
Figure 28 displays a close-up of several piles. With the x,y,z capability, it is possible to estimate feature dimensions such as object length.

Figure 28. Image. Coordinates from which length of a pile is estimated (Georgiana Slough).

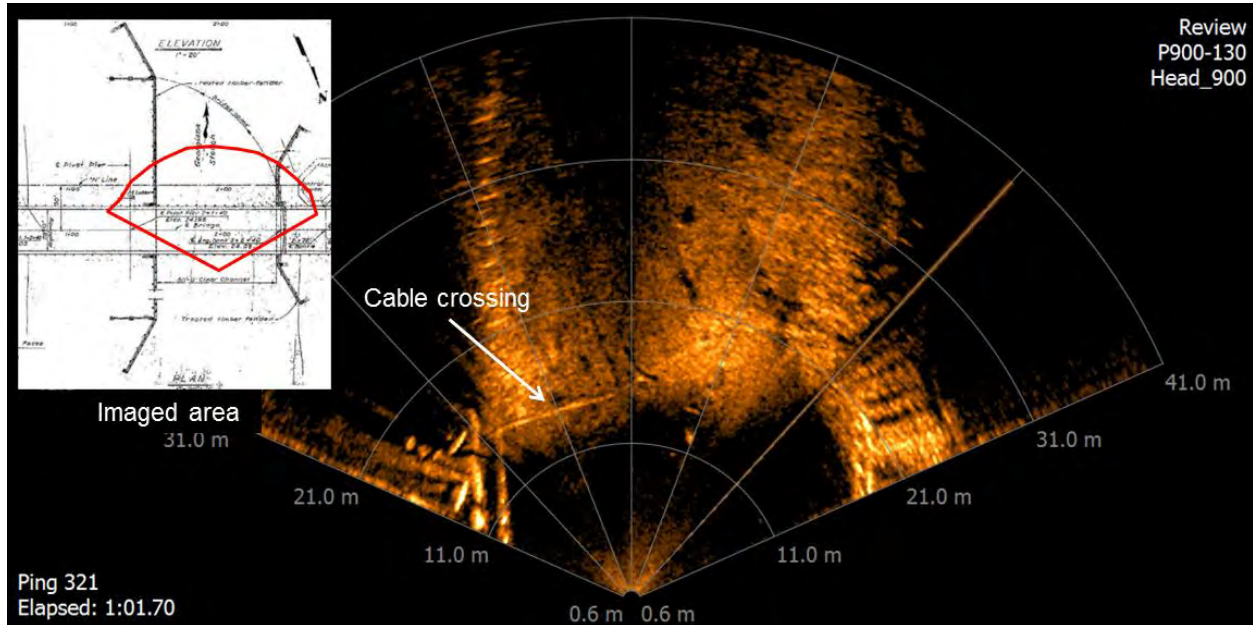
Inspection team B employed two sonar technologies for the inspection of the Georgiana Slough Bridge. Figure 29 shows an example image from a 2D multibeam sonar along with the inset providing the location of the image at the site. The image resulted from a single ping and was captured from boat-mounted equipment. The piles on either side of the channel are evident as is a cable crossing the channel.

Figure 29. Image. 2D image from a single ping at Georgiana Slough (plan view).

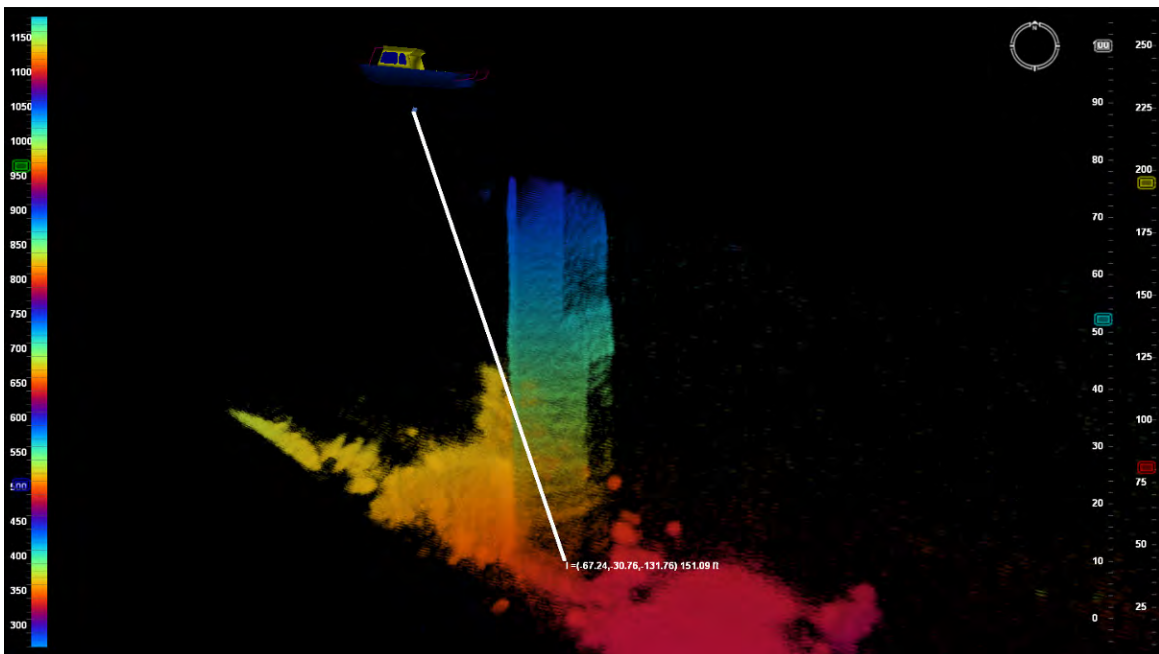
Figure 40 shows the image of bent 4 captured by the sonar. A symbol representing the data collection boat is also shown to illustrate the range required of the sonar at this site. Figure 41 is a data mosaic showing bents 4 and 5 as viewed from the west side of the bridge. The annotations on the figure demonstrate how structure dimensions can be obtained from the image. Close analysis of the images may reveal reportable observations. For example, a closer view of the base of bent 4 shown in figure 42 provides an indication of scour at the base of the bent.

Figure 40. Image. Bent 4 with boat location showing sonar range.

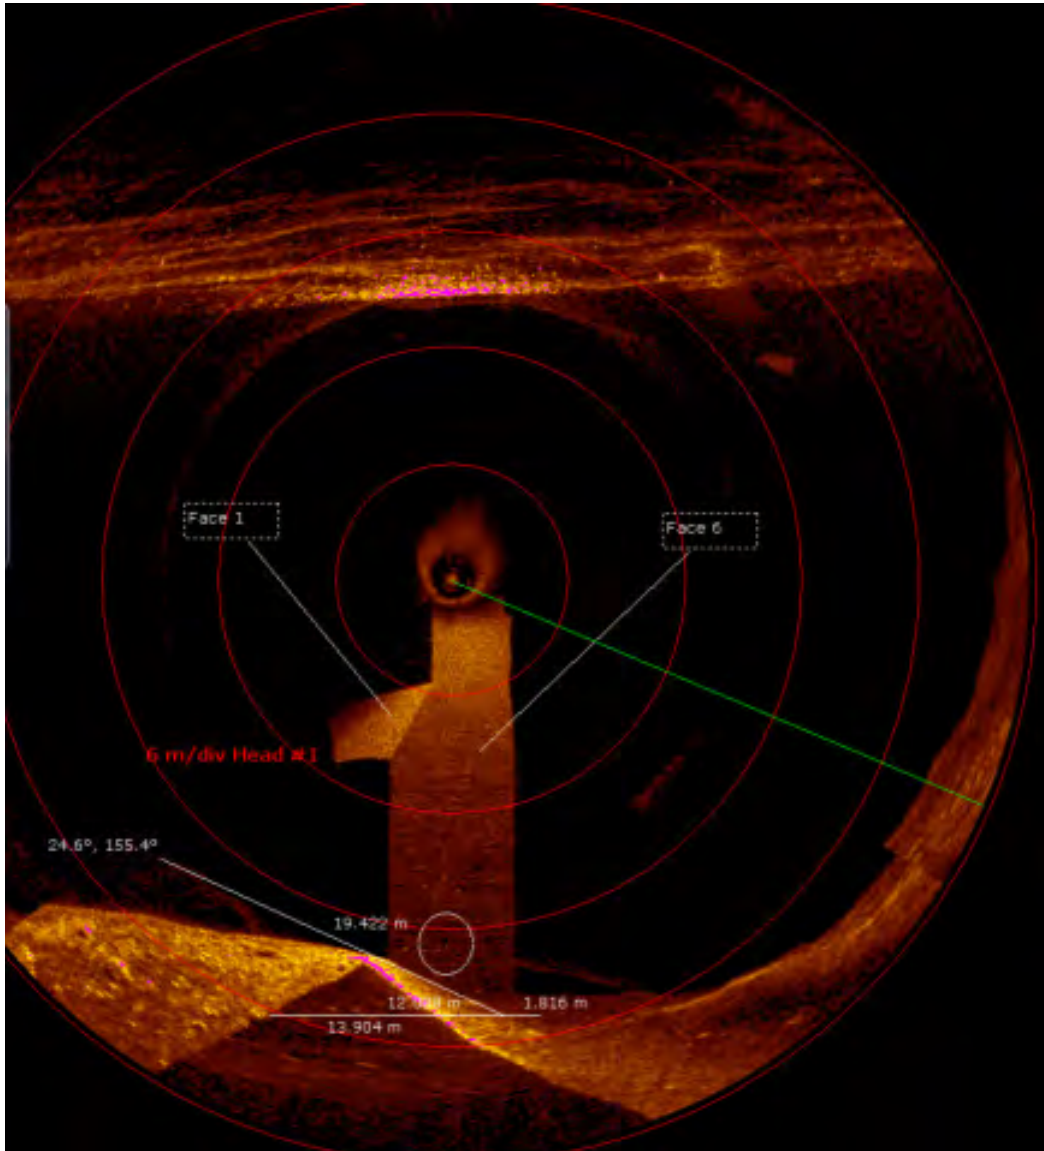
After completing the bottom scans the head was fitted into a drop frame and lowered along each face of the pier. As an example, figure 47 displays the image for face 6. It appears in good condition with the lakebed slope at the mud line at 24.6 degrees. The circled 'target' is 7.2 ft (2.2 m) above the mud line and may be a small void in the concrete face. Various anomalies were reported on other faces.

Figure 47. Image. Face 6 of the James E. Roberts Bridge.

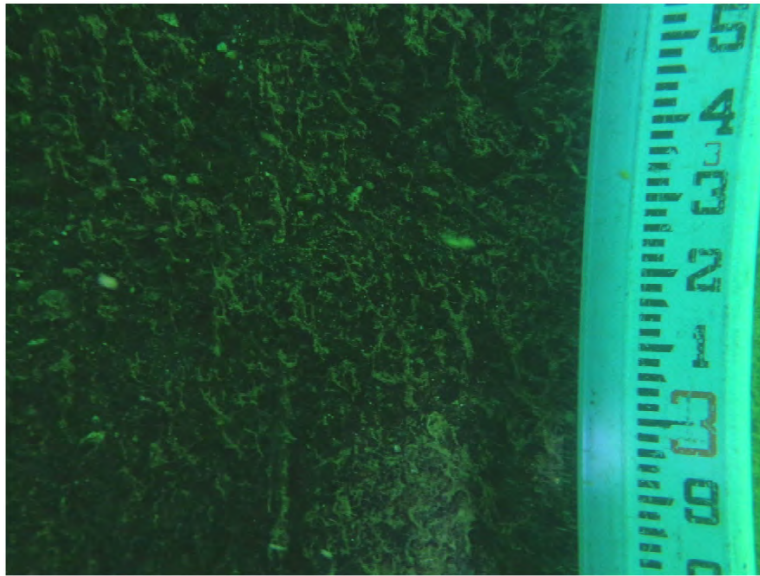
Figure 48. Photo. Marine growth on concrete 15 ft (4.6 m) below the waterline.

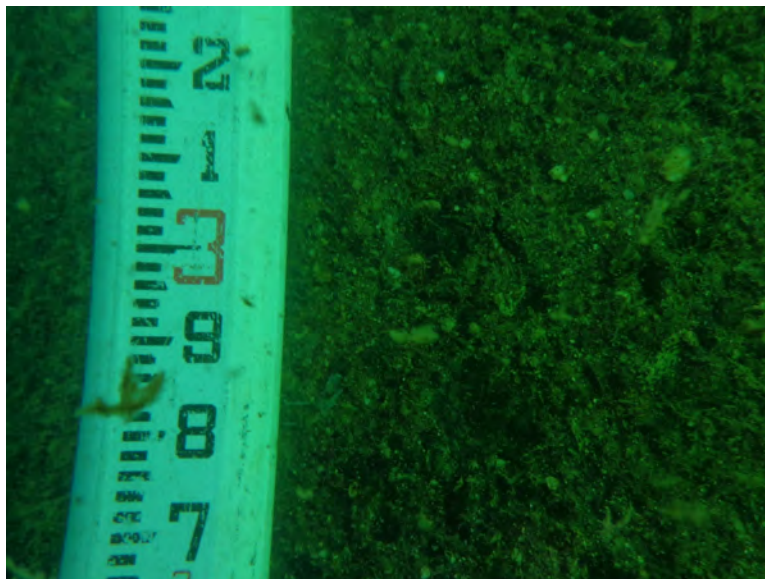
Figure 49. Photo. Typical concrete condition with level II cleaning (15 ft (4.6 m) below the waterline).

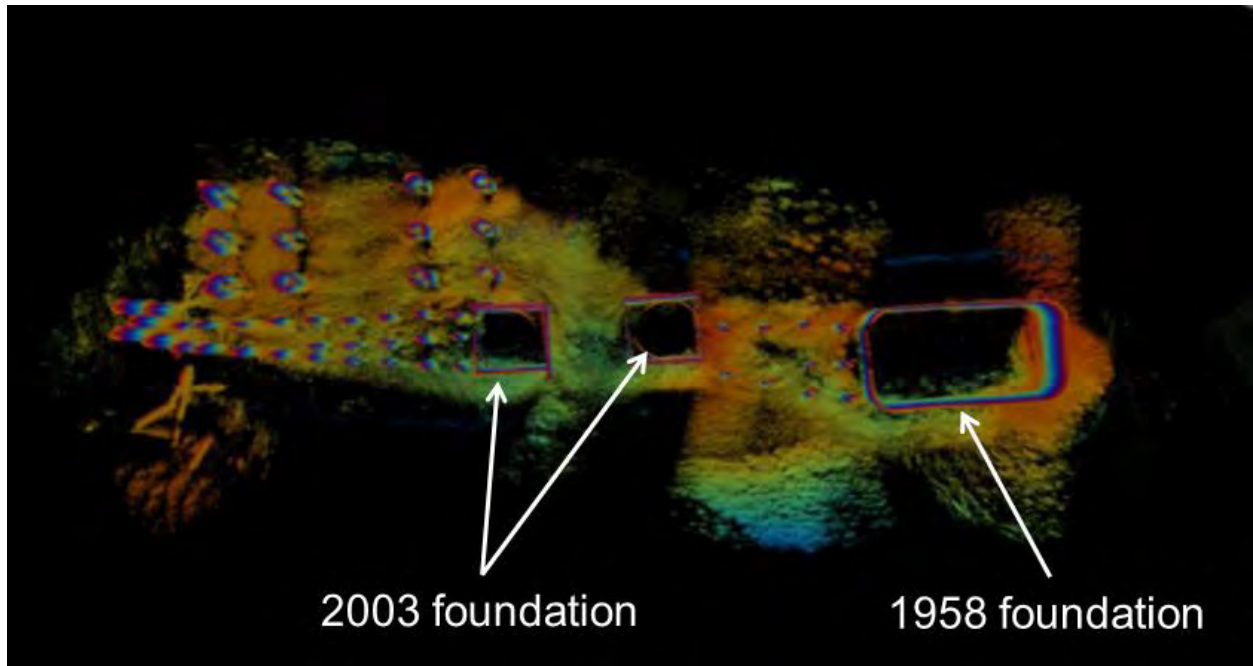
Water depth at tower 3 at the time of the inspection by team A was approximately 50 ft (15 m) on the west side and 80 ft (24 m) on the east side. A plan view of the sonar results is shown in figure 64. Figure 65 and figure 66 show views from the north and the south, respectively.

Figure 64. Image. Tower 3 plan view.

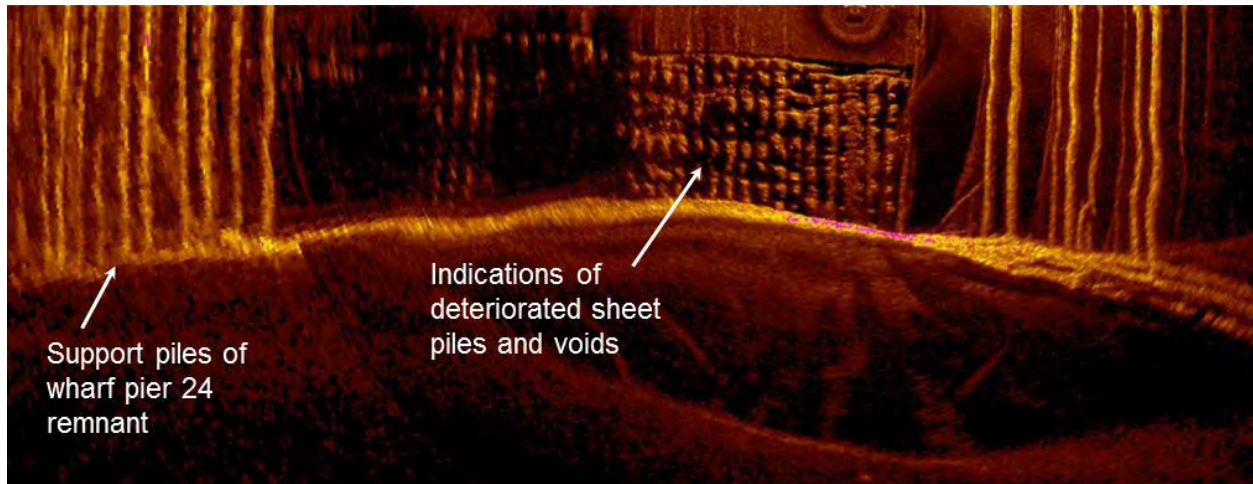
Figure 82. Image. Southeast corner of pier W2.

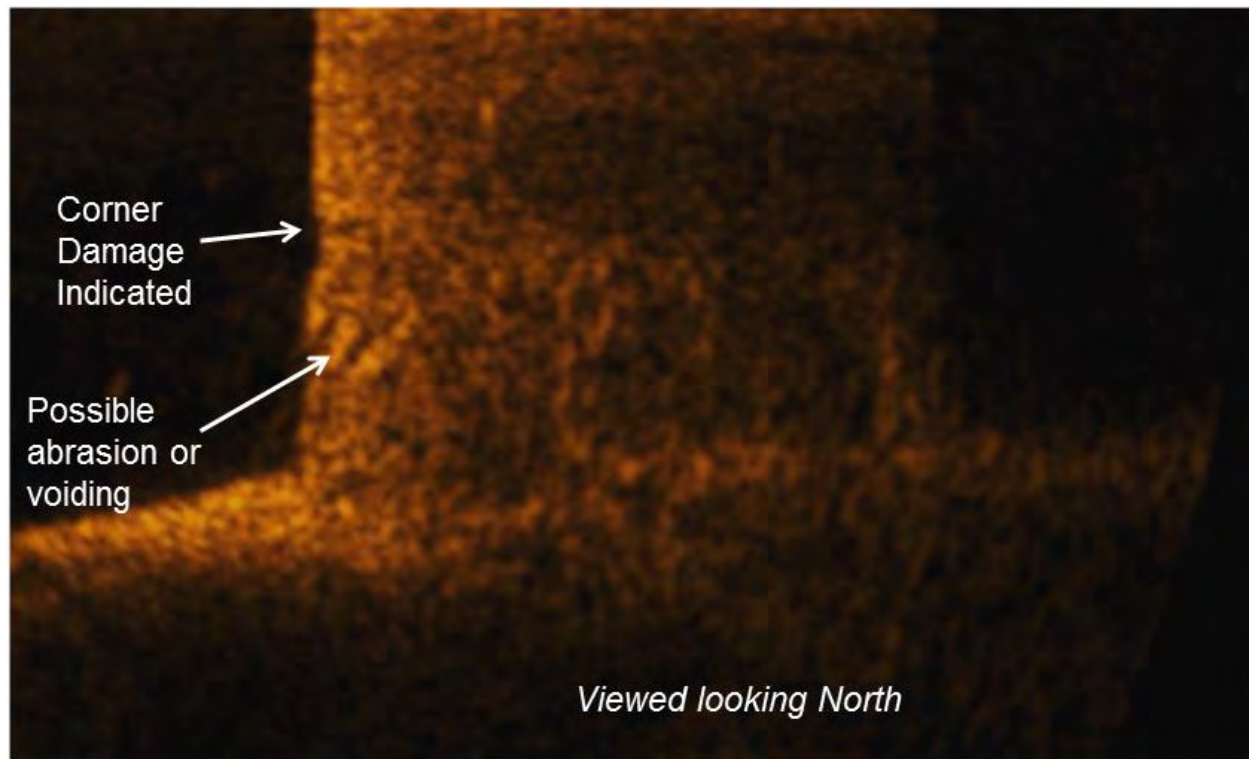
Figure 97. Image. Detail of south face of west support of the north channel pier.
