Analysis of Cracking in Jointed Plain Concrete Pavements

Course No: C01-034
Credit: 1 PDH

FHWA Publication No.: FHWA-HRT-16-073

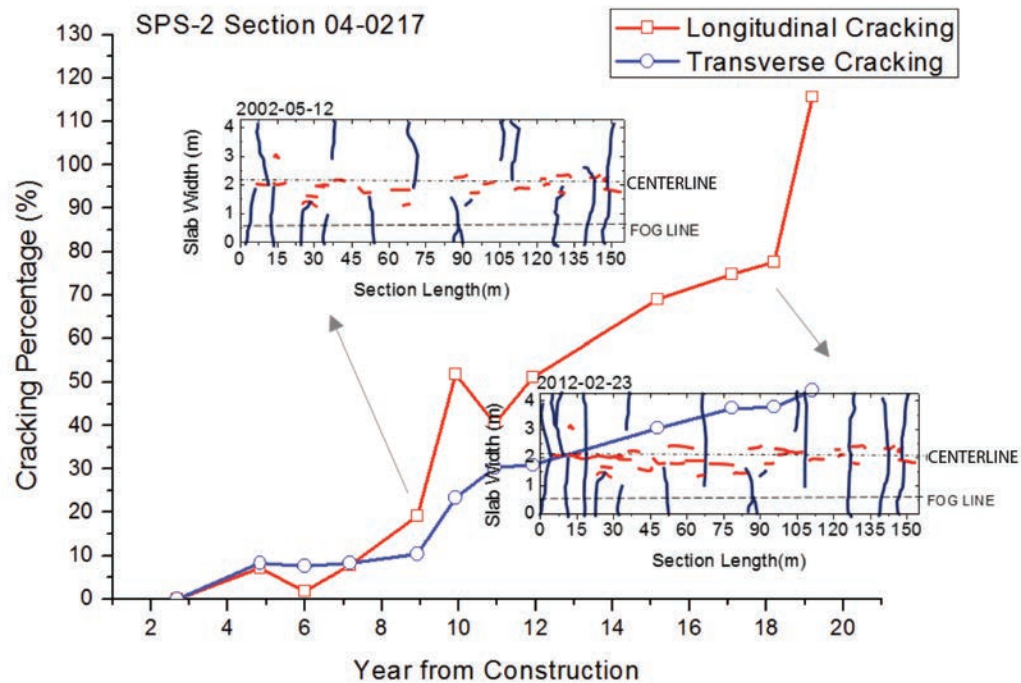
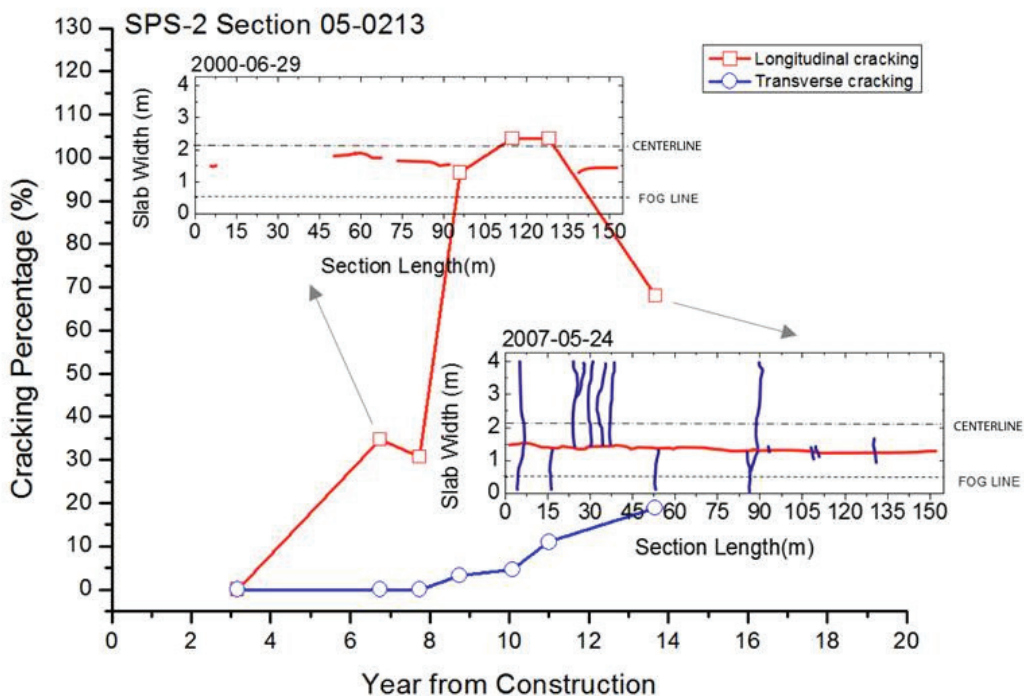
Figure 15 through figure 20 display details of the cracking process in three sections (0213, 0217, and 0218) for Arizona and Arkansas, respectively. Each figure shows the percentage cracking along with recorded snapshots of the patterns of longitudinal and transverse cracks.

The crack patterns revealed that most longitudinal cracks initiated at slab transverse edges, and the rest initiated from transverse cracks. Most transverse cracks initiated at the concrete slab edge close to the shoulder, and the rest initiated either at the slab edge in the middle of the lane (i.e., with the longitudinal joints) or from longitudinal cracks.

- Almost continuous single crack relatively near the shoulder (as seen for sections 04-0213, 05-0213, and 05-0217).

- A set of discrete cracks closer to the longitudinal centerline of slabs (as seen for sections 04-0217, 04-0218, and 05-0218).

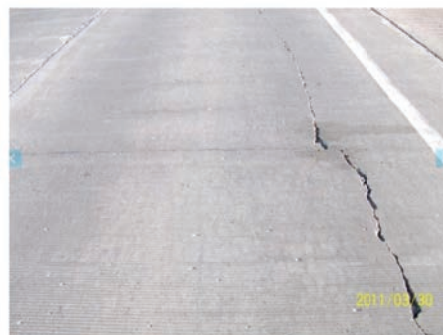
The snapshots featured in figure 21 through figure 30 were selected from 10 different sections in 7 sites (States). They share almost continuous single cracks relatively near the shoulder. These cracks occurred only

in the sections with DGAB (section 0213) and LCB (sections 0217, 0218, and 0206). This pattern of cracking was only found in the 10 sections in LTPP SPS-2 (according to monitoring results updated in 2013).

Details of the structural factors and climatic conditions of these sections are presented in table 3. The table shows that the pattern of longitudinal cracking was only exhibited in thinner pavements (design depth: 203 mm). By contrast, other sections with thick slabs (design depth: 279 mm) did not exhibit such longitudinal cracking. The table also shows

that this pattern of longitudinal cracking occurred mainly in sections constructed with wide slabs (with the exception of section 08-0218). This longitudinal cracking pattern (single cracking near the shoulder) occurred for soil types, shoulder types, and climatic conditions.
