Distresses and Treatment/Repair Methods in Flexible and Rigid Payments

Course No: C05-030
Credit: 5 PDH

Najib Gerges, Ph.D., P.E.

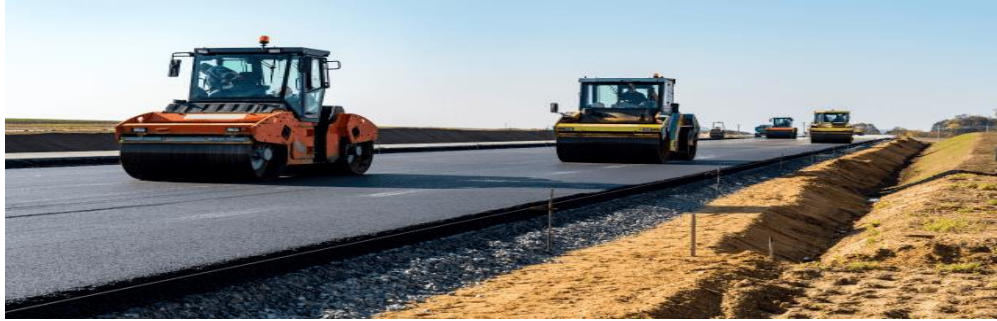
Figure 4 Surface Course/ Wearing Course

The surface course consists of multiple layers of pavement structure where the top layer is directly exposed to traffic as shown in Figure 4. The surface course is also called the wearing course. For flexible pavements, the bituminous surface is the wearing course, whereas in rigid pavements the concrete surface act as the base course cum wearing course. The wearing course reduces the percolation of water and provides an anti-skid and abrasion-resistant riding surface. The functions of surface or wearing course are as follows:

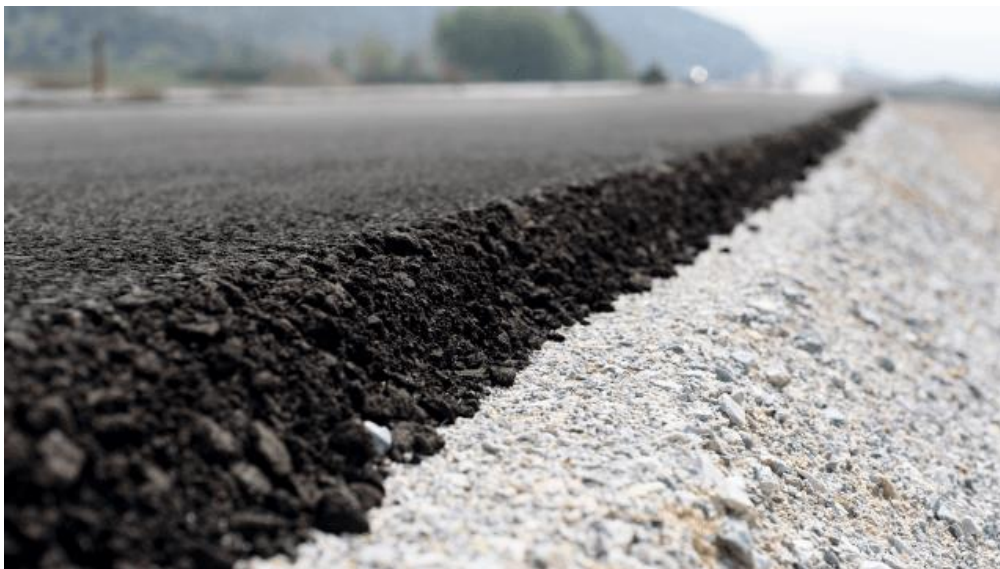
Figure 5 Base Course

The base course is the most important layer of a road structure which transfers the stresses developed due to traffic impacts through the wearing course. The base course layer provides the required foundation stiffness and structural strength.

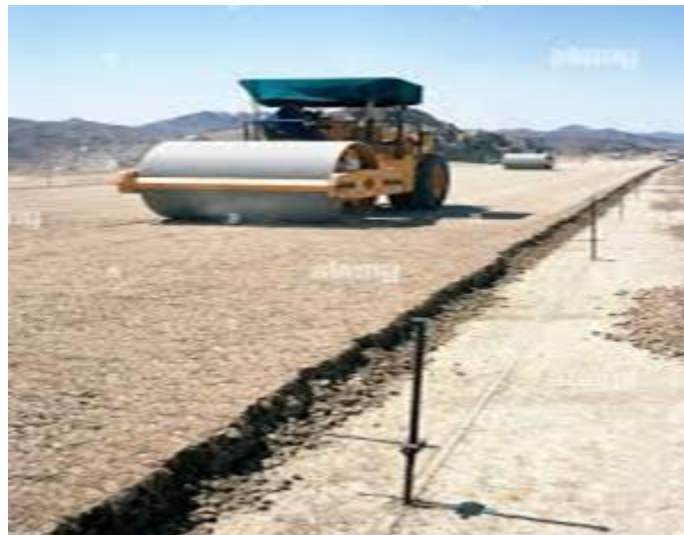
Figure 6 Subbase Course

This layer is necessary if the subgrade is of poor quality. In that case, an additional layer of burnt clinkers, gravel, slag, etc., is provided to strengthen the sub grade. The functions of the subbase course are as follows:

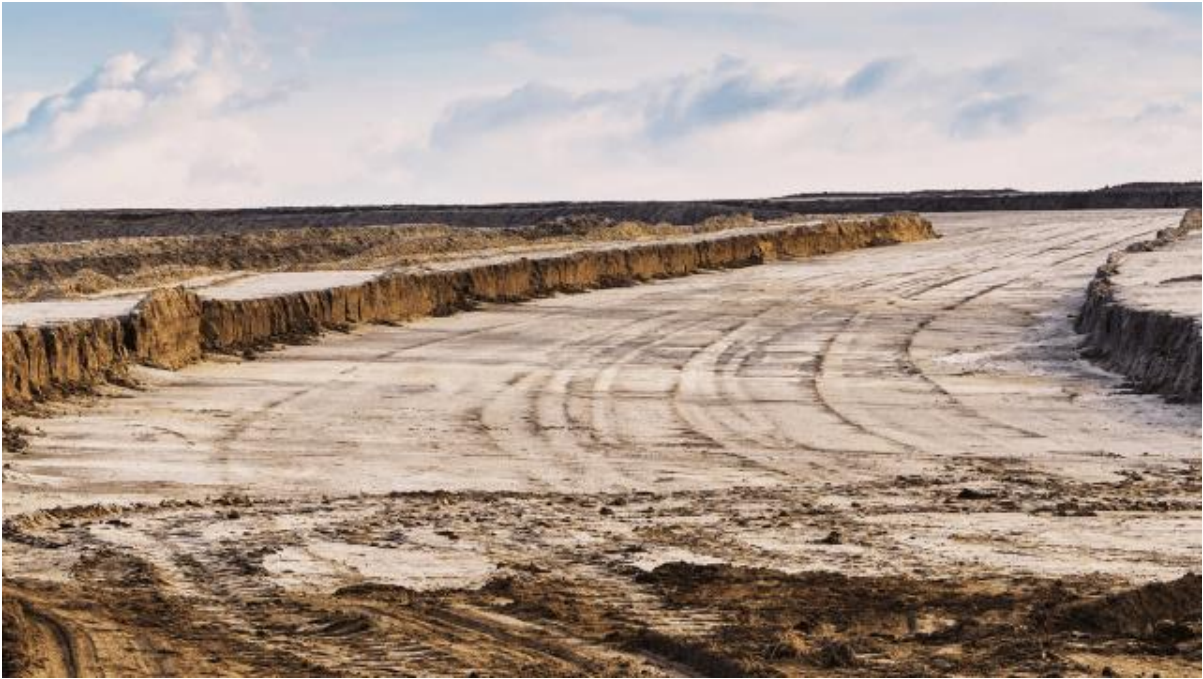
Figure 7 Subgrade Course

The subgrade is the compacted natural soil below the pavement layers and it is the finished or compacted surface on which the pavement rests. The subgrade course is also known as the formation and serves as the foundation of the pavement layers as shown in Figure 7.

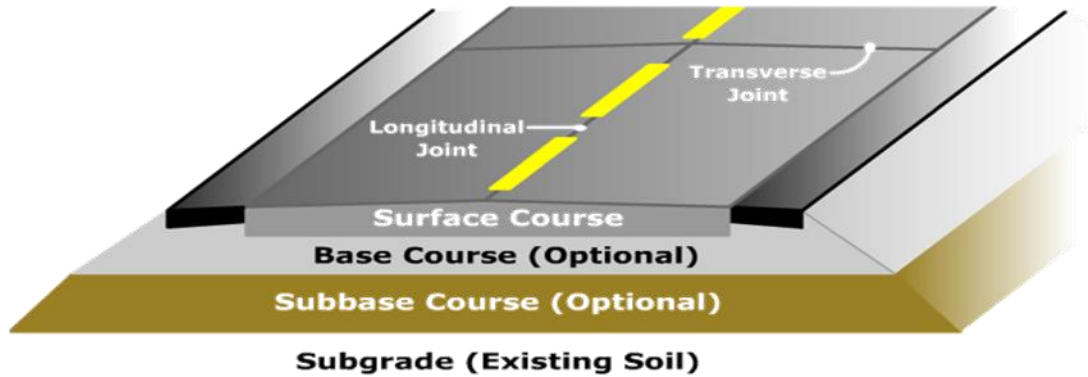
Figure 11 Cross-Sectional View of Typical Rigid Pavements

Figure 11 clearly displays a typical cross-sectional view of a rigid pavement.

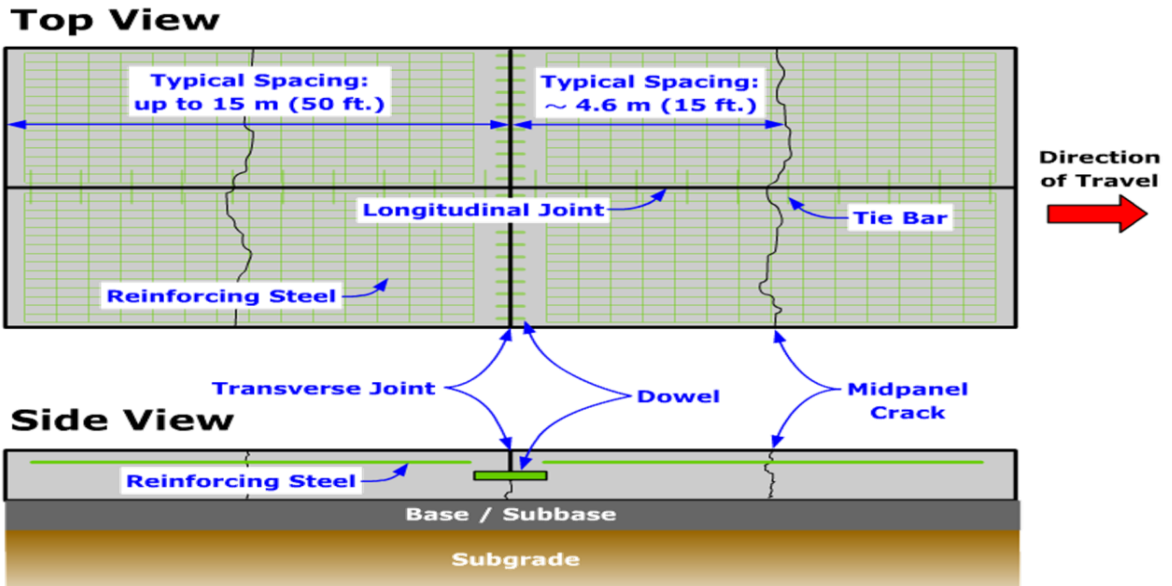
Figure 13 Top View and Side View of Jointed Reinforced Concrete Pavement

- Jointed Reinforced Concrete Pavement (JRCP) as shown in Figure 13.

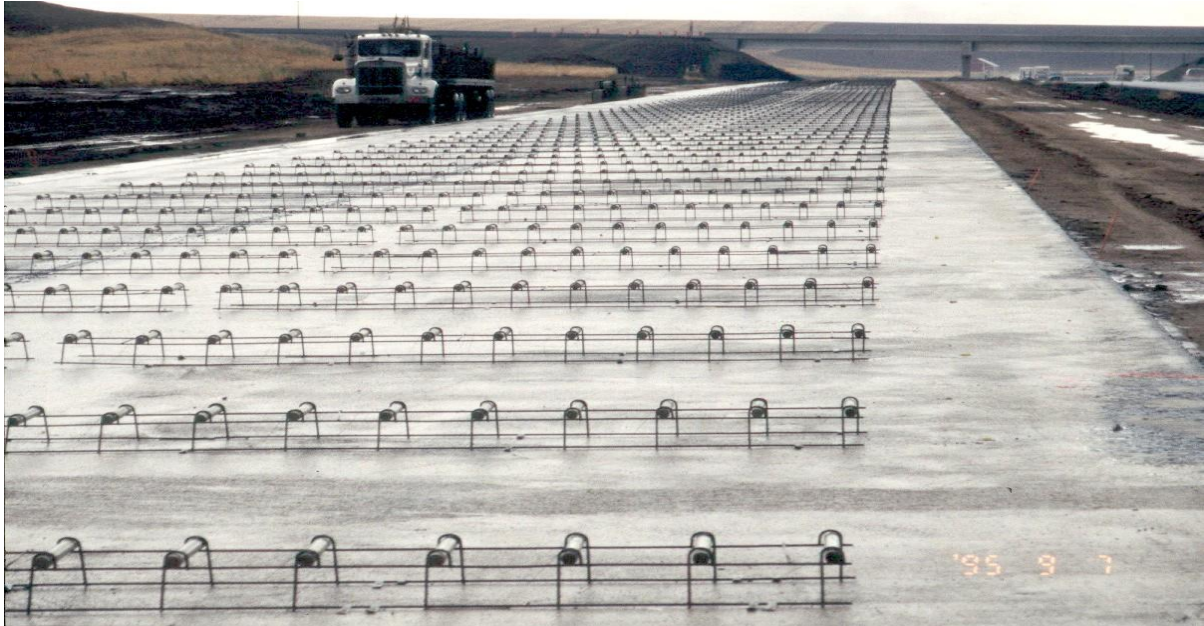
Figure 17 Dowel Bars in Rigid Pavements

expansion and contraction of adjacent slabs independently. Dowel bars are short steel bars that are installed in concrete slabs to provide a mechanical connection that does not restrict horizontal joint movement. They are designed to reduce joint deflection and stress in the approach and leave slab by increasing load transfer efficiency.

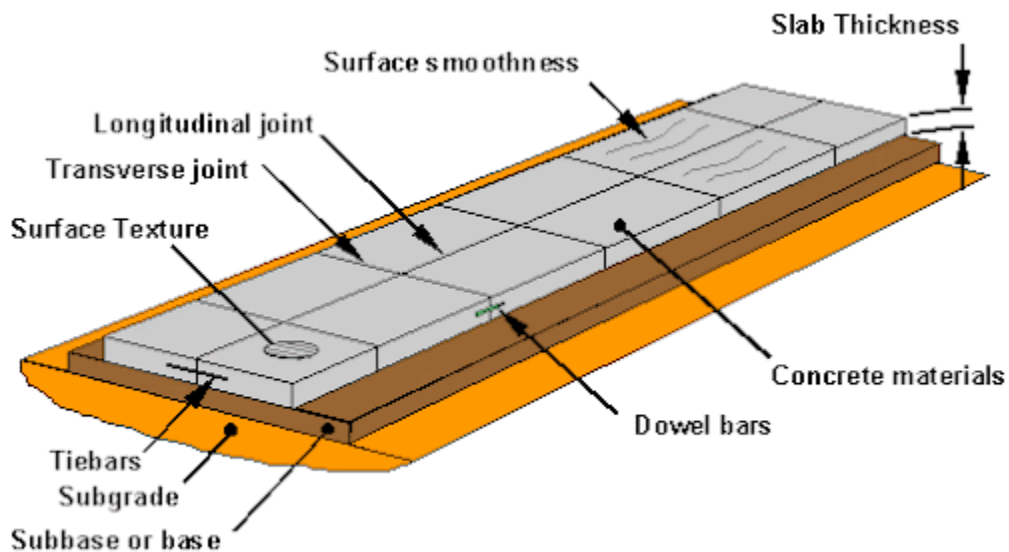
Figure 18 Tie Bars and Dowel Bars in Rigid Pavements

Figure 18 illustrates the placement of tie bars and dowel bars in rigid pavements.

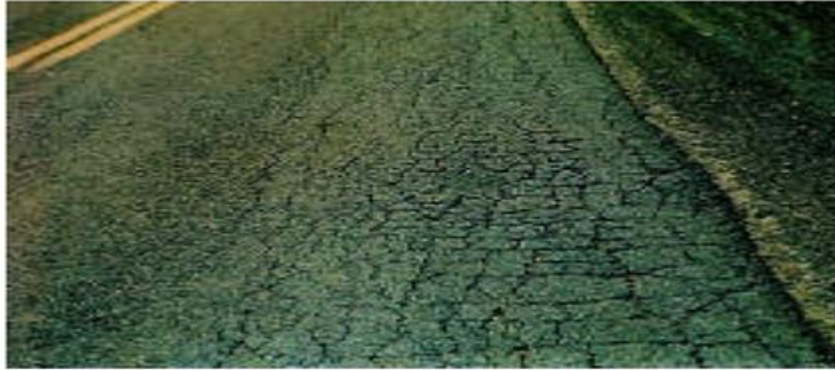
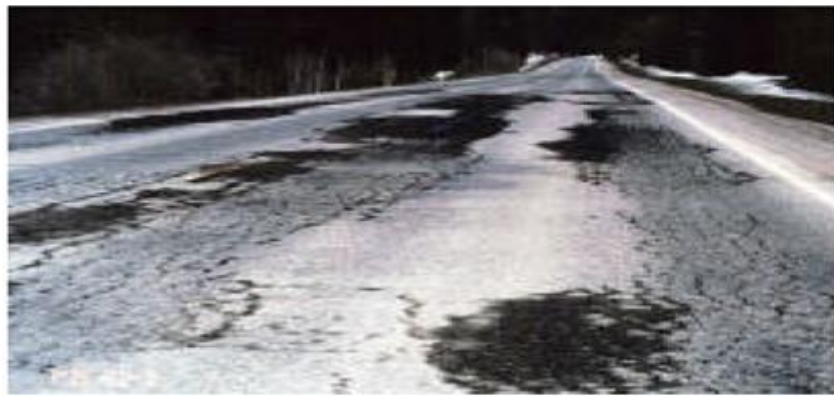
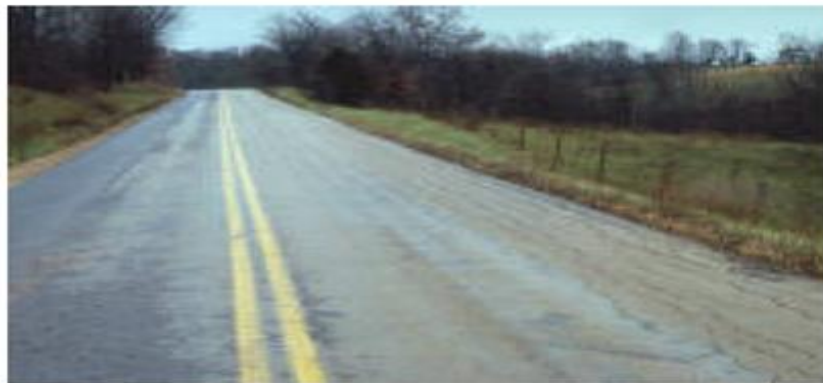
Description: Fatigue or alligator cracking is defined as a series of interconnected cracks caused by fatigue failure of the HMA surface (or stabilized base) under repeated traffic loading. In thin pavements, cracking initiates at the bottom of the HMA layer where the tensile stress is the highest then propagates to the surface as one or more longitudinal cracks. This is commonly referred to as "bottom-up" or "classical" fatigue cracking. In thick pavements, the cracks most likely initiate from the top in areas of high localized tensile stresses resulting from tire-pavement interaction and asphalt binder aging (top-down cracking). After repeated loading, the longitudinal cracks connect forming many-sided sharp-angled pieces that develop into a pattern resembling the back of an alligator or crocodile. Figures 19, 20, and 21 illustrate various forms of alligator/fatigue cracking.

Figure 19 Bad Fatigue Cracking

Figure 20 Fatigue Cracking from Frost Action

Figure 21 Fatigue Cracking from Edge Failure

Problem: Indicator of structural failure, cracks allow moisture infiltration, roughness, may further deteriorate to a pothole.

Possible Causes: Inadequate structural support, which can be caused by a myriad of things. A few of the more common ones are listed here:

- Decrease in pavement load supporting characteristics.
- Loss of base, subbase or subgrade support (e.g., poor drainage or spring thaw resulting in a less stiff base).
- Stripping on the bottom of the HMA layer (the stripped portion contributes little to pavement strength so the effective HMA thickness decreases).
- Increase in loading (e.g., more or heavier loads than anticipated in design).
- Inadequate structural design.
- Poor construction (e.g., inadequate compaction).

Repair: A fatigue cracked pavement should be investigated to determine the root cause of failure. Any investigation should involve digging a pit or coring the pavement to determine the pavement's structural makeup as well as determining whether or not subsurface moisture is a contributing factor. Once the characteristic alligator pattern is apparent, repair by crack sealing is generally ineffective. Fatigue crack repair generally falls into one of two categories:

- Small, localized fatigue cracking indicative of a loss of subgrade support. Remove the cracked pavement area then dig out and replace the area of poor subgrade and improve the drainage of that area if necessary. Patch over the repaired subgrade.
- Large fatigue cracked areas indicative of general structural failure. Place a Hot Mix Asphalt (HMA) overlay over the entire pavement surface. This overlay must be strong enough structurally to carry the anticipated loading because the underlying fatigue cracked pavement most likely contributes little or no strength.

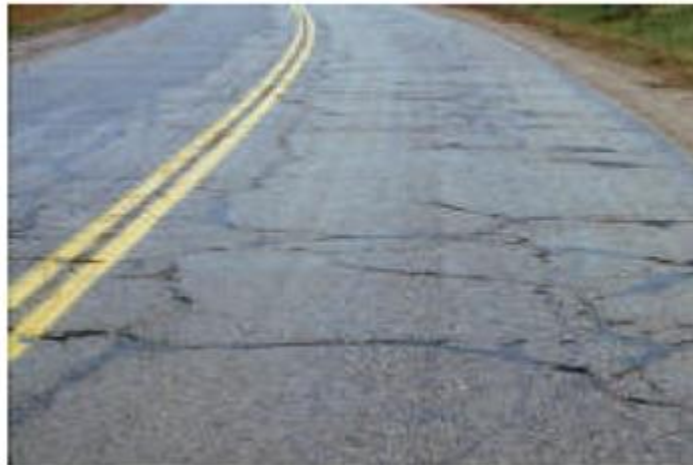
Figure 24 Block Cracking

Description: Block cracking is defined as interconnected cracks that divide the pavement up into rectangular pieces as shown in Figure 24. Blocks range in size from approximately 0.1 m² (1 ft²) to 9 m² (100 ft²). Larger blocks are generally classified as longitudinal and transverse cracking. Block cracking normally occurs over a large portion of pavement area but sometimes will occur only in non-traffic areas.

Problem: Allows moisture infiltration, roughness.

Possible Causes: HMA shrinkage and daily temperature cycling. Typically, caused by an inability of asphalt binder to expand and contract with temperature cycles because of the following:

Repair: Strategies depend upon the severity and extent of the block cracking:

- Low severity cracks (< 1/2 inch wide). Crack seal to prevent (1) entry of moisture into the subgrade through the cracks and (2) further raveling of the crack edges. HMA can provide years of satisfactory service after developing small cracks if they are kept sealed.
- High severity cracks (> 1/2-inch-wide and cracks with raveled edges). Remove and replace the cracked pavement layer with an overlay.

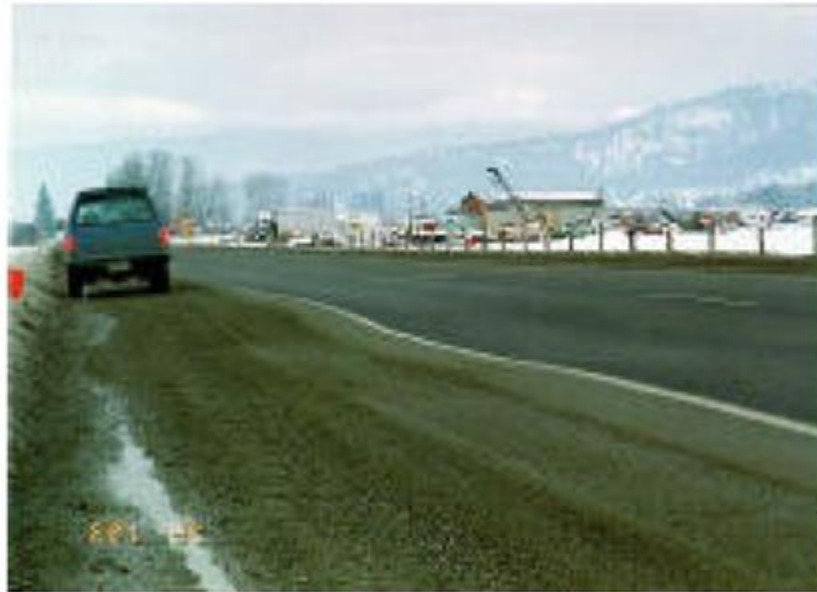
Figure 26 Depression in Left Lane and Shoulder

Description: Depression is defined as localized pavement surface areas with slightly lower elevations than the surrounding pavement as illustrated in Figure 26. Depressions are very noticeable after a rain when they fill with water.

Problem: Roughness, depressions filled with substantial water can cause vehicle hydroplaning.

Possible Causes: Frost heave or subgrade settlement resulting from inadequate compaction during construction.

Repair: By definition, depressions are small localized areas. A pavement depression should be investigated to determine the root cause of failure (i.e., subgrade settlement or frost heave). Depressions should be repaired by removing the affected pavement then digging out and replacing the area of poor subgrade. Patch over the repaired subgrade.

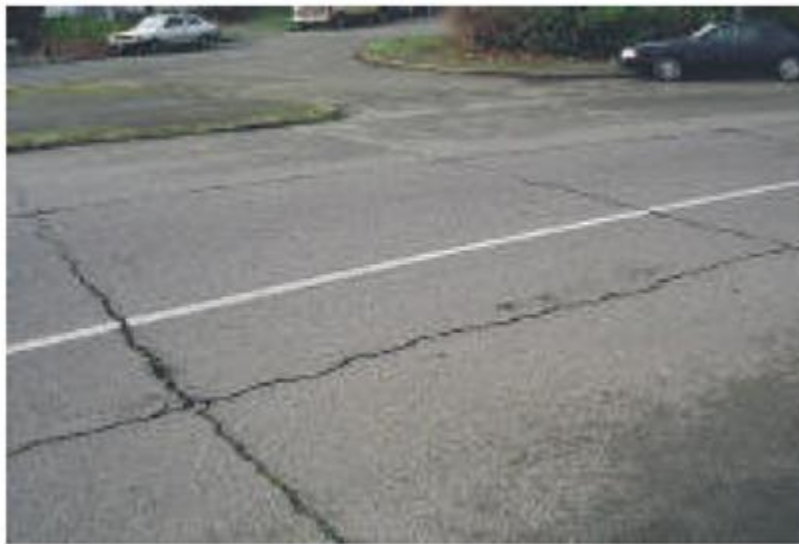
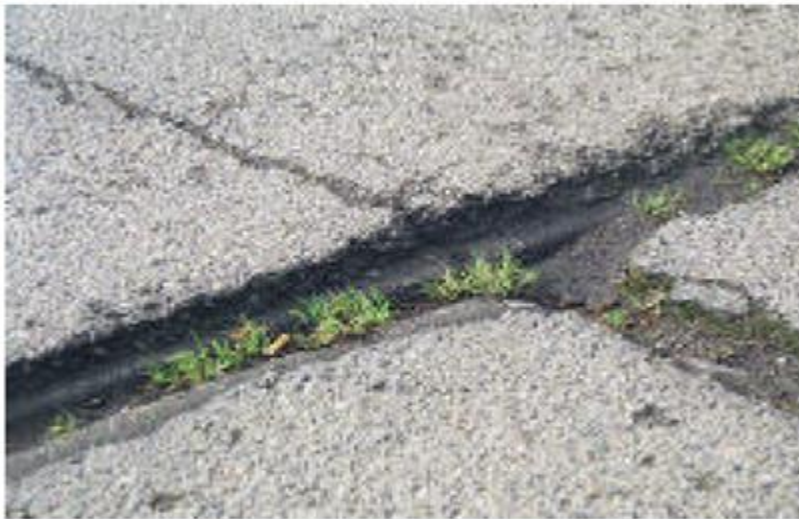
Description: Joint reflection cracking are cracks in a flexible overlay of a rigid pavement. The cracks occur directly over the underlying rigid pavement joints as illustrated in Figures 27 and 28. Joint reflection cracking does not include reflection cracks that occur away from an underlying joint or from any other type of base (e.g., cement or lime stabilized).

Figure 27 Joint Reflection Cracking on an Arterial

Figure 28 Joint Reflection Cracking Close-Up

Problem: Allows moisture infiltration, roughness.

Repair: Strategies depend upon the severity and extent of the cracking:

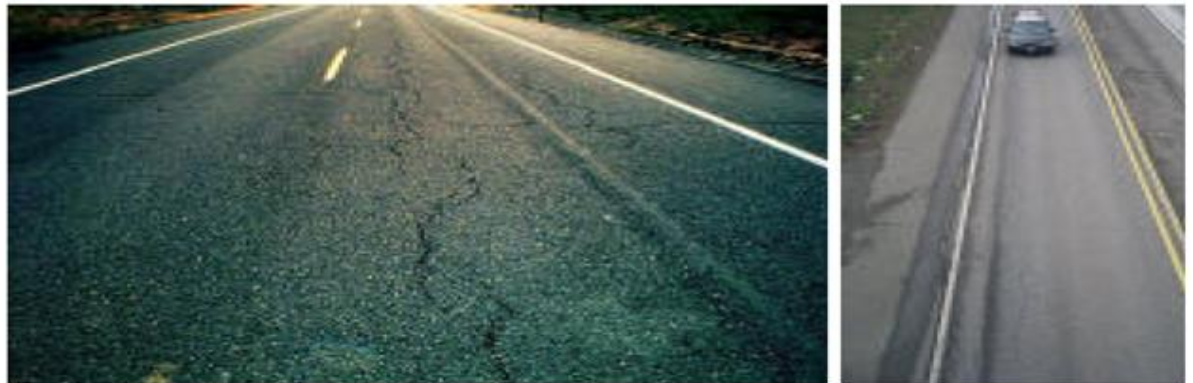
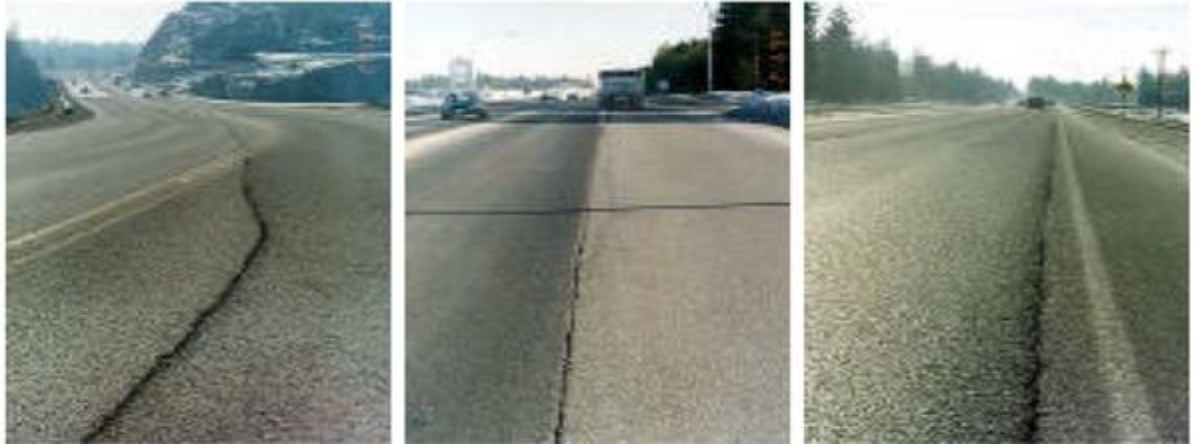
Description: Longitudinal cracking are cracks parallel to the pavement's centerline or laydown direction as illustrated in Figures 29 and 30. These cracks are usually a type of fatigue cracking.

Figure 29 Longitudinal Cracking as the Onset of Fatigue Cracking

Figure 30 Longitudinal Cracking from Poor Joint Construction

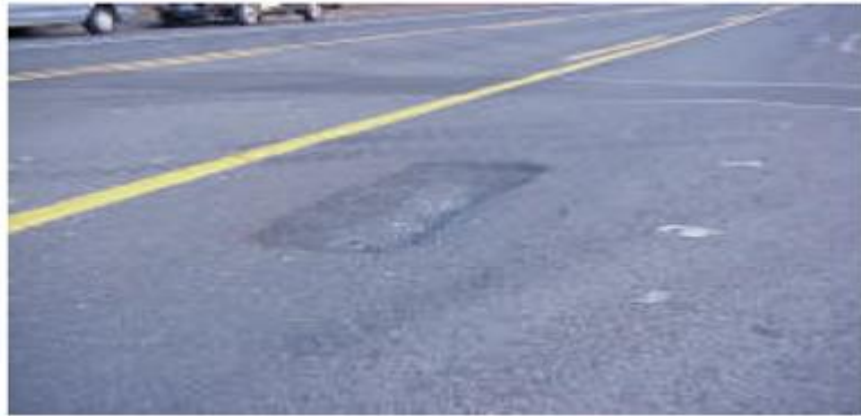
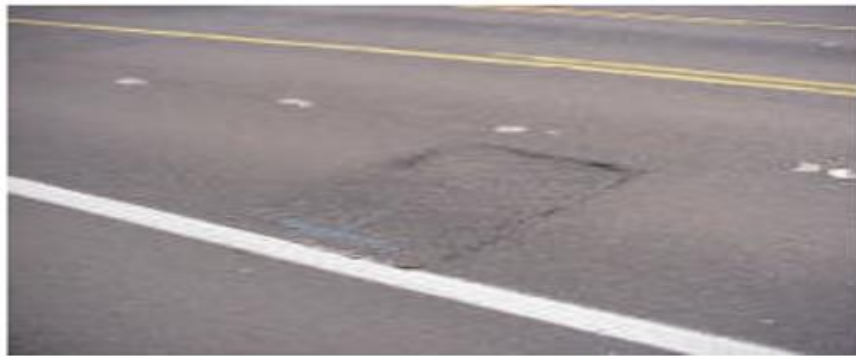
Description: Patching is defined as an area of pavement that has been replaced with new material to repair the existing pavement as illustrated in Figures 31, 32, and 33. A patch is considered a defect no matter how well it performs.

Figure 31 Failing Patch

Figure 32 Patch over Localized Distress

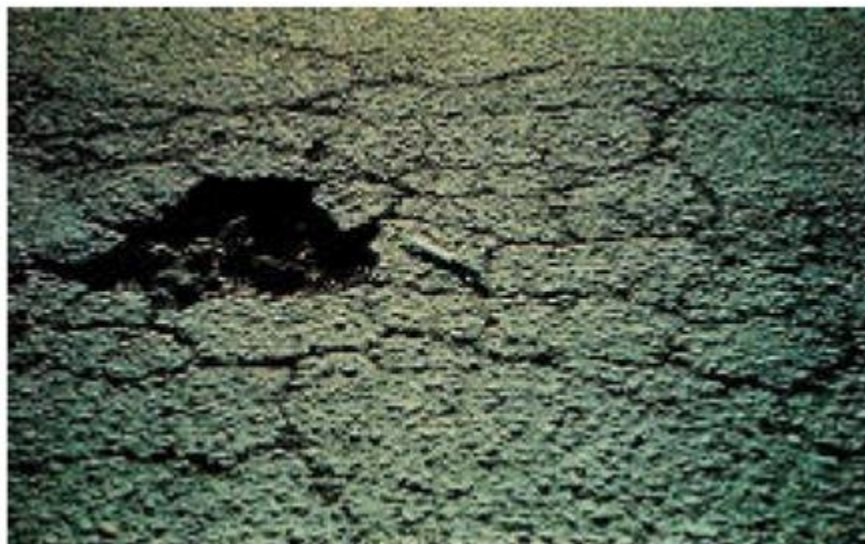
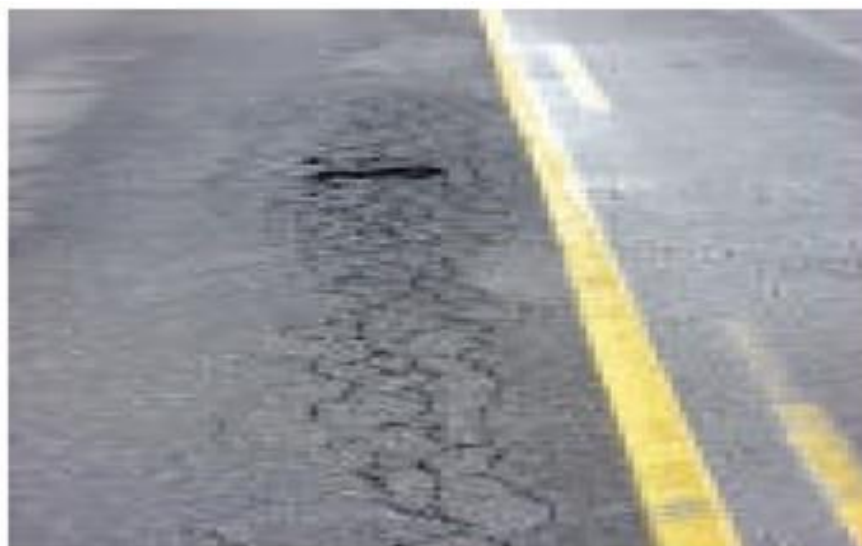
Description: Potholes are small, bowl-shaped depressions in the pavement surface that penetrate all the way through the HMA layer down to the base course as illustrated in Figures 36 and 37. They generally have sharp edges and vertical sides near the top of the hole. Potholes are most likely to occur on roads with thin HMA surfaces (25 to 50 mm (1 to 2 inches)) and seldom occur on roads with 100 mm (4 inch) or deeper HMA surfaces.

Figure 36 Pothole from Fatigue Cracking

Figure 37 Developing Pothole

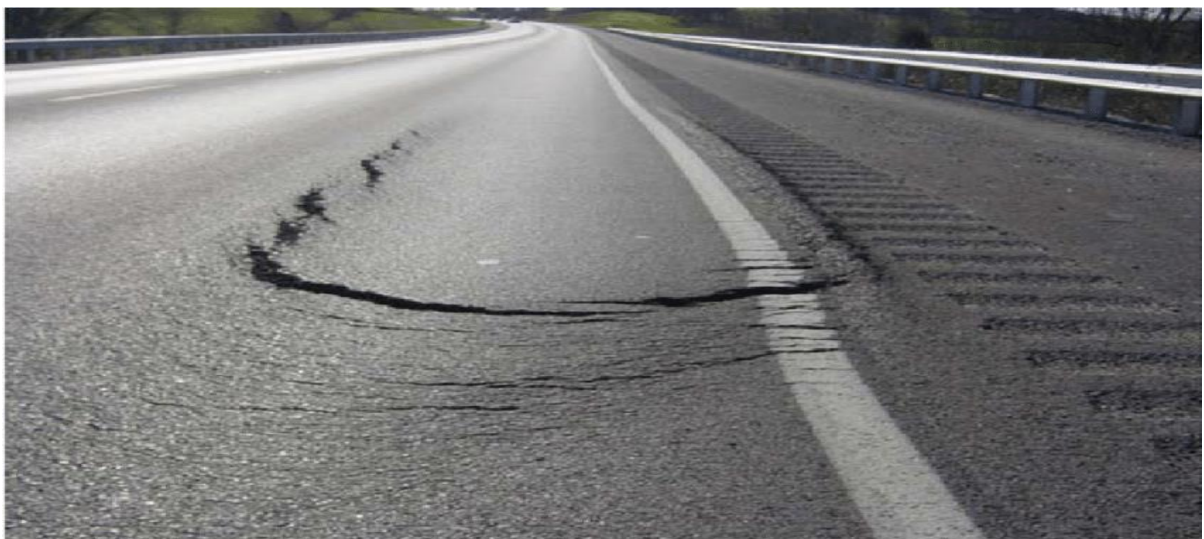
Figure 40 Slippage Cracking

Description: Slippage cracking are crescent or half-moon shaped cracks generally having two ends pointed into the direction of traffic as illustrated in Figure 42.

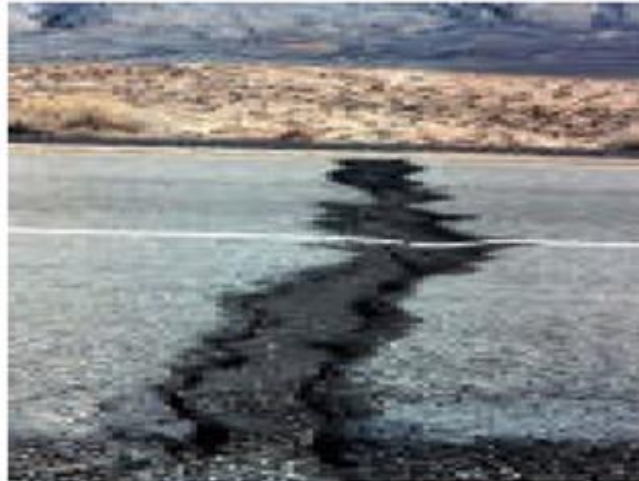
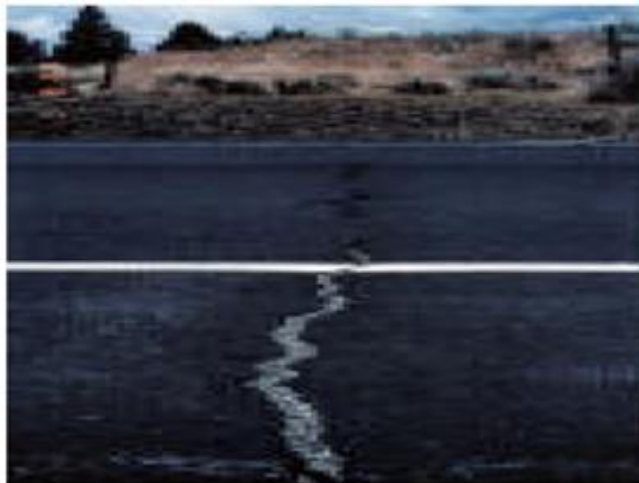
Description: Transverse or thermal cracking are cracks perpendicular to the pavement's centerline or lay down direction as illustrated in Figures 46, 47, and 48. Usually a type of thermal cracking.

Figure 44 Large Patched Thermal Crack

Figure 45 Smaller Patched Thermal Crack

Figure 46 Small Thermal Crack

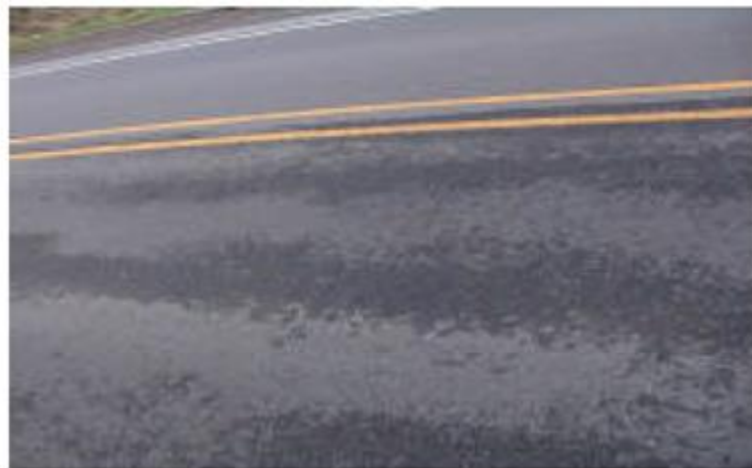
Figure 47 Water Bleeding Up Close

Description: Water bleeding occurs when water seeps out of joints or cracks or through an excessively porous HMA layer as illustrated in Figure 49. Pumping occurs when water and fine material is ejected from underlying layers through cracks in the HMA layer under moving loads as illustrated in Figure 50.

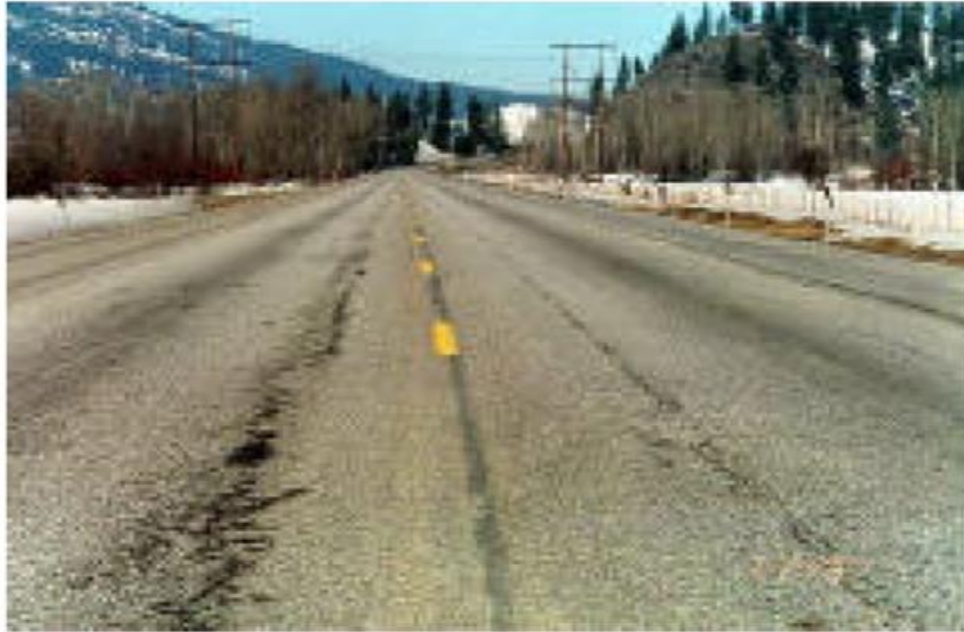
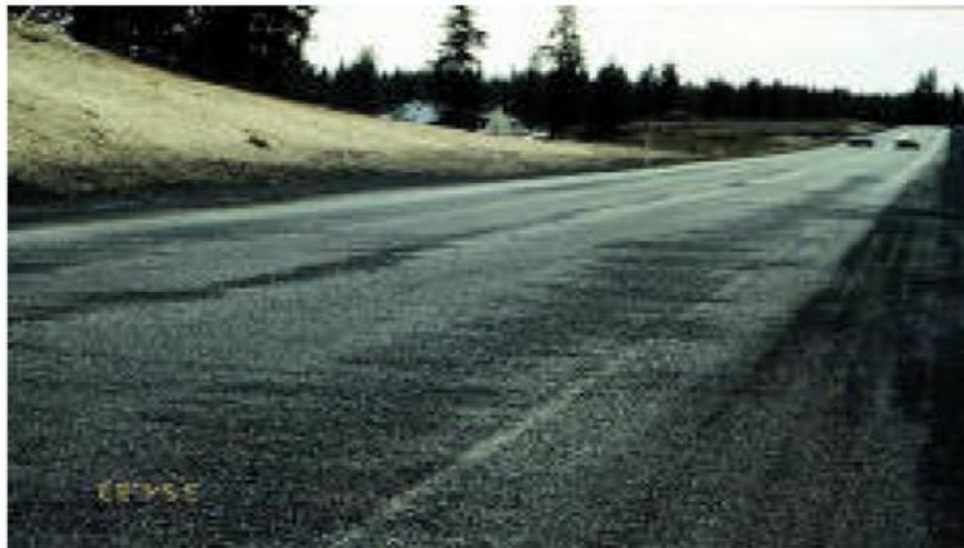
Description: As pavement ages and hardens, the asphalt binder and fine aggregate may begin to wear away. This process is called weathering. As weathering progresses, the coarse aggregate becomes exposed, dislodged, and missing, resulting in a distress called raveling; so raveling can be defined as the progressive disintegration of an HMA layer from the surface downward as a result of the dislodgement of aggregate particles as illustrated in Figures 38 and 39.

Figure 49 Raveling Due to Low Density

Figure 50 Raveling from Snow Plot

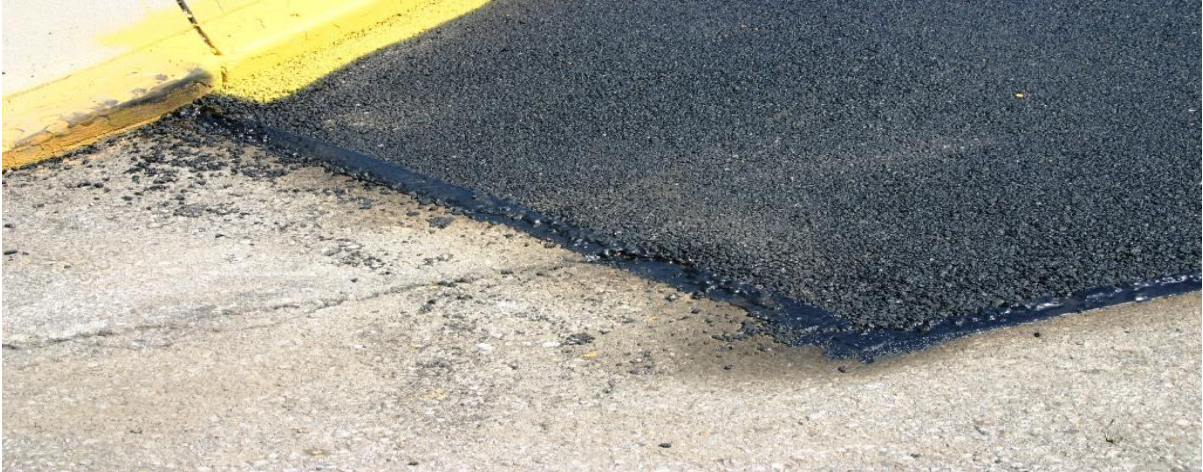
Figure 51 New Asphalt Binder over an Existing Pavement

Definition: Asphalt Surface Treatments refer to the reconditioning of the wearing (surface) course of older existing asphalt pavements. The term may also be applied to the final phases of new asphalt pavement construction. Surface treatments are installed by placing a layer of new asphalt binder on the existing pavement as illustrated in Figure 51.

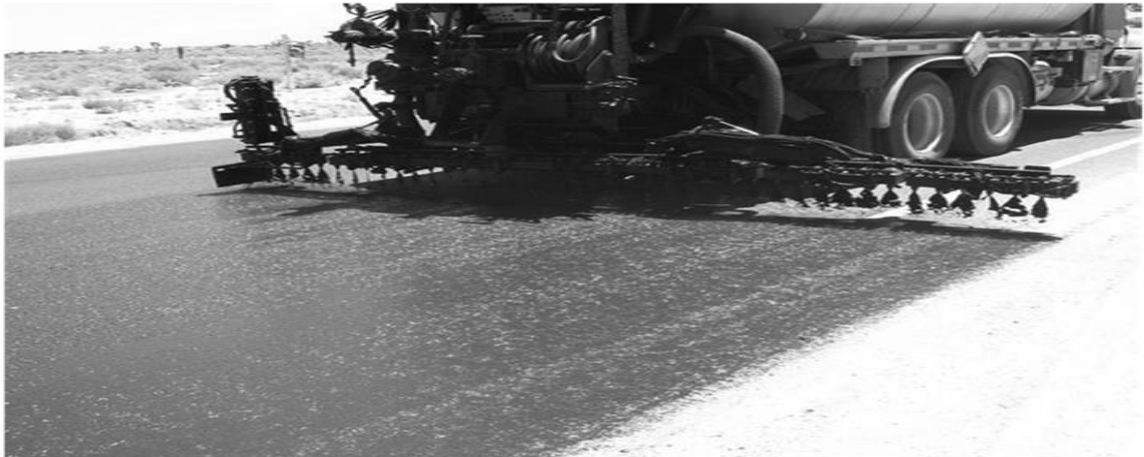
Figure 52 Fog Seal

Fog Seal contains globules of paving asphalt, water, an emulsifying agent or surfactant, and sometimes a rejuvenator. Soap is a common form of a surfactant. A rejuvenator is an asphalt additive that when applied to the existing pavement will slightly soften the pavement it is applied to creating a better bond.

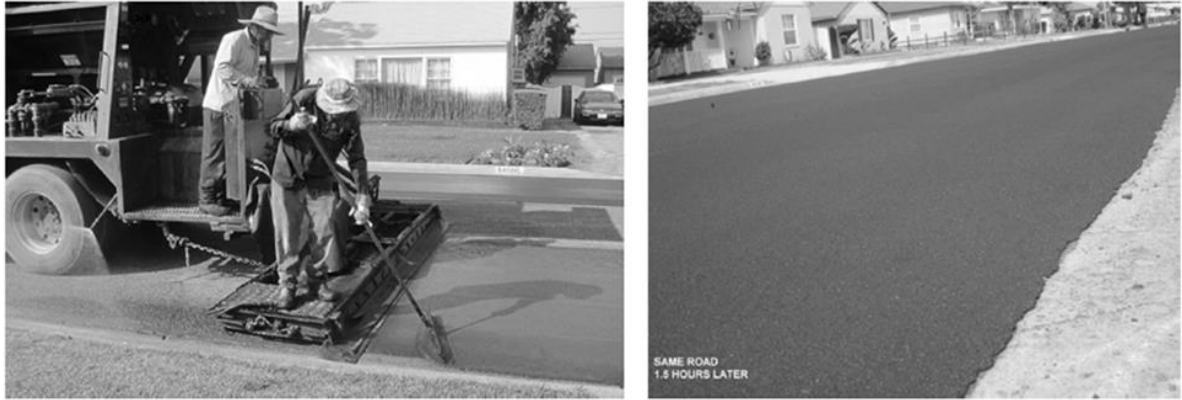
Figure 54 Slurry Seal

It is applied in a thin layer of 3- to 6-mm layers to seal the pavement. and prevent some minor distresses such as raveling, minor/narrow cracks, crack joints, mat tearing, etc. However, it provides no structural strength. A Slurry Seal is similar to a Fog Seal except the slurry seal has aggregates as part of the mixture.

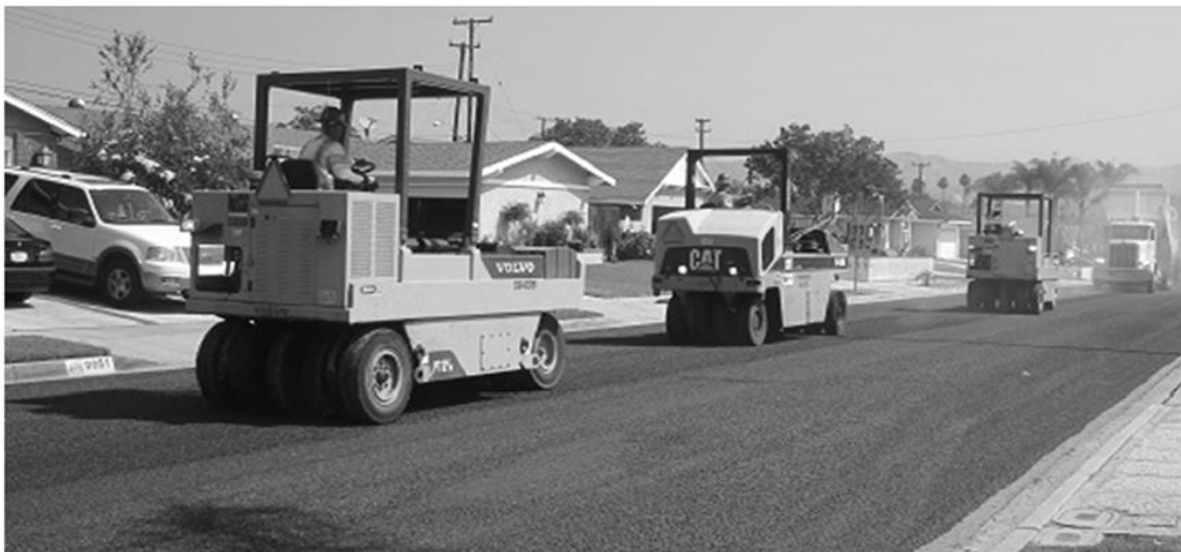
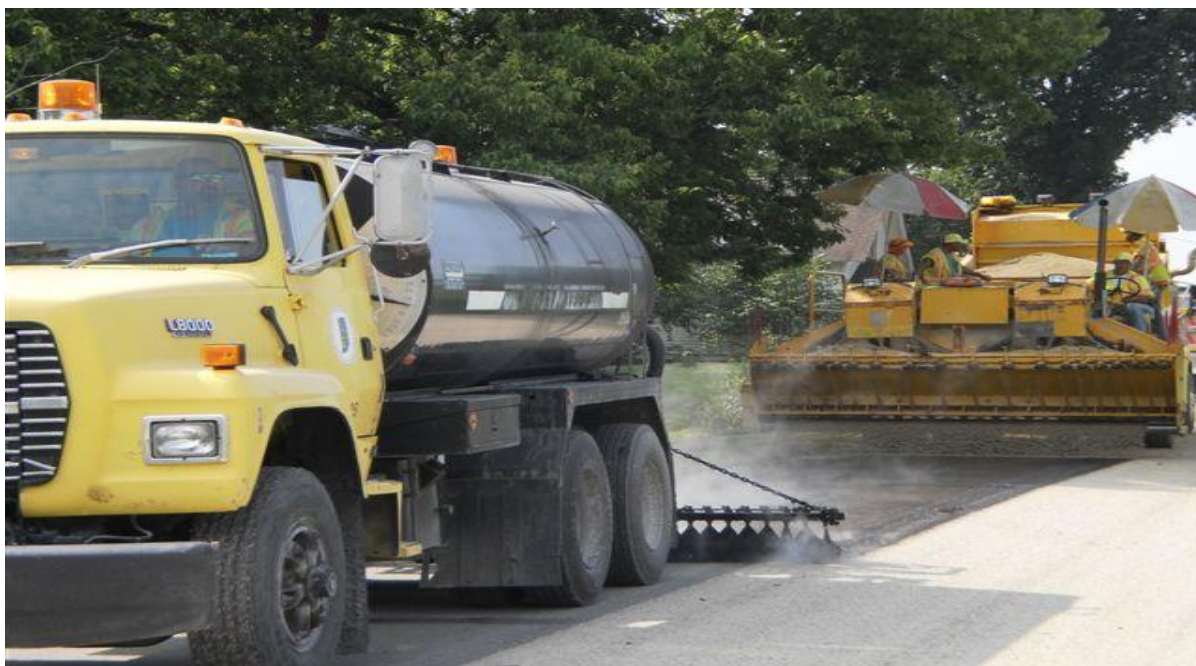
Asphalt emulsions used in Chip Seal applications contain globules of paving asphalt, water, an emulsifying agent or surfactant, polymer, and sometimes a rejuvenator.

Figure 56 Chip Seal

Figure 57 Chip Seal Application

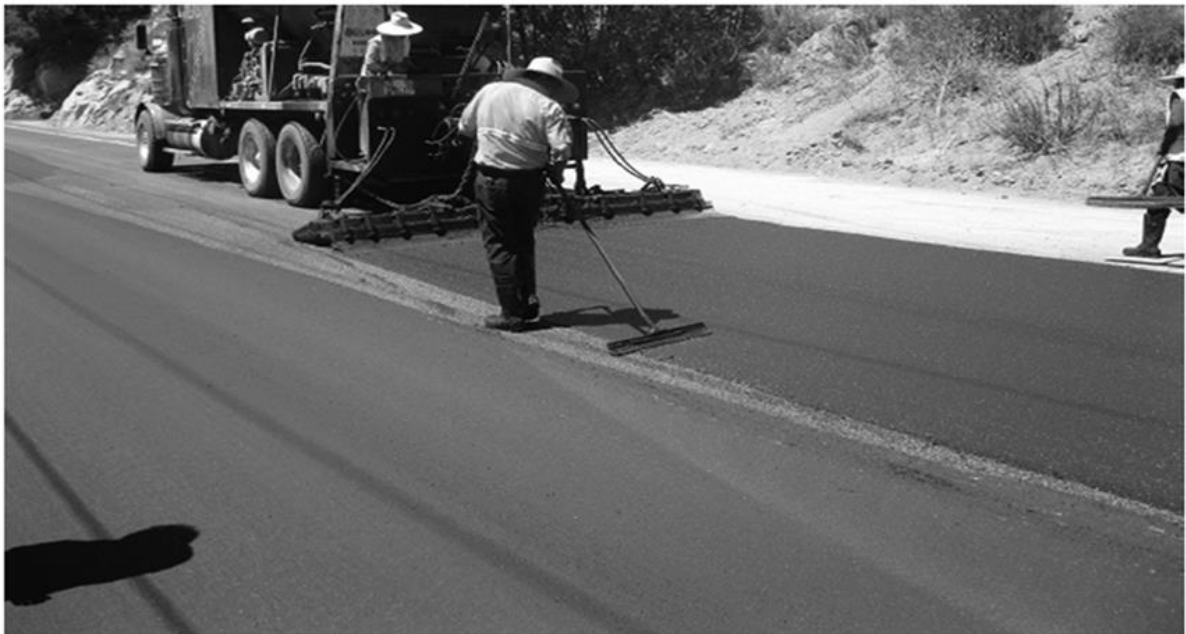
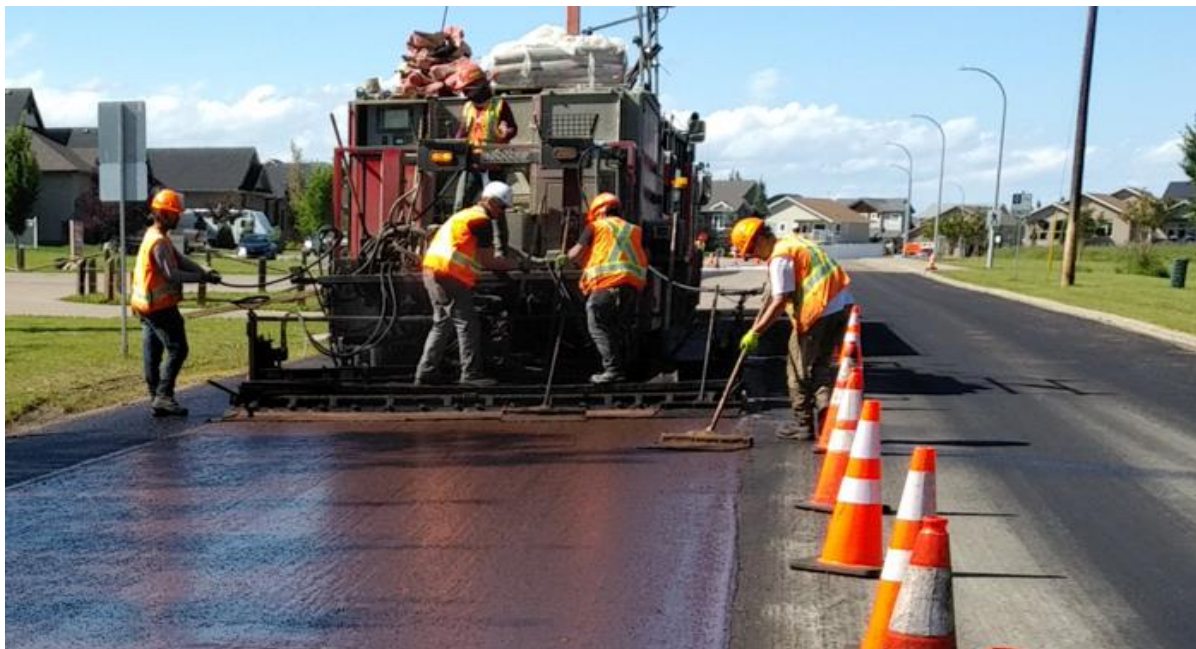
The major difference between Slurry Seal and Microsurfacing is in how they “break” or harden. Slurry relies on evaporation of the water in the asphalt emulsion. The asphalt emulsion used in Microsurfacing contains chemical additives that allow it to break without relying on the sun or heat for evaporation to occur. Refer to Figures 58 and 59.

Figure 58 Microsurfacing

Figure 59 Microsurfacing Application

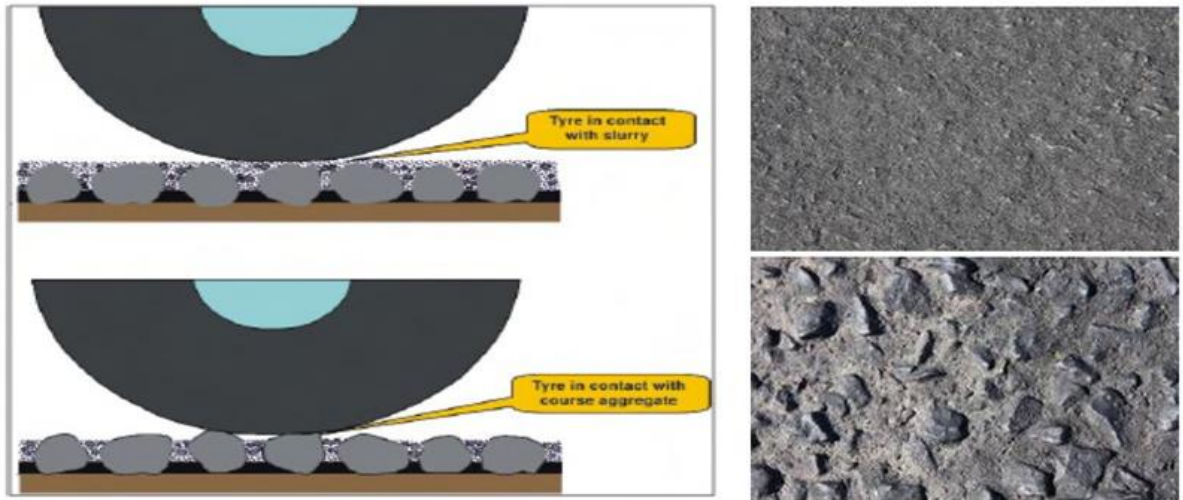
Figure 62 Cape Seal

The Slurry Seal or Microsurfacing serves to improve the chip retention and smoothness of the driving surface.

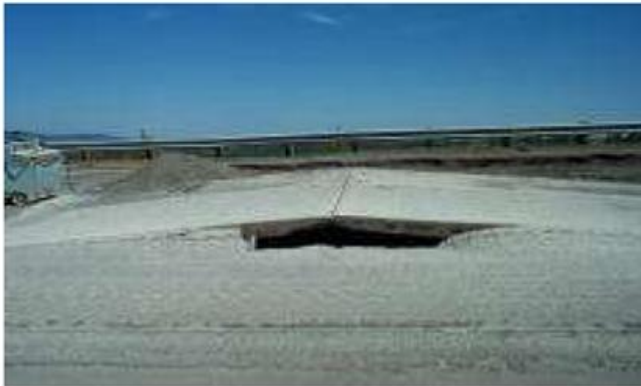
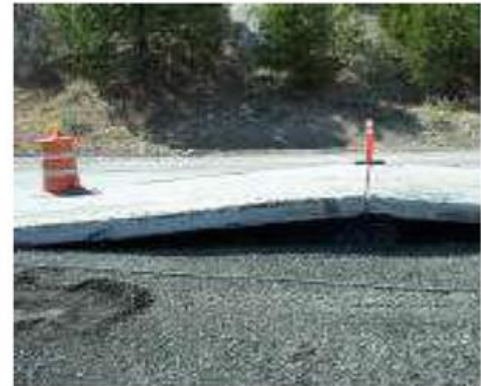
Figure 65 Severe Blowup

Description: Blowup or buckling is a localized upward slab movement and shattering at a joint or crack as illustrated in Figure 65. Usually occurs in spring or summer and is the result of insufficient room for slab expansion during hot weather.

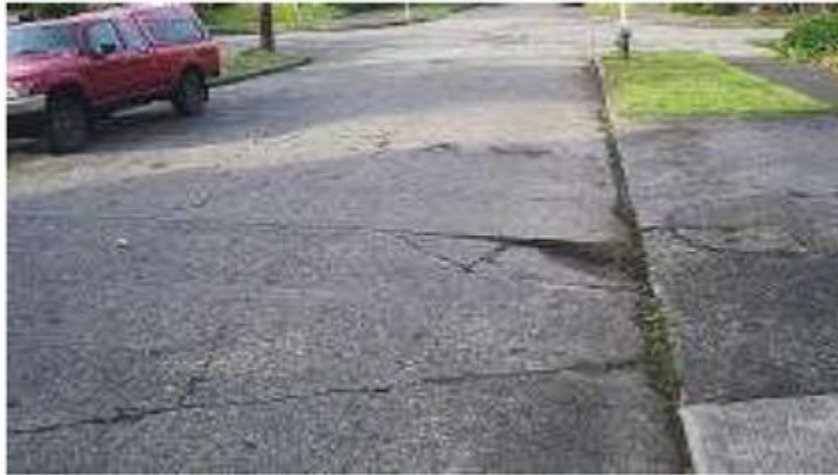
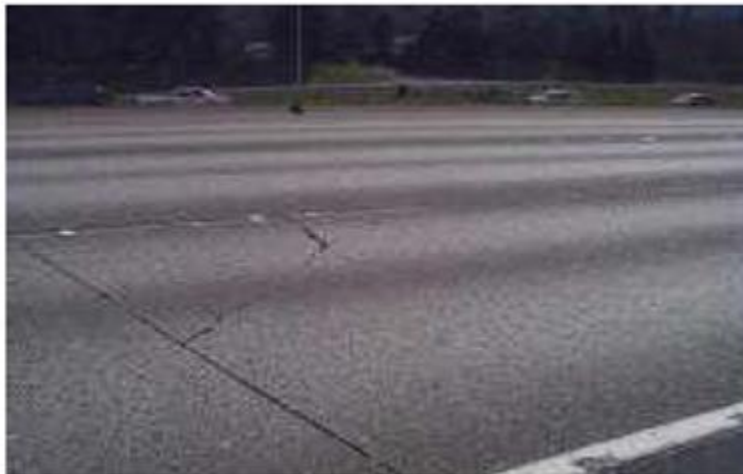
Description: Corner break is a crack that intersects the PCC slab joints near the corner as illustrated in Figures 66 and 67. "Near the corner" is typically defined as within about 2 m (6 ft) or so. A corner break extends through the entire slab and is caused by high corner stresses.

Figure 66 Corner Break on a Residential Street

Figure 67 Corner Break on a Highway

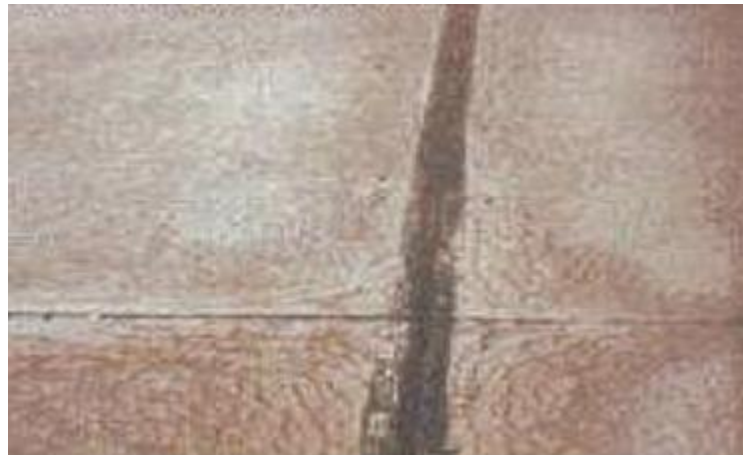
Figure 68 D Cracking at Panel Corners

Description: Durability cracking is a series of closely spaced, crescent-shaped cracks near a joint, corner or crack as illustrated in Figure 68. It is caused by freeze-thaw expansion of the large aggregate within the PCC slab. Durability cracking is a general PCC distress and is not unique to pavement PCC.
