Distresses and Treatment/Repair Methods in Flexible and Rigid Payments

Course No: C05-030
Credit: 5 PDH

Najib Gerges, Ph.D., P.E.

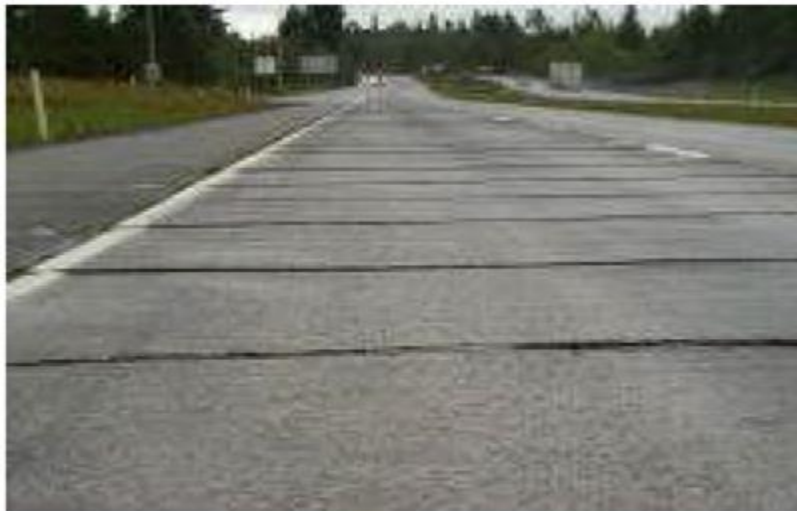
Figure 69 Faulting from Ground Level

Description: Faulting is defined as the difference in elevation across a joint or crack usually associated with undoweled JPCP as illustrated in Figures 69, 70, and 71. Usually the approach slab is higher than the leave slab due to pumping, the most common faulting mechanism. Faulting is noticeable when the average faulting in the pavement section reaches about 2.5 mm (0.1 inch). When the average faulting reaches 4 mm (0.15 in), diamond grinding or other rehabilitation measures should be considered.

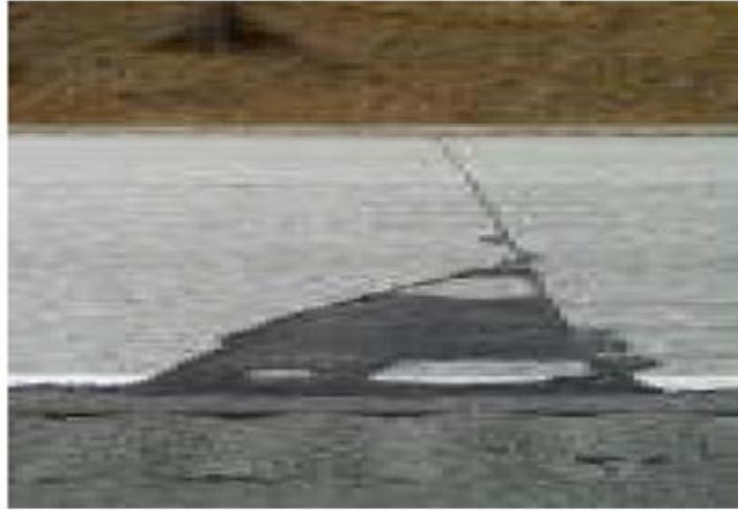
Figure 72 Patched Failure

Repair: Removal and replacement of the affected joint load transfer system followed by a full-depth patch for affected area.

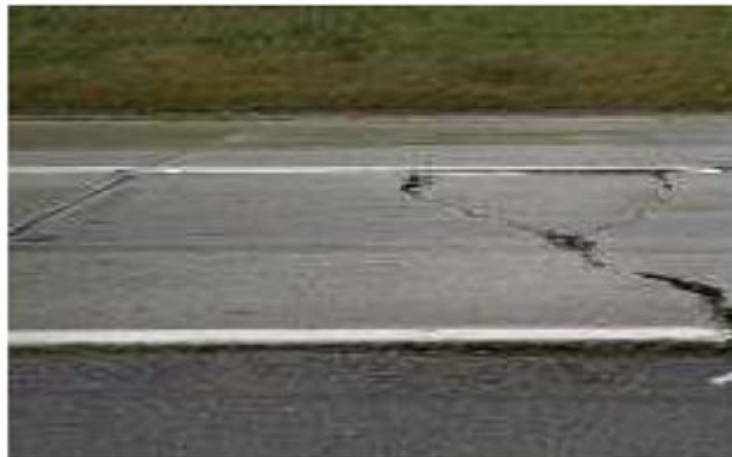
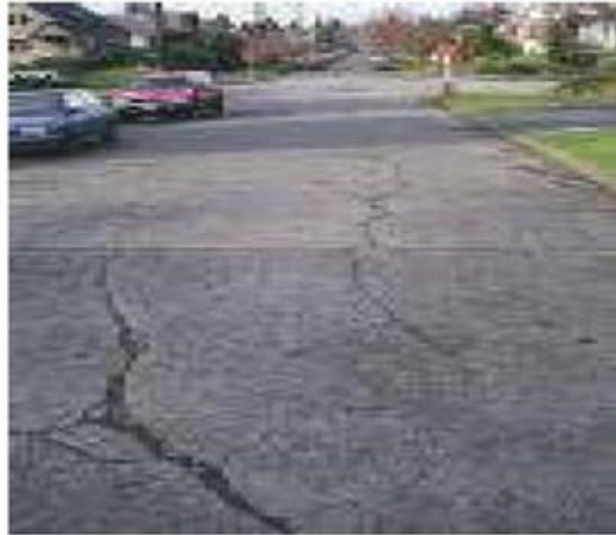
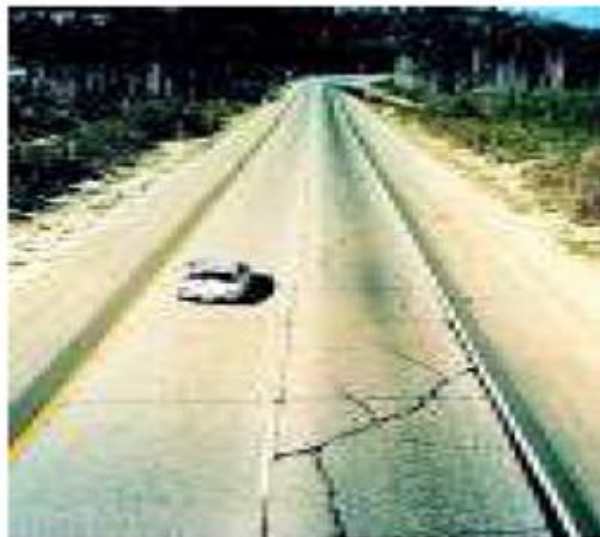
Description: Linear cracking are linear cracks not associated with corner breaks or blowups that extend across the entire slab as illustrated in Figures 73, 74, and 75. Typically, these cracks divide an individual slab into two to four pieces.

Figure 73 Large Panel Crack

Figure 74 Panel Crack on a Residential Street

Figure 75 Panel Cracking in the Truck Lane

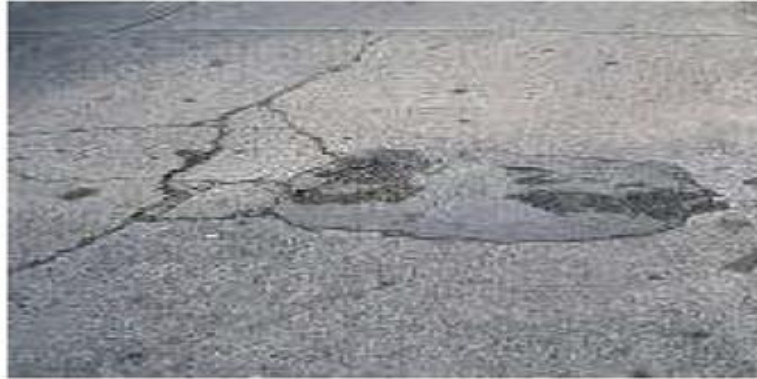
Figure 76 Patching on a Residential Street

Description: Patching is an area of pavement that has been replaced with new material to repair the existing pavement as illustrated in Figures 76 and 77. A patch is considered a defect no matter how well it performs.

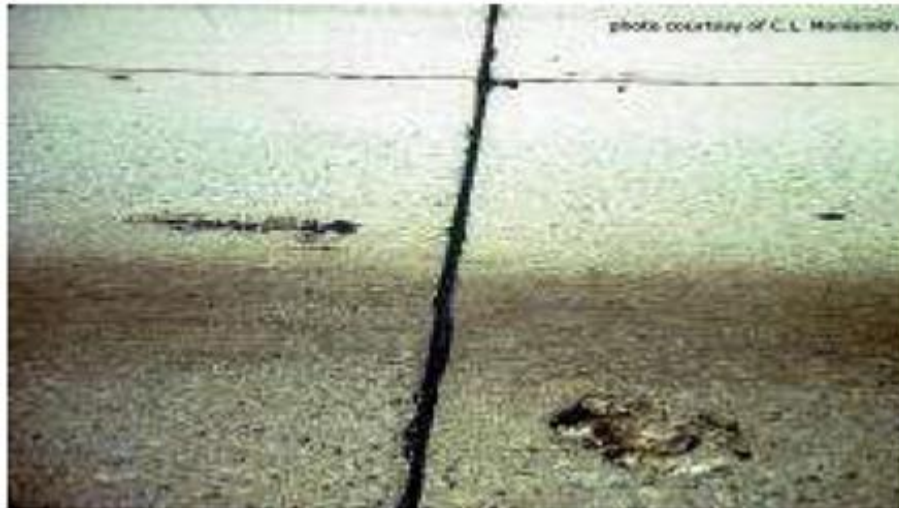
Figure 79 Large Popouts

Repair: Isolated low severity popouts may not warrant repair. Larger popouts or a group of popouts can generally be repaired with a partial-depth patch.

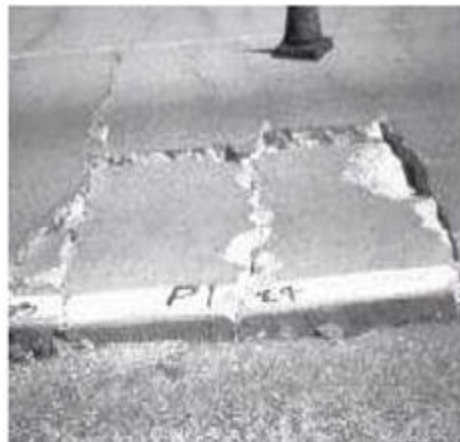
Figure 86 Severe Punchout

Description: Punchout is a localized slab portion broken into several pieces as illustrated in Figure 86. Typically, a concern only with CRCP.

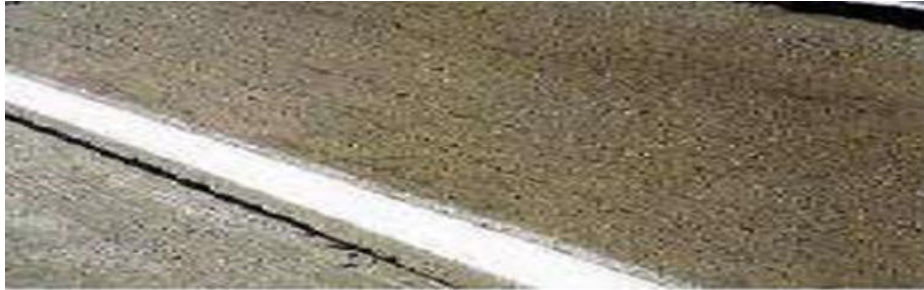
Figure 87 Severe Crazing

Description: Reactive aggregates distresses is a pattern or map cracking (crazing) on the PCC slab surface caused by reactive aggregates as illustrated in Figure 87. Reactive aggregates are those that either expand or develop expansive by products when introduced to certain chemical compounds.

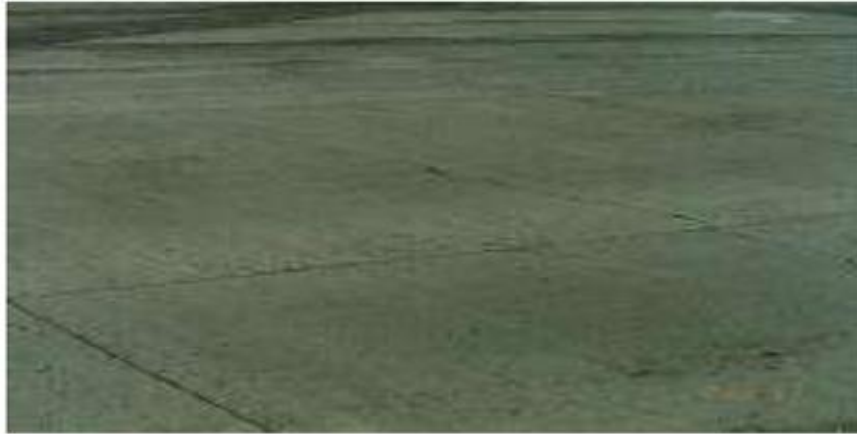
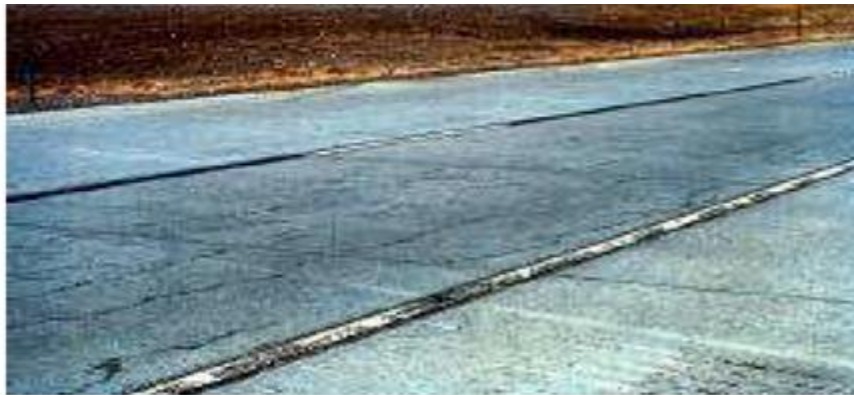
Description: Shrinkage cracking is defined as hairline cracks formed during PCC setting and curing that are not located at joints as illustrated in Figures 88 and 89. Usually, they do not extend through the entire depth of the slab. Shrinkage cracks are considered a distress if they occur in an uncontrolled manner (e.g., at locations outside of contraction joints in JPCP or too close together in CRCP).

Figure 88 Shrinkage Cracks on Brand New Slabs

Figure 89 Severe Shrinkage Cracking

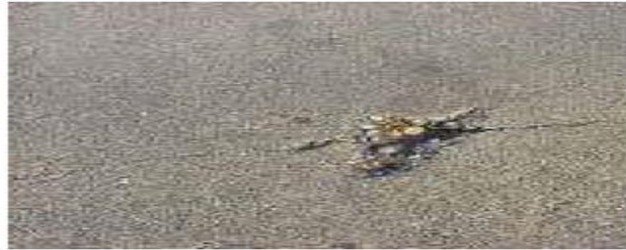
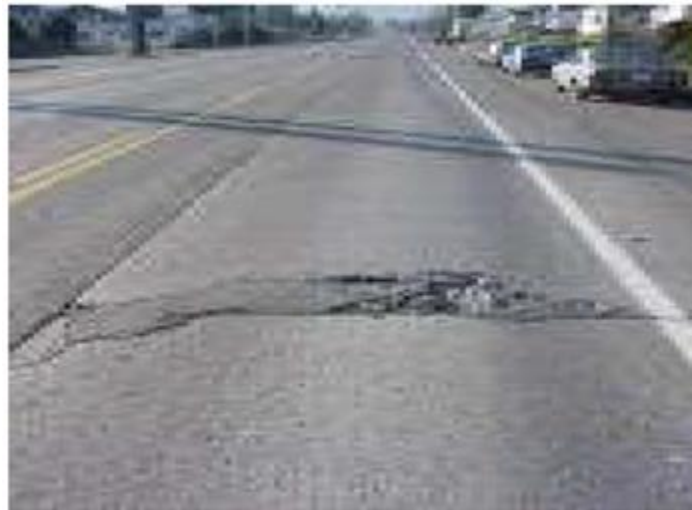
Description: Spalling is defined as cracking, breaking or chipping of joint/crack edges as illustrated in Figures 90 and 91. Usually occurs within about 0.6 m (2 ft.) of joint/crack edge.

Figure 90 Spalling

Figure 91 Spalling from a Bad Construction Joint

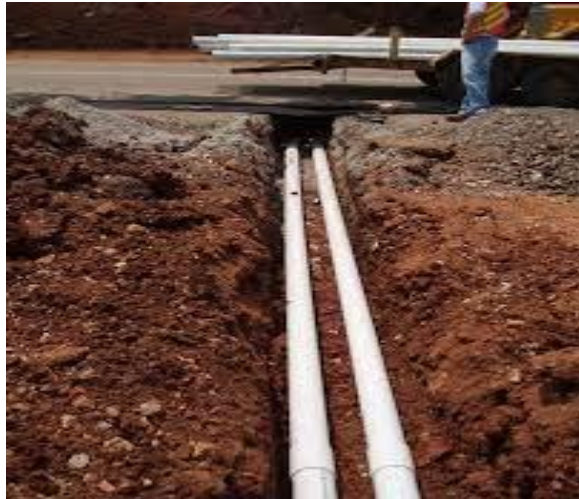
Figure 96 Retrofitted Edge Drains

Cutting of a trench along the pavement edge and placement of a longitudinal edge drain system (pipe or geo-composite drain, geotextile lining, bedding, and backfill material) in the trench, along with transverse outlets and headwalls as illustrated in Figure 96.

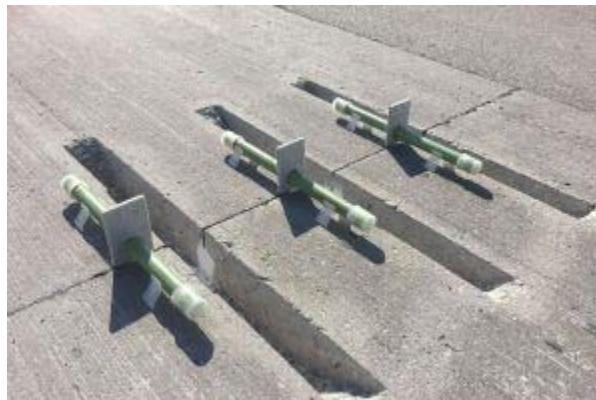
Figure 97 Dowel Bars Retrofit

Placement of dowel bars across joints or cracks in an existing concrete pavement to restore load transfer as illustrated in Figure 97.

A dowel bar retrofit (DBR) is a method of reinforcing cracks in highway pavement by inserting steel dowel bars in slots cut across the cracks. It is a technique which several U.S. states' departments of transportation have successfully used in repairs to address faulting in older jointed plain concrete pavements.

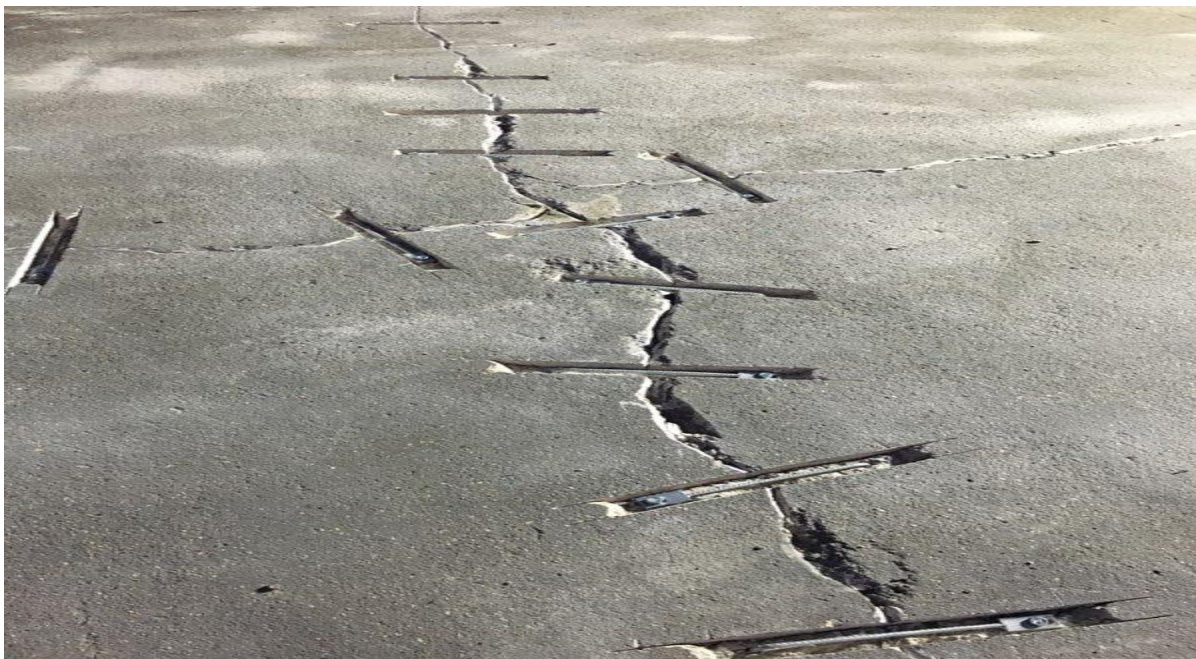
Figure 98 Cross Stitching

Placement of deformed tie bars into holes drilled at an angle through cracks (or, in some cases, joints) in an existing concrete pavement as illustrated in Figure 98.

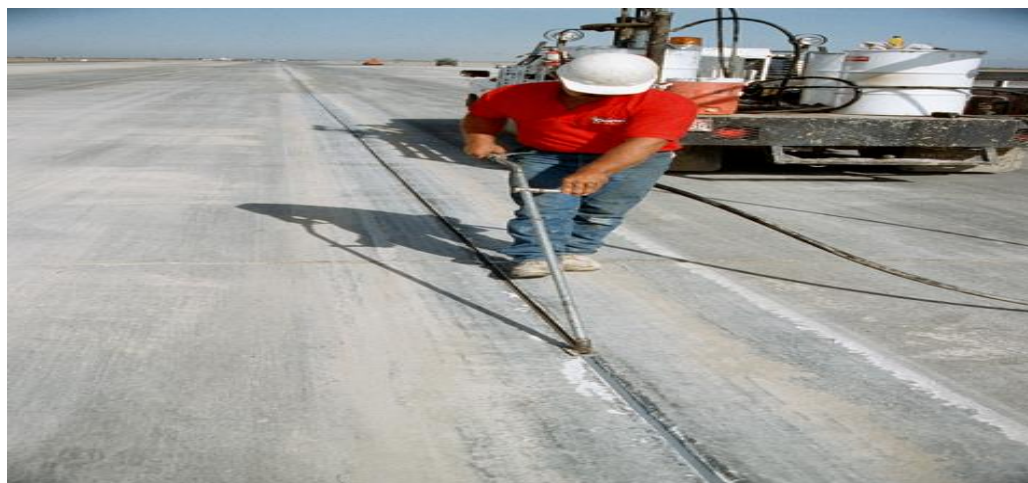
Figure 101 Joint Resealing

Removal of existing deteriorated transverse and/or longitudinal joint sealant (if present), refacing and pressure cleaning the joint sidewalls, and installing new material (liquid sealant and backer rod or preformed compression seal) as illustrated in Figure 101.
