Ethical Issues from the Tacoma Narrows Bridge Collapse

Course No: LE2-003
Credit: 2 PDH

J. Paul Guyer, P.E., R.A., Fellow ASCE, Fellow AEI

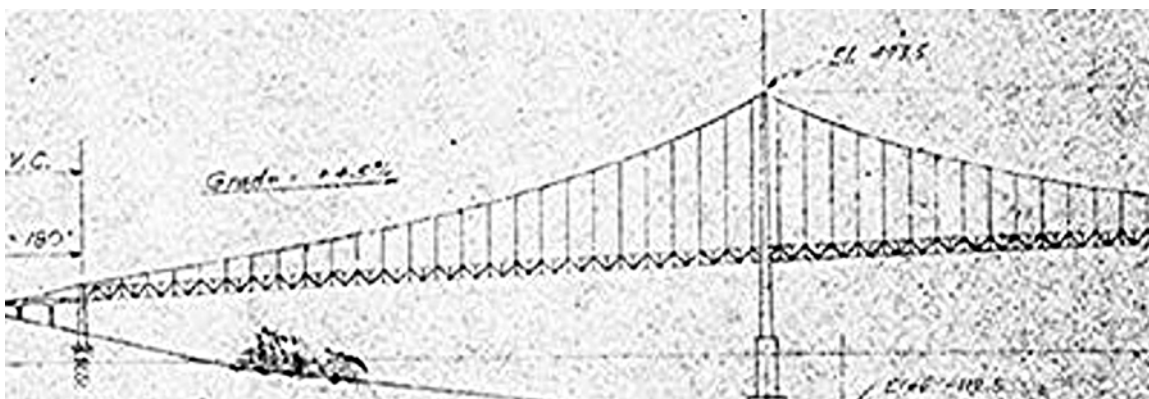
Figure 3
The Eldridge Design
(Washington State DOT records)

With the prospect of federal funding now in view, the Washington Department of Highways, under the direction of engineer Clark Eldridge, prepared plans for a suspension bridge using convention suspension bridge design practices as they were known at that time. Specifically, the roadway deck was supported by deep (25-foot) truss girders to stiffen it. The Authority submitted the Eldridge design to the federal Public Works Administration (PWA) with a request for \$11 million.
