Ethical Issues from the Kansas City Hyatt Hotel Collapse

Course No: LE2-001
Credit: 2 PDH

J. Paul Guyer, P.E., R.A., Fellow ASCE, Fellow AEI

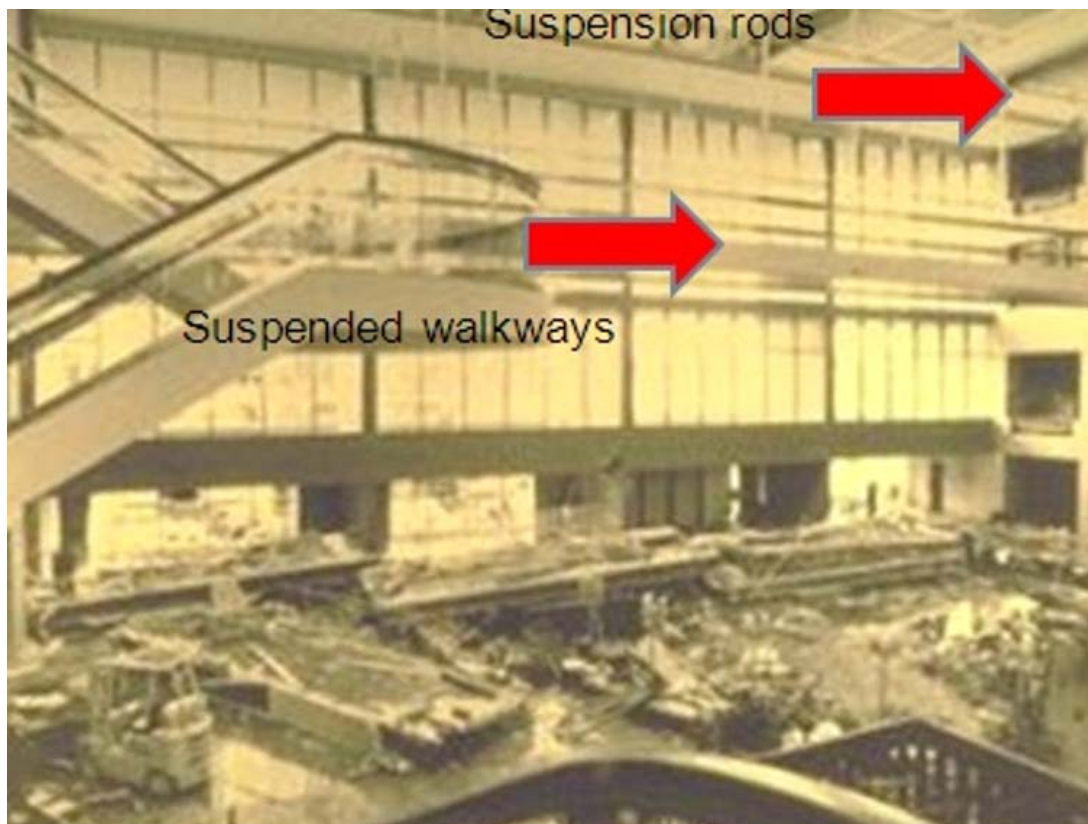
Figure 5
Suspended Walkways at the Atrium Lobby

The structural failure occurred at two of the three suspended walkways that traversed from one side to the other of the atrium lobby. Walkways that failed were directly in line with each other and crossed from one side to the other at the second and fourth floors. The third walkway, at the third floor, was offset from the other two and was not involved in the failure.

The fourth floor walkway failed, collapsed onto the second floor walkway, both crashed to the lobby floor, and 114 people were killed and 200 injured.
