Underwater Inspection of Bridge Substructures Using Imaging

Course No: S12-001
Credit: 12 PDH

This course was adapted from the Department of Transportation, Publication No. DOT-FHWA-HIF-18-049, “Underwater Inspection of Bridge Substructures Using Imaging Technology”, which is in the public domain.

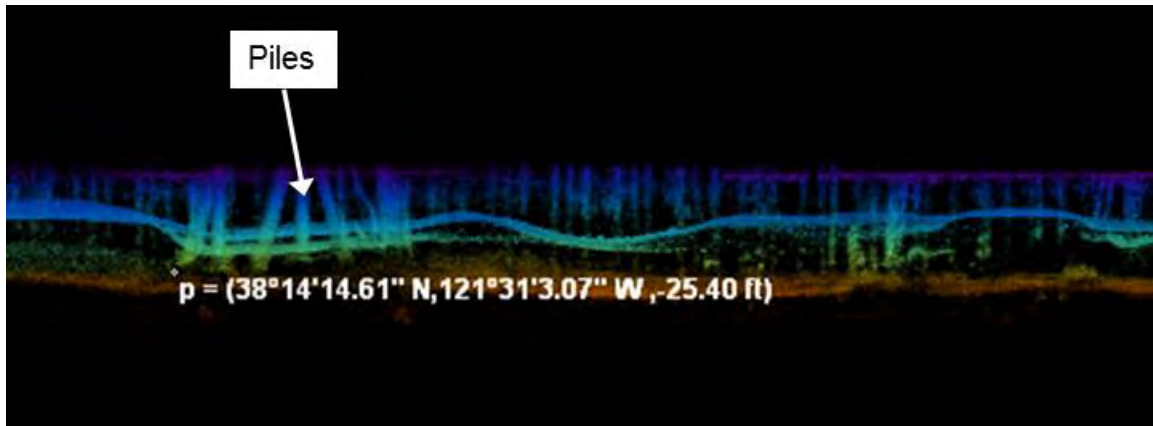
Figure 26. Image. Piles from back side of the fender (Georgiana Slough).

Using a real-time multibeam sonar, inspection team A collected data in the field that produced images that captured general pile features. The images in figure 26 and figure 27 reveal the piles supporting the fender in profile and plan view, respectively. In the profile view, it is evident that several piles are not aligned vertically. In the plan view, the curved alignment of the set of piles is clearly seen.

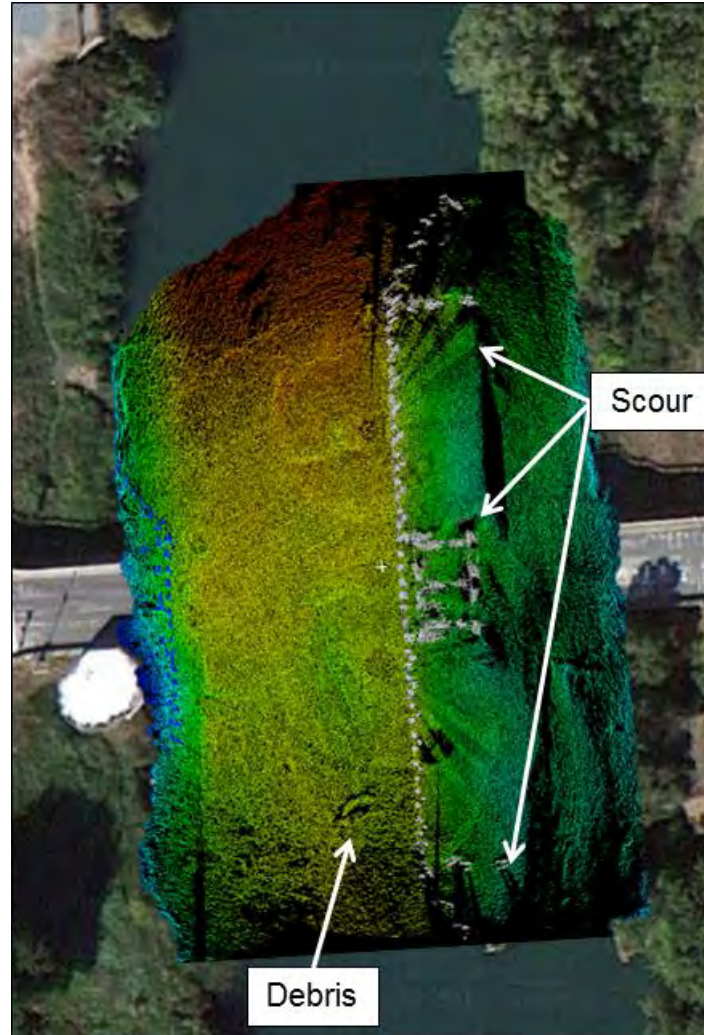
Figure 32. Image. Indications of scouring from 3D image (Georgiana Slough).

Figure 32 provides a sonar image overlain on an aerial photo that highlights darker areas indicative of minor scour around the structures. The image also shows moderate levels of debris, including tree limbs and tires, but no visible damage to the substructure.

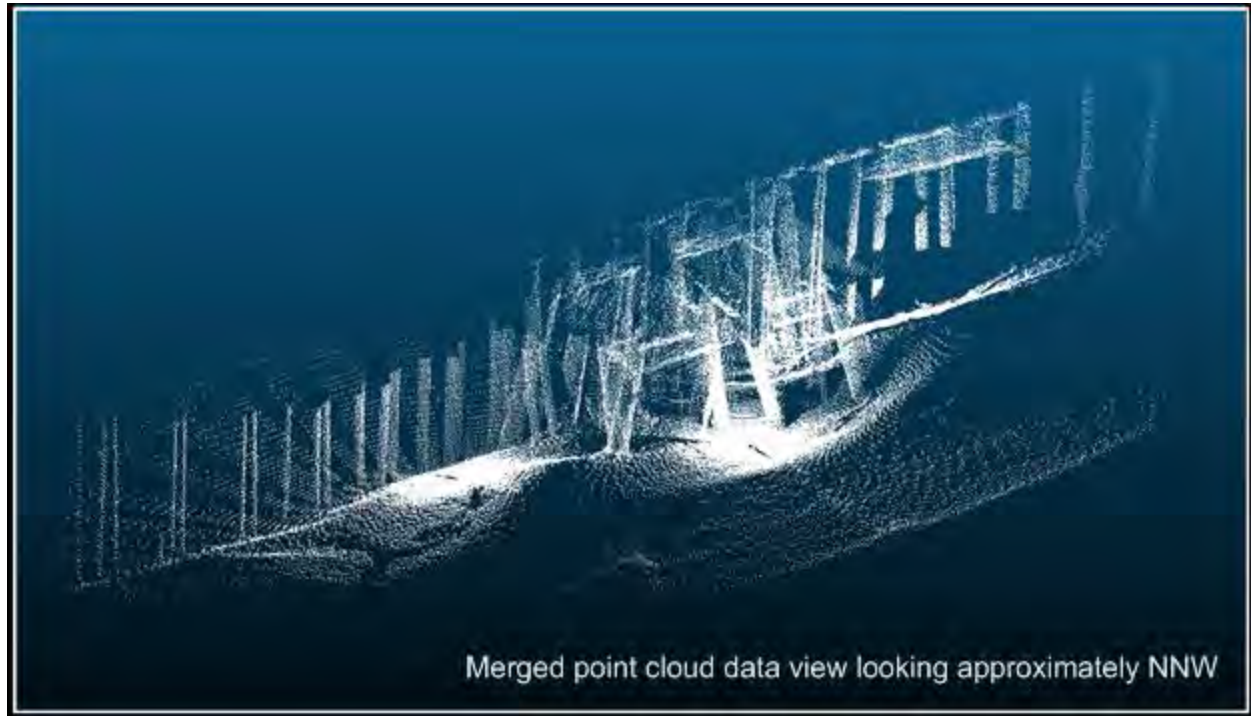
Figure 35. Image. Merged point cloud data at Georgiana Slough Bridge.

After completing the bottom drops, the head was horizontally mounted on a pole and positioned three feet below the surface to vertically scan the fender wall. The data collected from the bottom drops and vertical scans were merged to create 3D representations as shown in figure 35.

The inspection team observed in both the imaging and profiling datasets that although the fender system is there to protect the structure from vessel traffic, it appears to have caused localized scour on the upstream side of the pier. This local scour has induced sediment degradation on the upstream nose and aggregation on the downstream side of the structure. The fender system

appears to be structurally sound with no breaks or splits in the piles. Debris build up was noted on the upstream dogleg. The team reported that the vertical and batter pipe piles appeared to be structurally sound with no visible impact damage or structural deterioration.

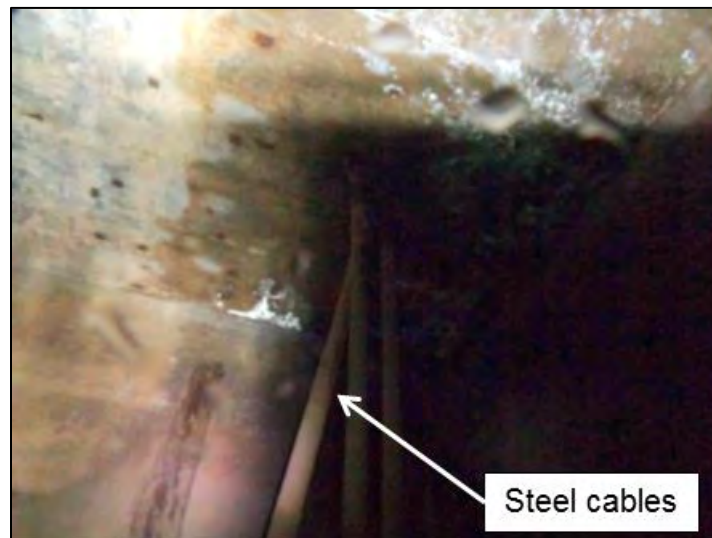
Figure 37. Photo. Above water view of steel cables.

- Three 4-inch (100 mm) diameter steel cables were observed extending vertically from the northwest quadrant of the south bay to the channel bottom as shown in figure 37.

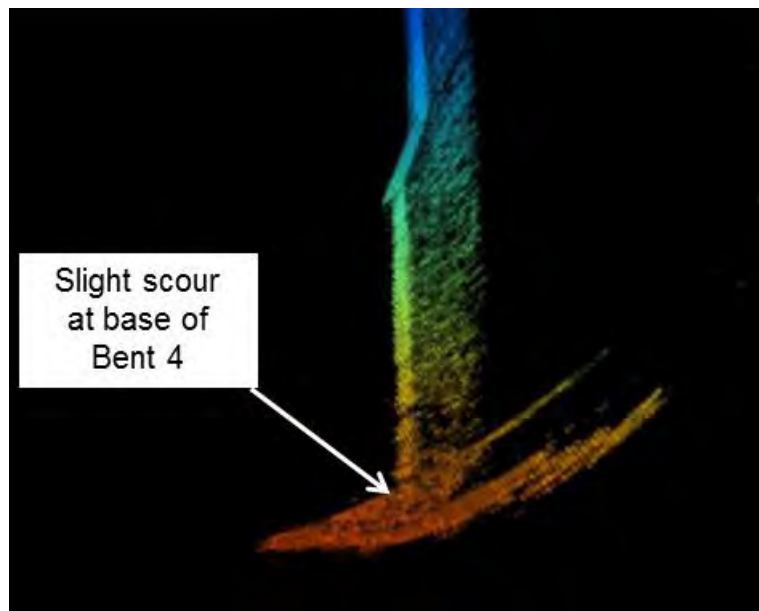
Figure 42. Image. Bent 4 mud line side image.

Figure 40 shows the image of bent 4 captured by the sonar. A symbol representing the data collection boat is also shown to illustrate the range required of the sonar at this site. Figure 41 is a data mosaic showing bents 4 and 5 as viewed from the west side of the bridge. The annotations on the figure demonstrate how structure dimensions can be obtained from the image. Close analysis of the images may reveal reportable observations. For example, a closer view of the base of bent 4 shown in figure 42 provides an indication of scour at the base of the bent.

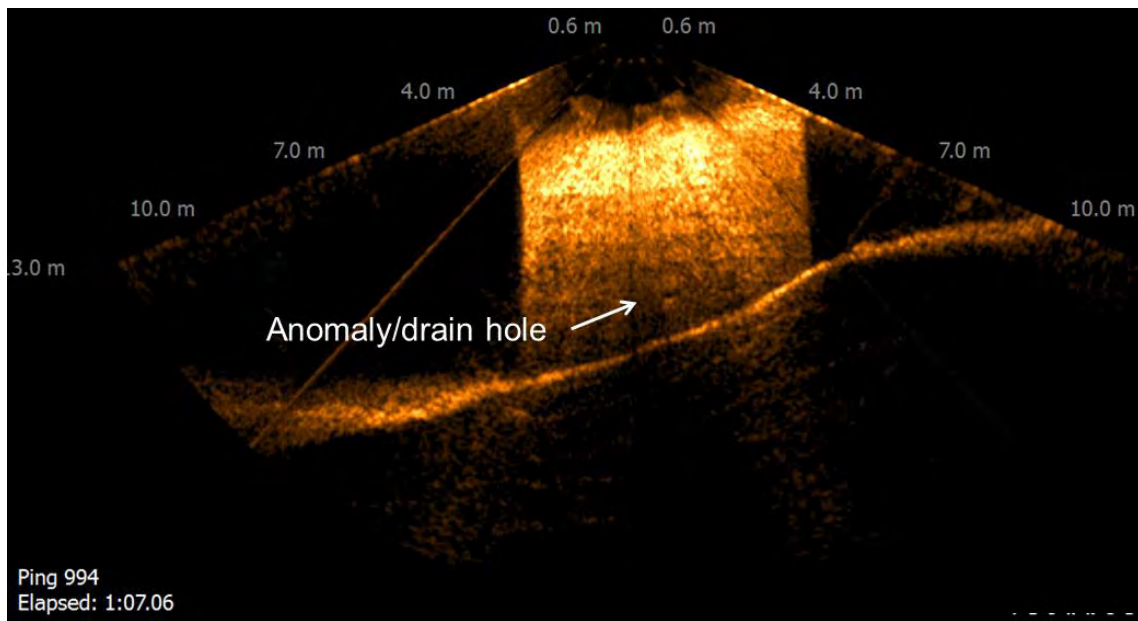
Figure 44. Image. Sonar wing at the bottom of face 3.

Figure 43 displays a plan view of the James E. Roberts Bridge with the naming convention used by inspection team B to label data and images on bent 4. Figure 44 is a sonar wing close-up of the base of face 3 that reveals evidence of an anomaly on the surface.

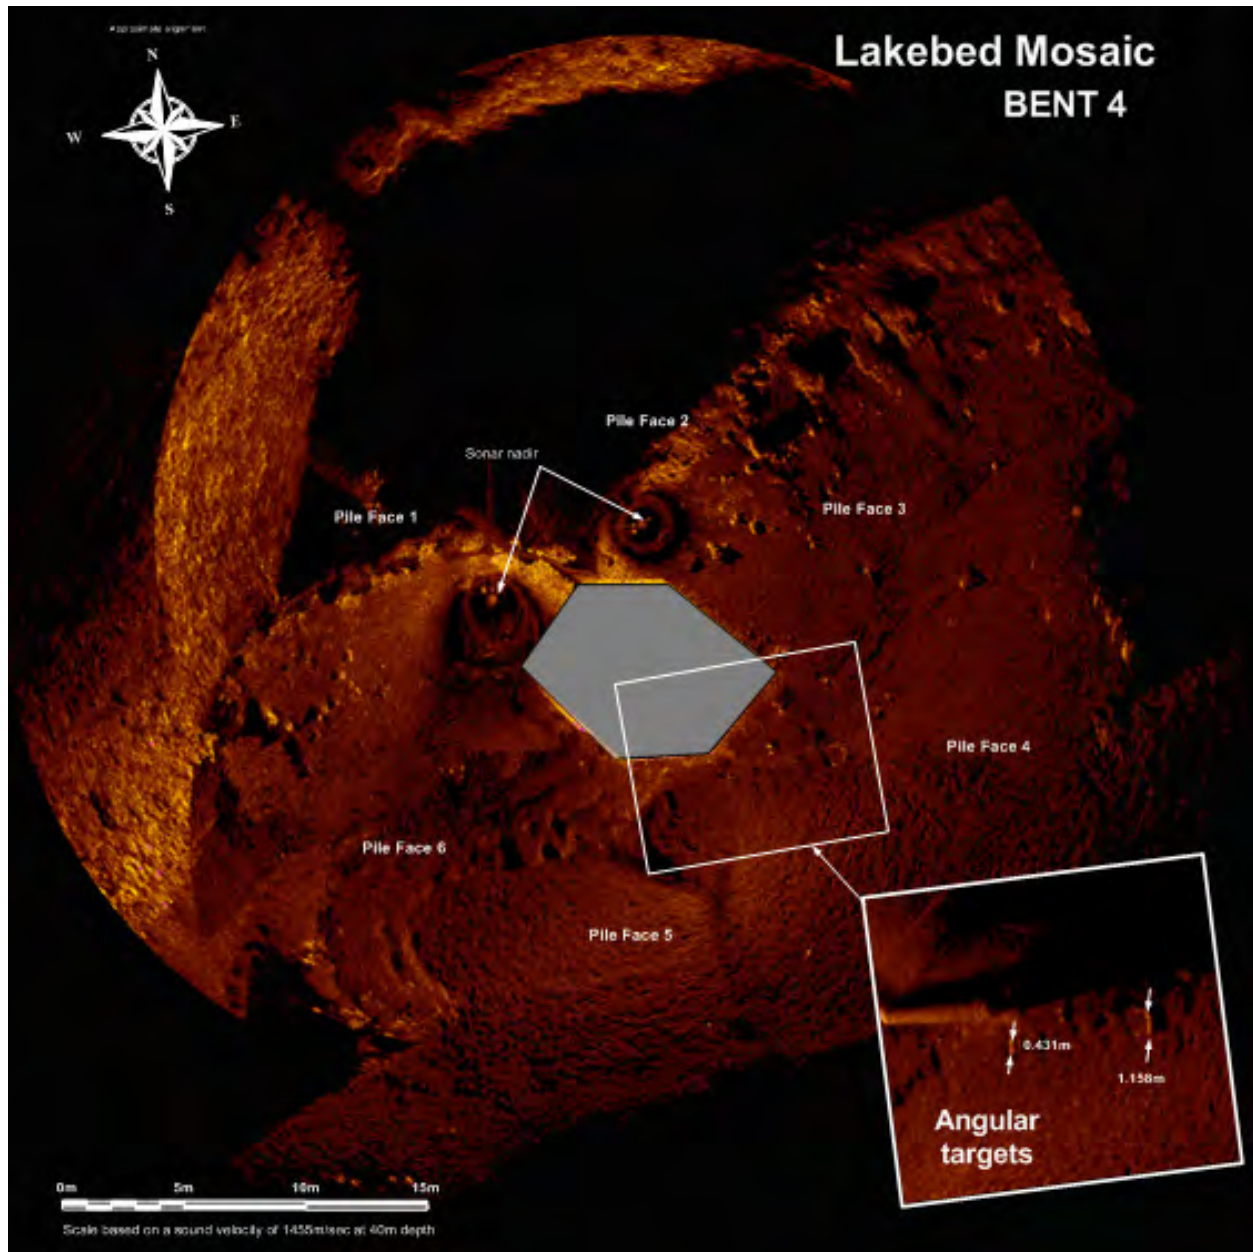
Figure 46. Image. Mosaic bed image of the James E. Roberts Bridge.

A total of six 98 ft (30 m) radius scans were collected. These were combined into a mosaic of the vicinity around bent 4 as shown in figure 46. The bottom shows significant upward elevation change to the northwest of bent 4 (shaded area). This elevation difference has resulted in some acoustic distortion in plotting the shape of the base of bent 4 as the record cannot be slant-range corrected to a single elevation plane without introducing additional range errors. There are a few angular targets situated close to the structure; their shape suggests they are not natural objects. There is no indication of bottom scour adjacent to the structure or of slope instability in this mosaic.

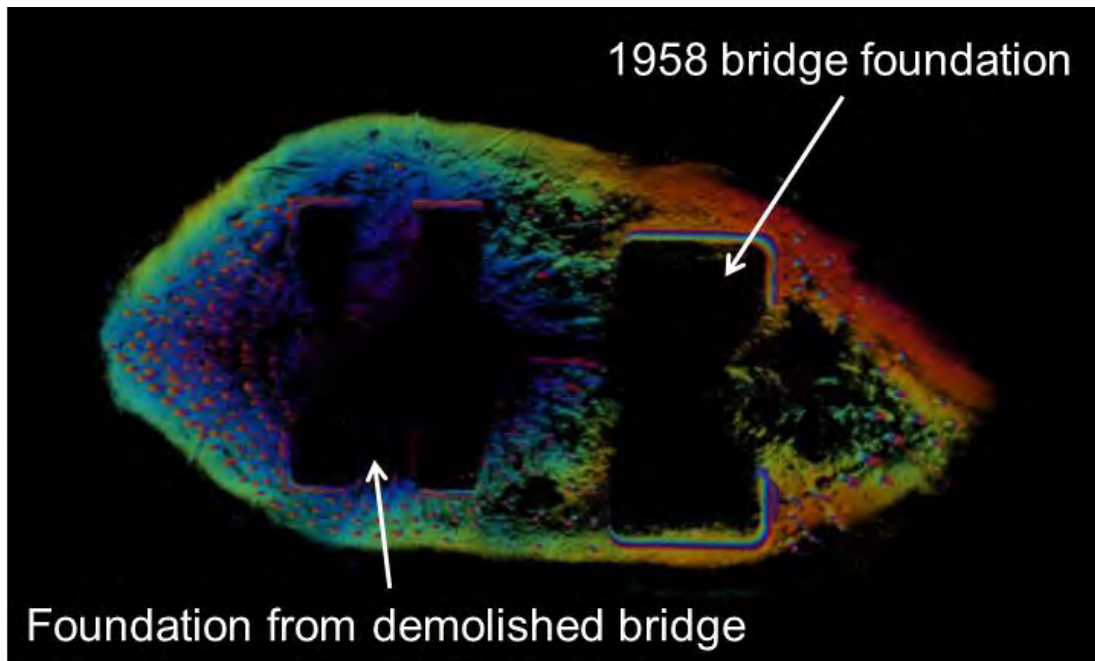
Figure 54. Image. Pier 3 plan view.

Water depth at the pier at the time of the inspection by team A was approximately 75 ft (23 m) on both the north and south sides of the pier. A plan view of the sonar results is shown in figure 54. The foundation for the 1958 bridge is the dark area on the right; the darker area on the left is the remaining foundation from the demolished 1927 bridge. A fender is shown to enclose both foundations. Figure 55 and figure 56 show views from the north and the south, respectively. The partial demolition of the 1927 foundation is clearly visible.

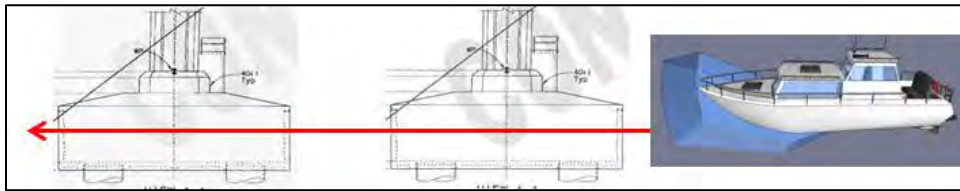
Figure 67. Image. 2D image from an eastward scanning pass.

Inspection team B performed a combination of 2D and 3D scanning of the 2003 Carquinez Bridge. An example of the 2D imaging is shown in figure 67. The figure is an image of the north pilings imaged as the boat was traveling from west to east using the 2D multibeam sonar in the vertical orientation. An example of 3D imaging is shown in figure 68 where several signs of debris are apparent.

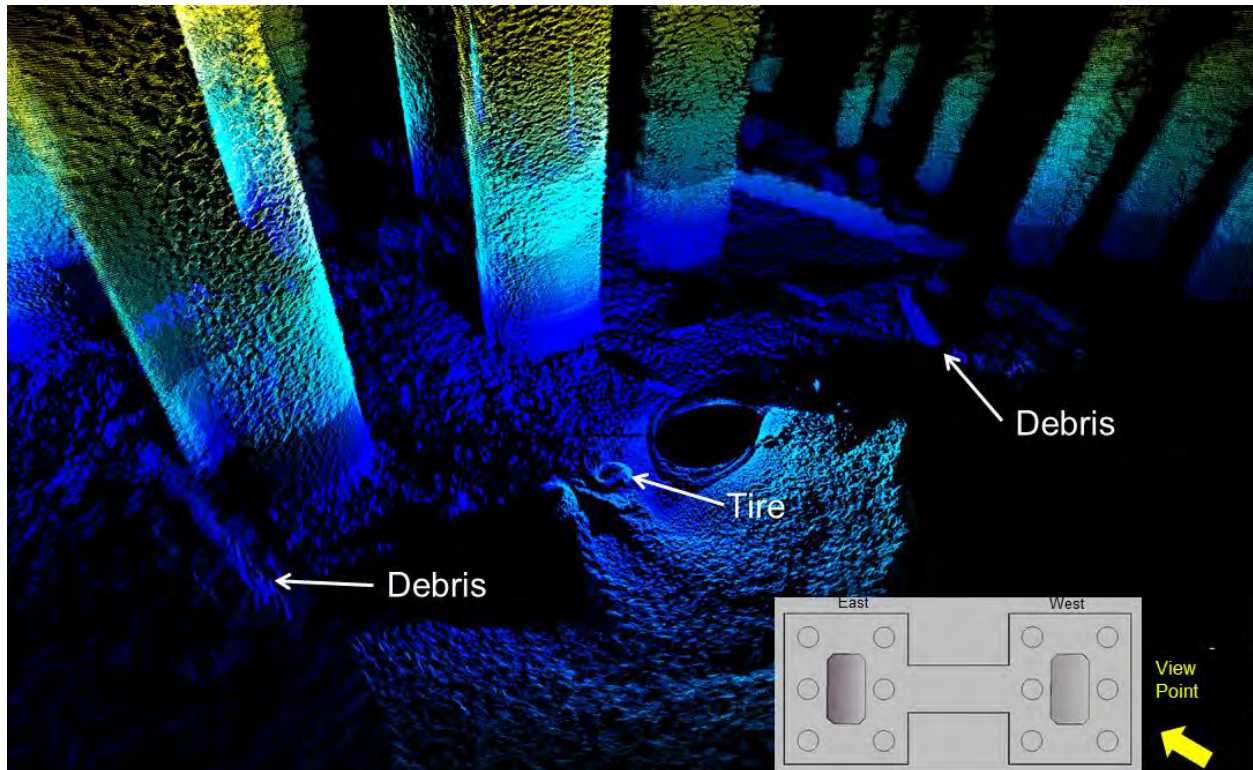
Figure 68. Image. 3D image viewed from the west side of the pier foundation.

Overall, the inspection team reported little evidence of scour and moderate levels of debris to the west with little debris elsewhere. No indication of structural damage was identified.

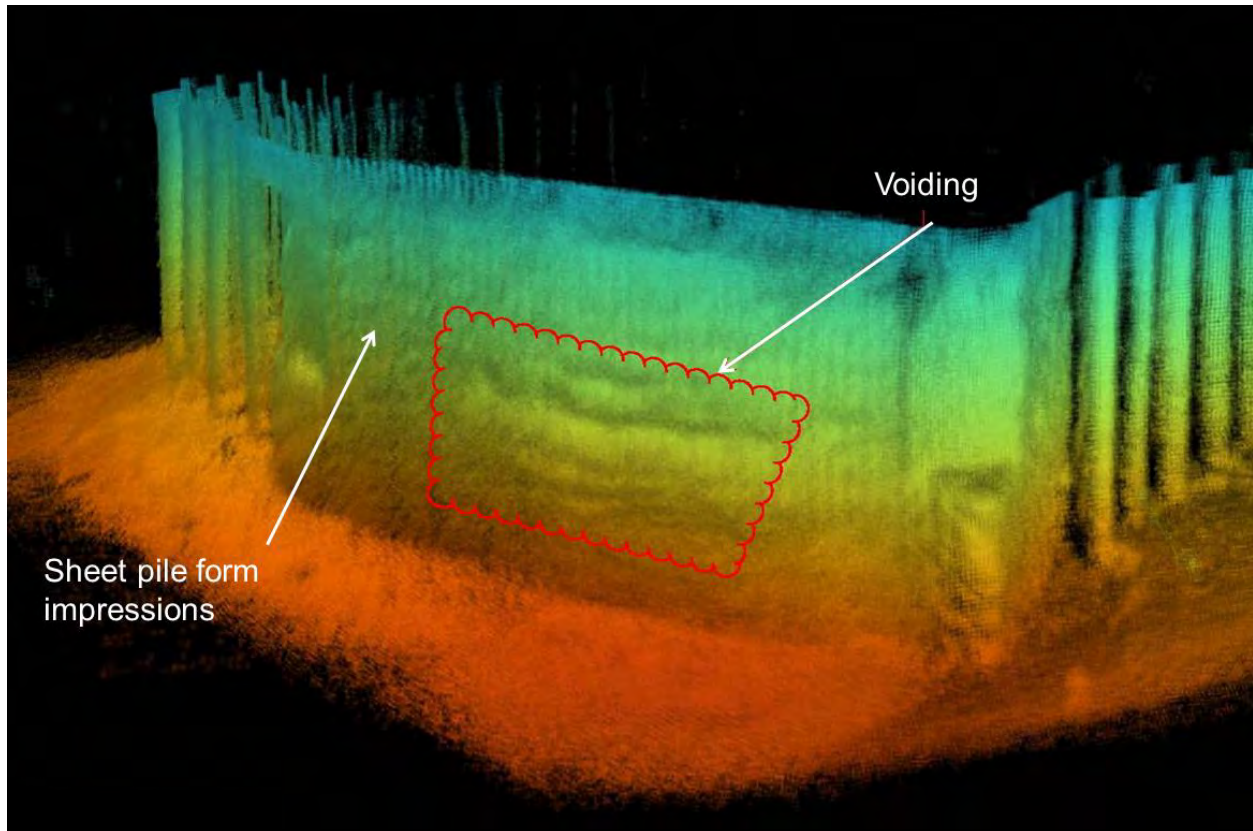
Figure 79. Image. Pier W2 viewed from the east.

The piles from old Wharf Pier 24 prevented access to the south and west faces of the concrete caisson for inspection team A. Team A reported that sheet pile form impressions were visible on all inspected faces (east and north) of pier W2. As shown in figure 79, the underwater acoustic imaging results show areas of voiding along the east face of pier W2. These horizontal bands varied in size, up to a maximum of 50 ft (15 m) long by 4 ft (1.2 m) high by 1.5 ft (0.46 m) deep, and are located near the center of the east face, ranging from approximately 10 ft (3 m) above the channel bottom to approximately 30 ft (9 m) above the channel bottom.

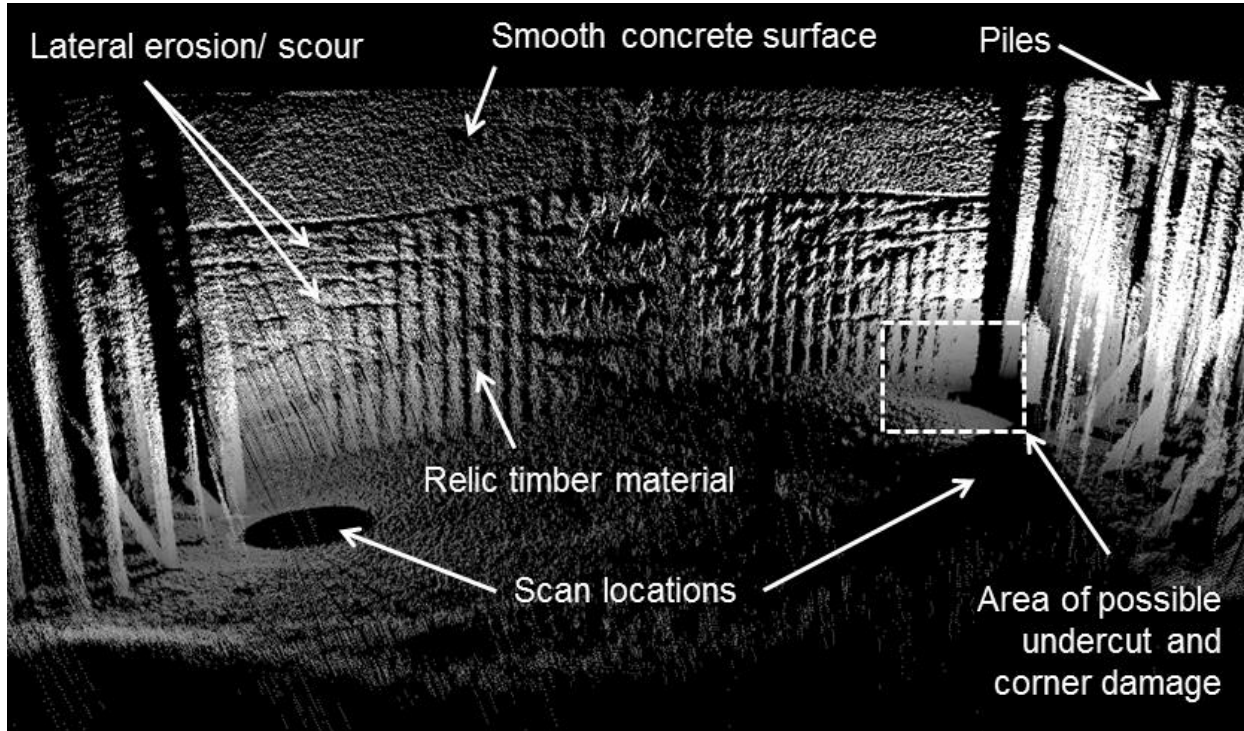
Figure 80. Image. Pier W2 3D data viewed from west.

Inspection team B reported that much of the sheet pile appears to have deteriorated from the submerged portions of the caisson at pier W2. As shown in figure 80, there were intermittent horizontal bands of voiding in the concrete caisson throughout the lengths of the entire east and west faces, with a maximum height of approximately 6 ft (1.8 m) and a maximum depth of approximately 1 to 2 ft (0.3 to 0.6 m). On the east face, the voids were most prominent at approximately 15 ft (4.6 m) and 30 ft (9.1 m) above the channel bottom. On the west face, the voids were evident beginning just below the top of the sheet pile form and extending down to approximately 8 ft (2.4 m) above the channel bottom near the center of the face. These voids were also visible on the northeast and southeast corners of the caisson.

analyst identified the transition from smooth concrete in the upper portion of the image to where the original concrete forms had been removed. They further identified numerous lateral erosion pockets, which were easily discernable in the data.

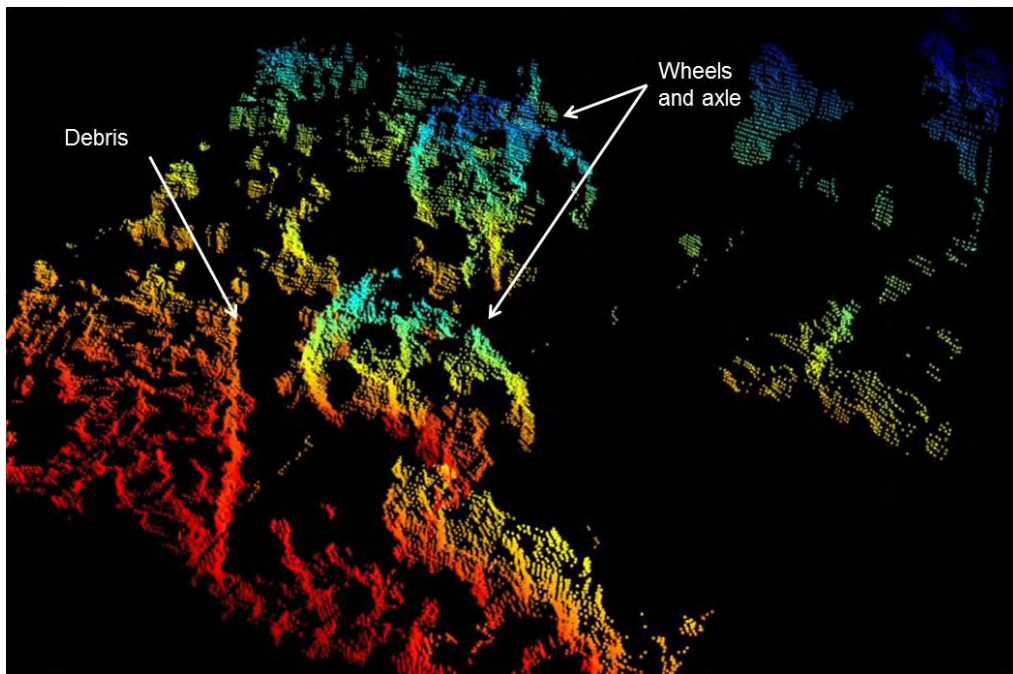
Figure 81. Image. Detail at bed near pier W2.

Inspection team B also identified debris on the bed near pier W2. The image in figure 81 shows evidence of debris including an axle with a pair of wheels.

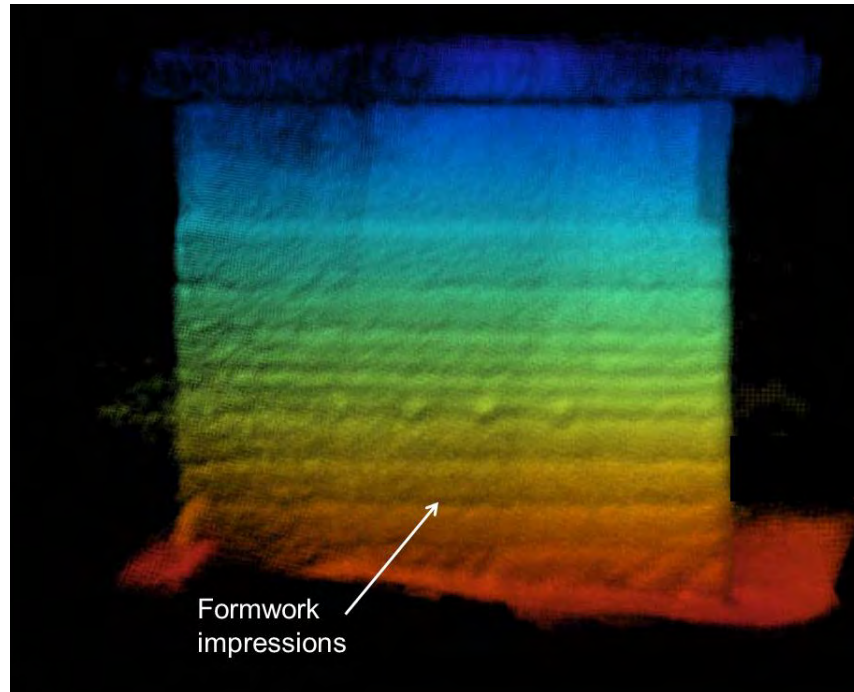
Figure 84. Image. Pier W6 viewed from the west.

Inspection team A reported that there were no significant deficiencies visible at pier W6. The report identified that formwork impressions are visible on all submerged faces of the caisson as shown in figure 84. The change from the smooth concrete to the formwork is visible in the figure.

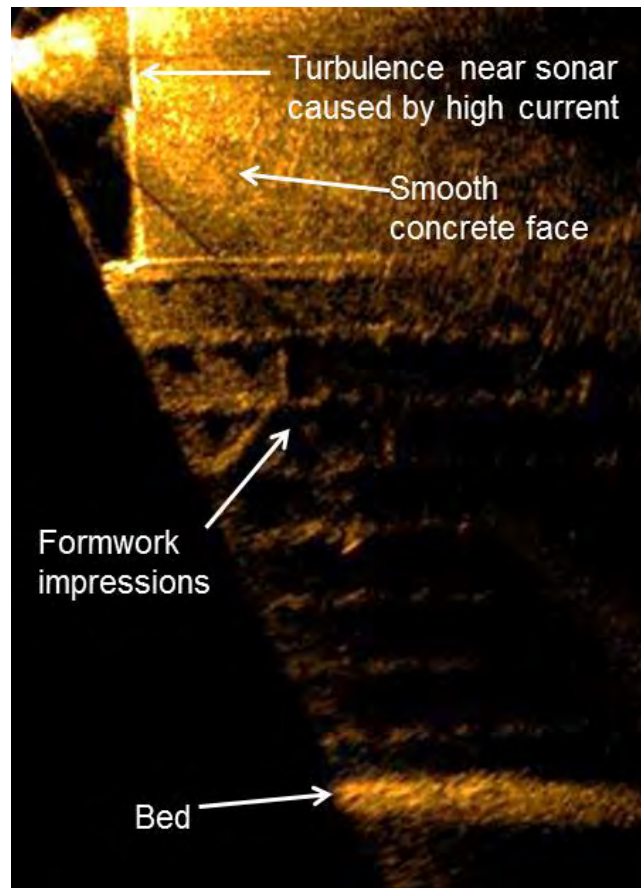
Figure 85. Image. South face of pier W6 in a 2D sonar image.

Inspection team B noted formwork impressions visible on the submerged caisson as shown in figure 85. A possible area of abrasion is distinguishable at the southeast corner, near the top of the caisson, just below the step-out.

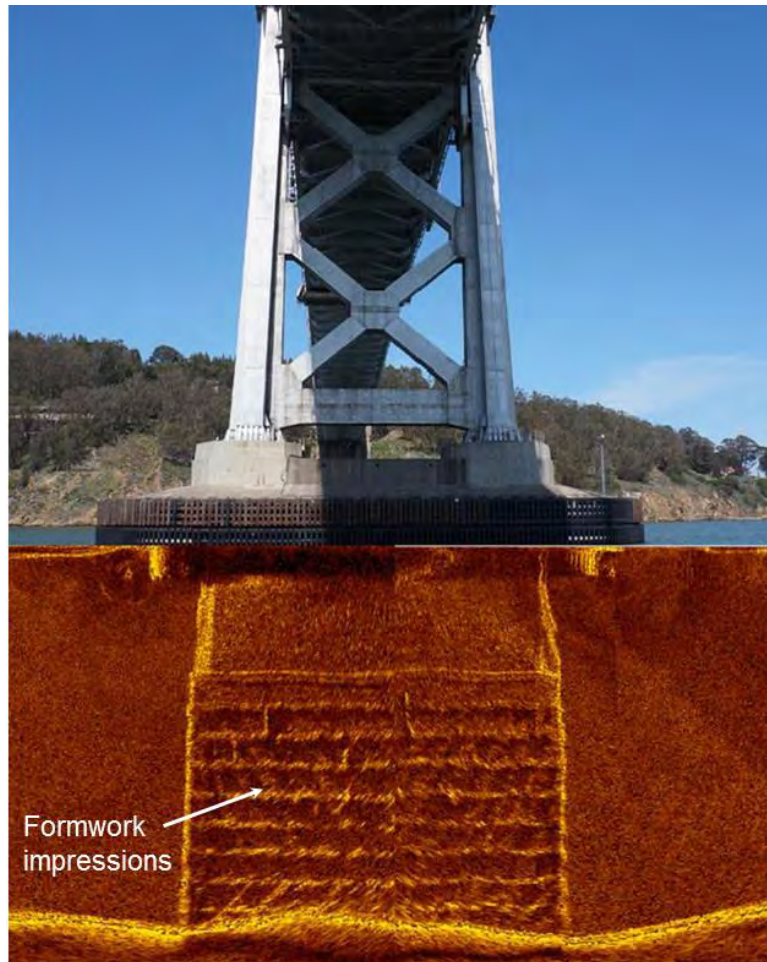
Figure 86. Image. West face of pier W6.

Inspection team C also noted formwork impressions visible on the submerged caisson at pier W6 as shown in figure 86. There are also possible diagonal sheathing remnants or impressions visible on the south and west faces near the southwest corner.

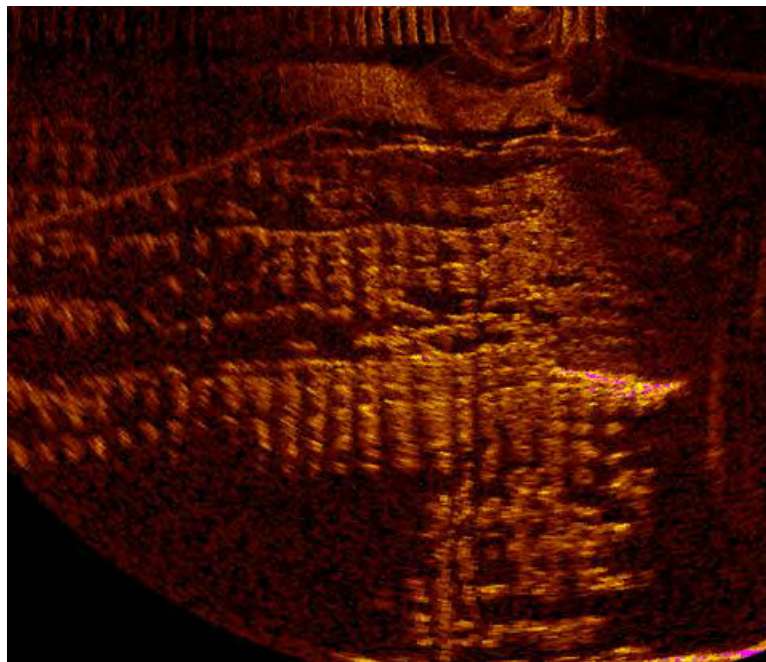
Figure 89. Image. Close-up view of the east face of pier W2.

The reanalysis noted that the close up views, such as the one shown in figure 89, revealed the deteriorated concrete and voids that number far more than the dive reports indicated and are too numerous to detail in light of the lack of structural significance. However, they maintained that it is possible to estimate penetration depths and to document each specific spall and void with the equipment and software used by team C.

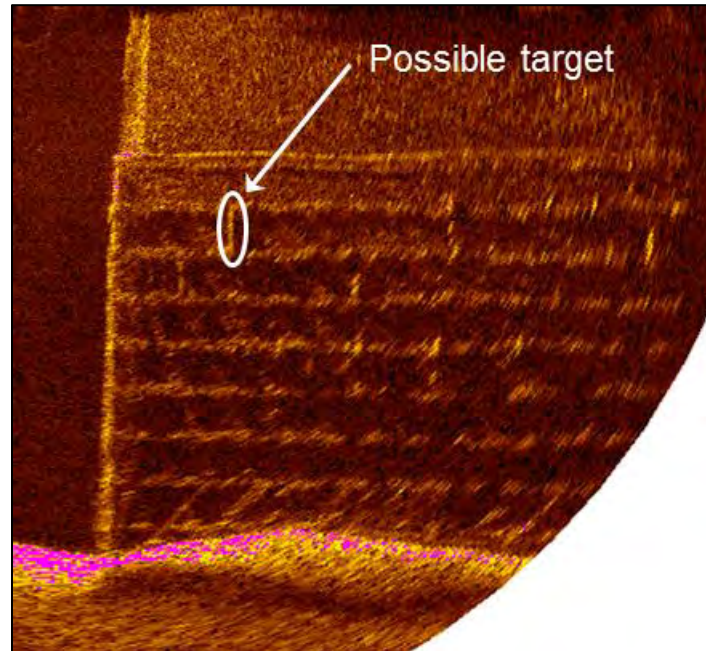
Figure 90. Image. South face of pier W6.

The reanalysis by inspection team C also resulted in several observations regarding the planted targets on pier W6. The analyst observed that while there is a signature shown in figure 90 that is in the correct location and exhibits the appropriate dimensions for planted target 2 (a 7 ft (2.1 m), 3/8-inch (9.5 mm) chain), the nature of the object, if present, could not be identified. Several other linear articles of debris hanging on the pier are observed in the sonar images. The analyst noted that this is typical so it is not practice to call out each article of debris if it is not of consequence to the structural integrity.

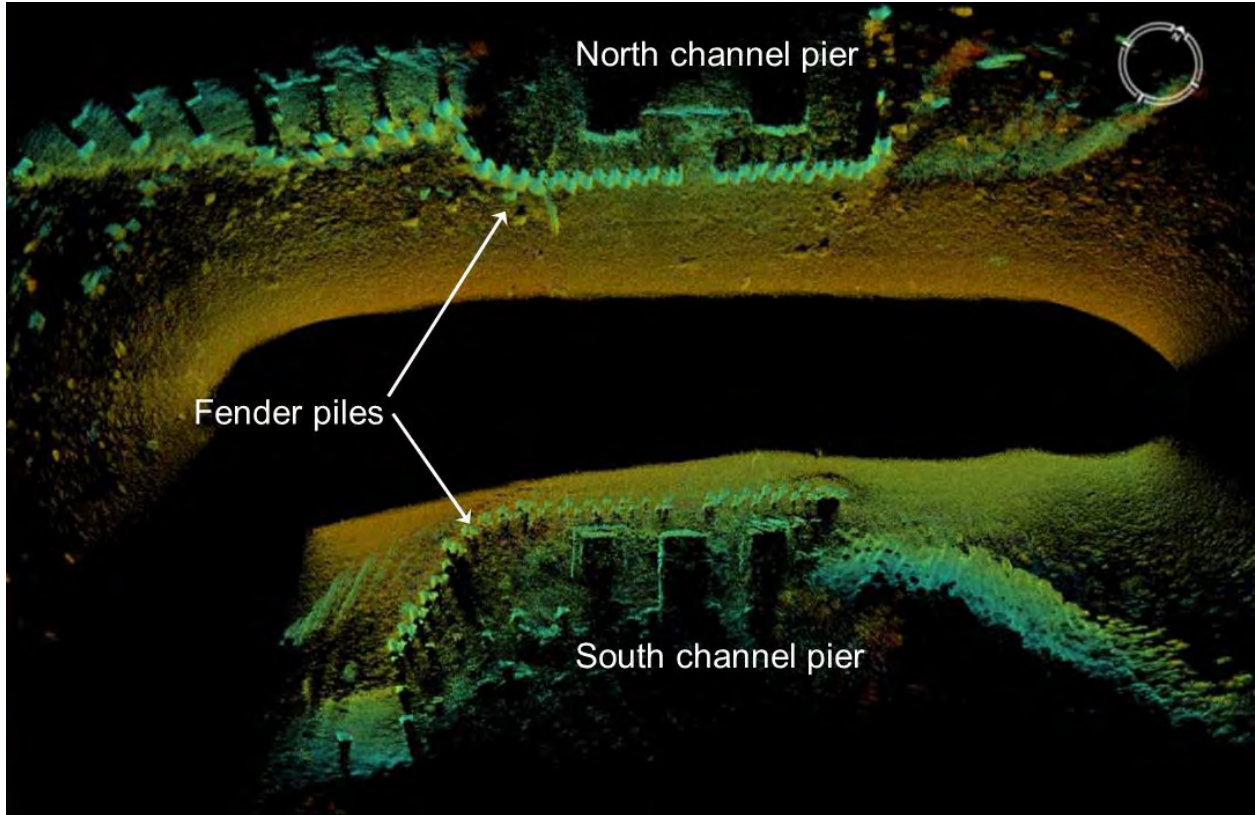
Figure 93. Image. North and south piers of the Third Street Bridge.

An image of both piers from sonar inspection team A is shown in figure 93. The report from sonar team A states that acoustic imaging of both the south channel pier (figure 94) and the north channel pier (figure 95) revealed no major deficiencies. The team reported that because of limited access, in-depth scanning was limited to the east support (column 2) of the north channel pier.

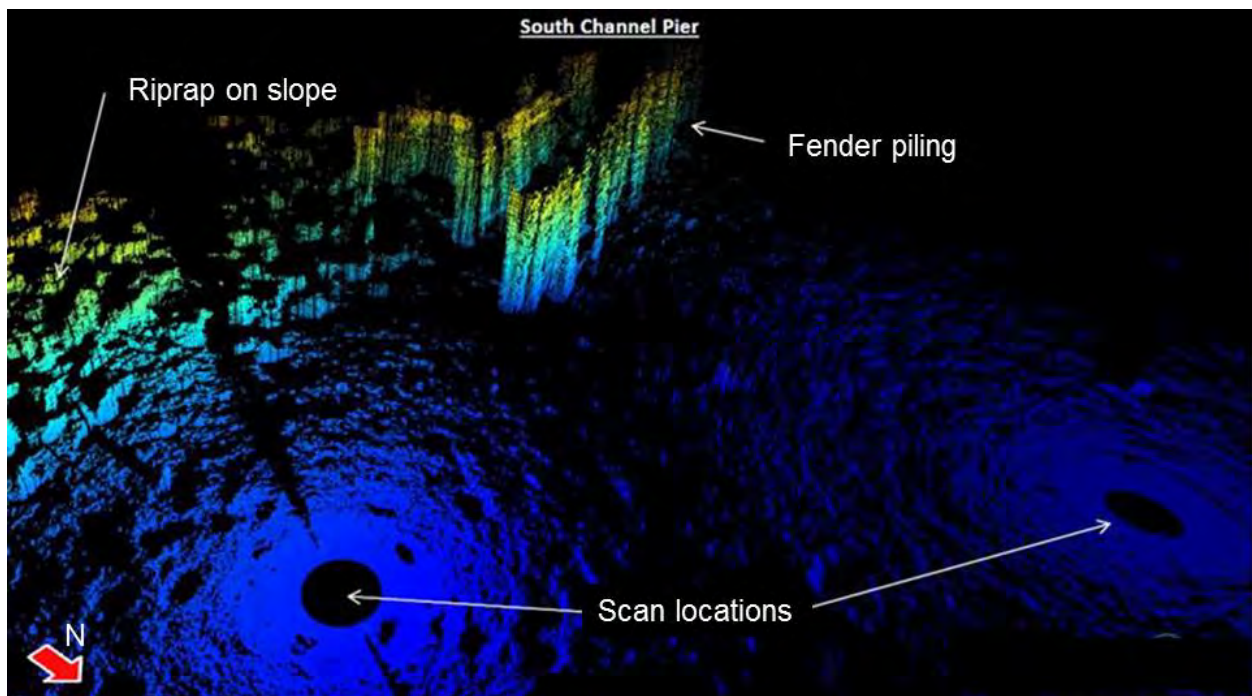
Figure 96. Image. South channel pier viewed from the northeast.

Inspection team B noted that because of limited access and time constraints, scanning of the south channel pier was limited to a few scans of the east support (column 2). These images, such as found in figure 96, revealed no significant deficiencies.

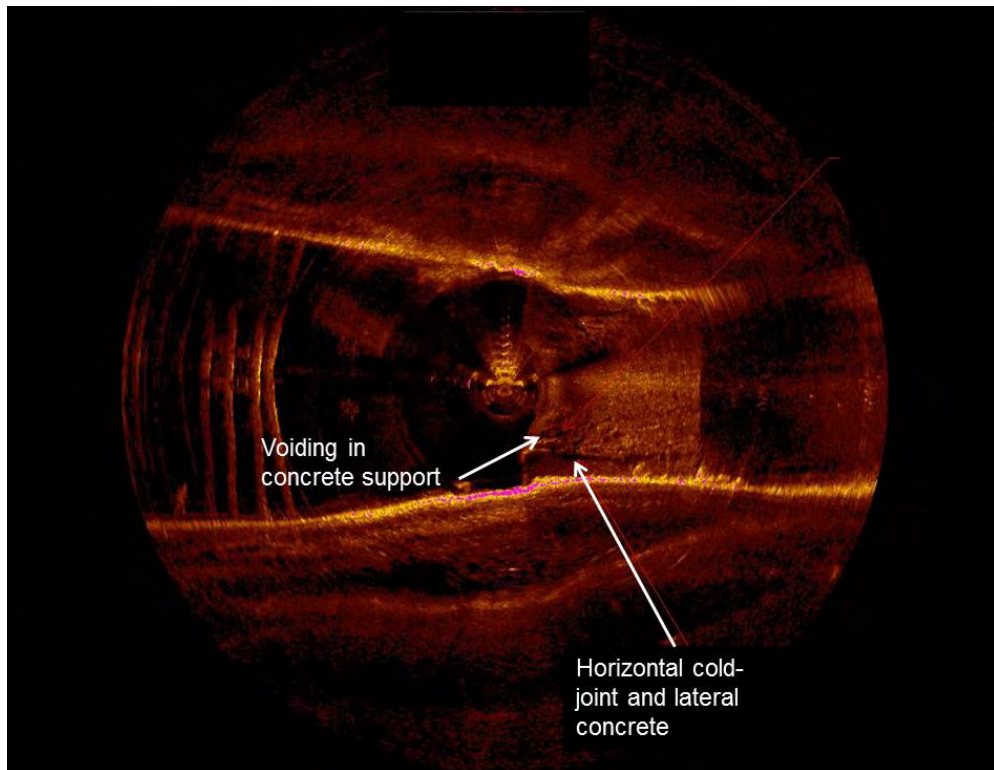
Figure 98. Image. Raw image of north channel pier, east support, south face.

At the north channel pier, the inspection report noted horizontal cold-joints and associated latent concrete visible on the supports as shown in figure 98 as well as vertical and horizontal

formwork impressions as shown in figure 99. In addition, the report noted voiding on the east support of the north channel pier. On the east face a void ranging from approximately 0.5 ft (0.15 m) to 2 ft (0.6 m) high located approximately 12 ft (3.7 m) below the top of the concrete support was identified. The report noted this voiding extended intermittently along the entire length of the east face and continued around the northeast corner to the north face for approximately 5 ft (1.5 m). Additional voiding at the east end of the south face approximately 5 ft (1.5 m) long by 6 inches (150 mm) high positioned approximately 19 ft (5.8 m) below the top of the concrete support was reported.
