Coastal Construction: Designing the Building Envelope

Course No: S04-018
Credit: 4 PDH

11 Designing the Building Envelope

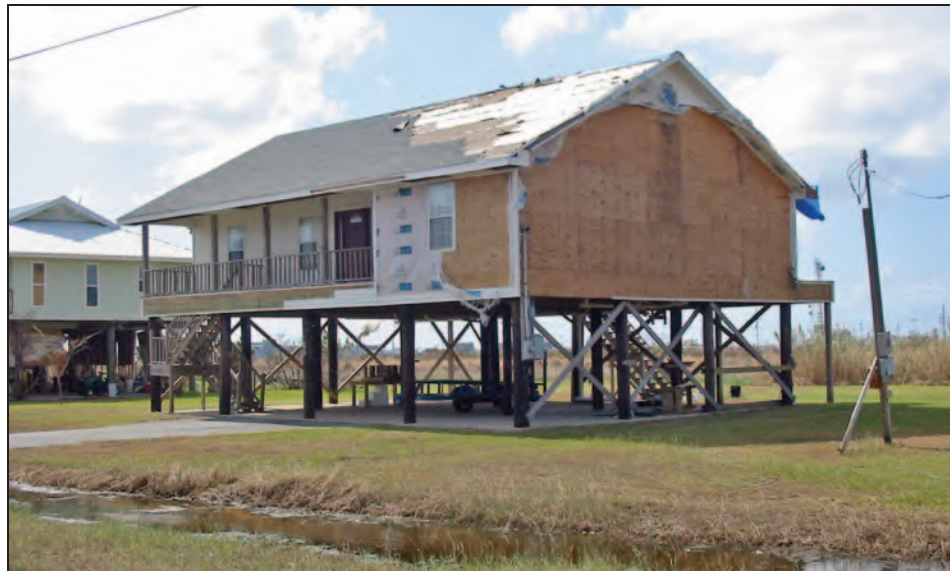
Figure 11-1.
Good structural system performance but the loss of shingles, underlayment, siding, housewrap, and soffits resulted in significant interior water damage. Estimated wind speed: 125 mph.³ Hurricane Katrina (Louisiana, 2005)

The predominant cause of damage to buildings and their contents during high-wind events has been shown to be breaching of the building envelope, as shown in Figure 11-1, and subsequent water infiltration. Breaching includes catastrophic failure (e.g., loss of the roof covering or windows) and is often followed by wind-driven water infiltration through small openings at doors, windows, and walls. The loss of roof and wall coverings and soffits on the house in Figure 11-1 resulted in significant interior water damage. Recommendations for avoiding breaching are provided in this chapter.

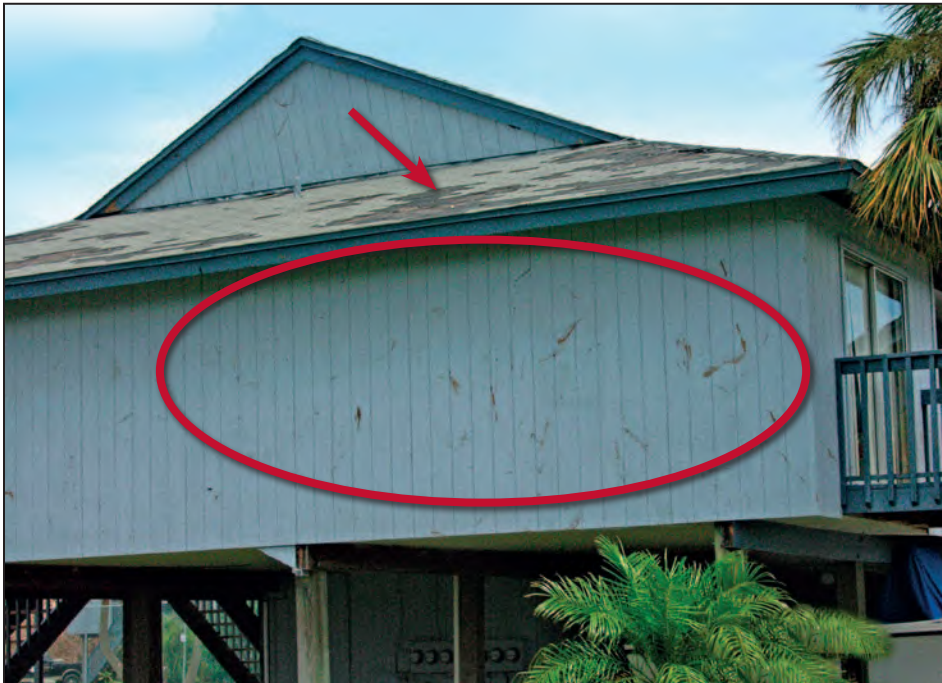
Figure 11-2. Numerous wind-borne debris scars on the wall of this house and several missing asphalt shingles. Estimated wind speed: 140 to 150 mph. Hurricane Charley (Florida, 2004)

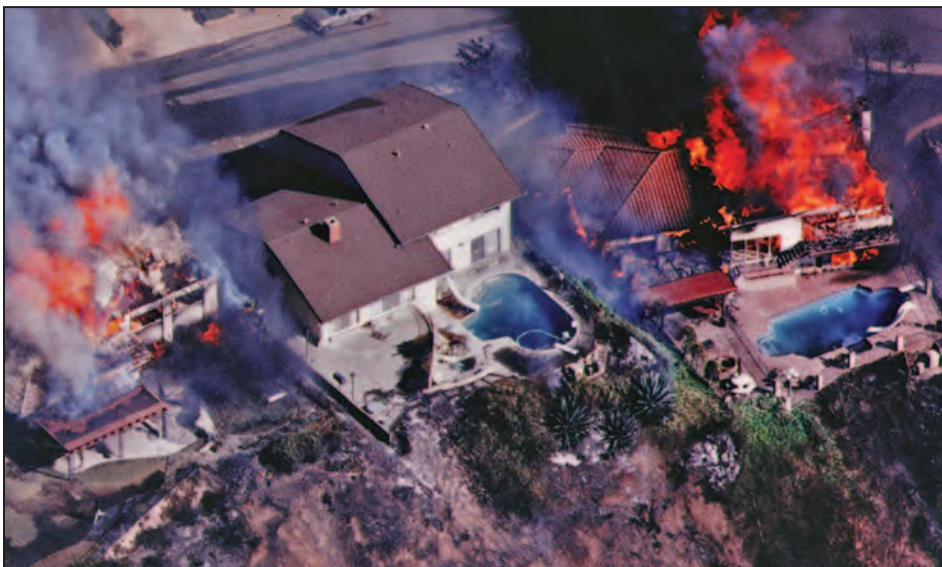
Figure 11-3. House that survived a wildfire due in part to fire-resistant walls and roof while surrounding houses were destroyed
SOURCE: DECRA ROOFING SYSTEMS, USED WITH PERMISSION

A building's susceptibility to wildfire depends largely on the presence of nearby vegetation and the characteristics of the building envelope, as illustrated in Figure 11-3. See FEMA P-737, *Home Builder's Guide to Construction in Wildfire Zones* (FEMA 2008), for guidance on materials and construction techniques to reduce risks associated with wildfire.

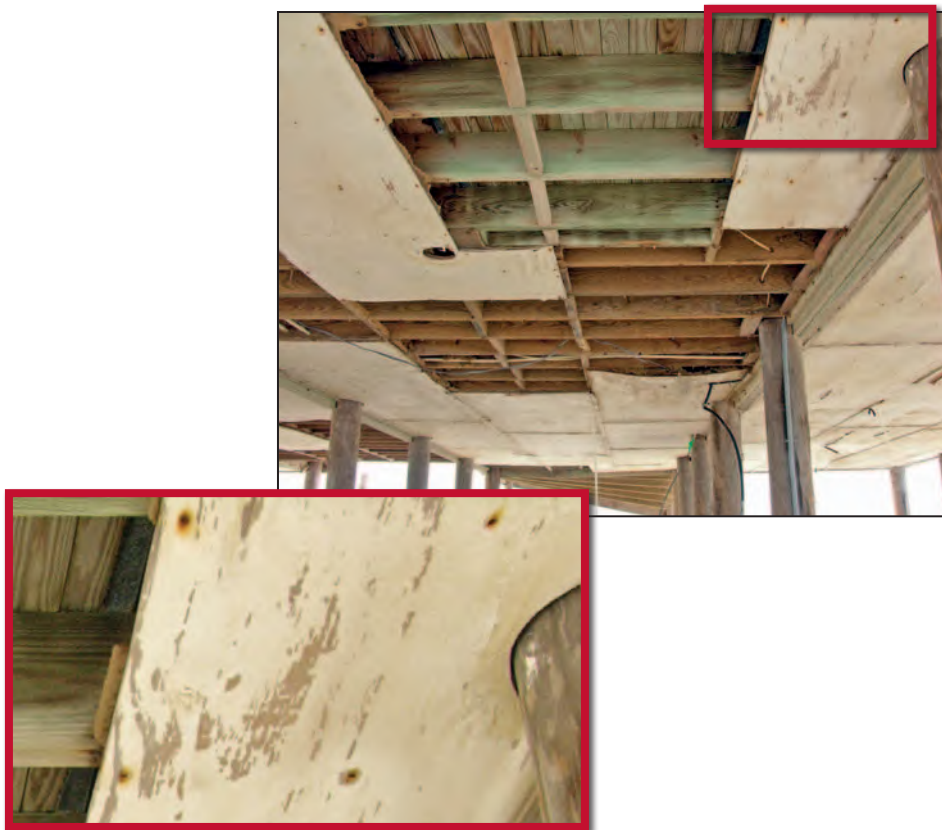
Figure 11-4. Plywood panels on the underside of a house that blew away because of excessive nail spacing. Note the corroded nails (inset). Estimated wind speed: 105 to 115 mph. Hurricane Ivan (Alabama, 2004)

A variety of sheathing materials have been used to sheath the framing, including cement-fiber panels, gypsum board, metal panels, plywood, and vinyl siding. Damage investigations have revealed that plywood offers the most reliable performance in high winds. However, as shown in Figure 11-4, even though plywood has been used, a sufficient number of fasteners are needed to avoid blow-off. Since ASCE 7 does not provide guidance for load determination, professional judgment in specifying the attachment schedule is needed. As a conservative approach, loads can be calculated by using the C&C coefficients for a roof with the slope of 7 degrees or less. However, the roof corner load is likely overly conservative for the underside of elevated floors. Applying the perimeter load to the corner area is likely sufficiently conservative.

To achieve good long-term performance, exterior grade plywood attached with stainless steel or hot-dip galvanized nails or screws is recommended (see the corroded nails in Figure 11-4).

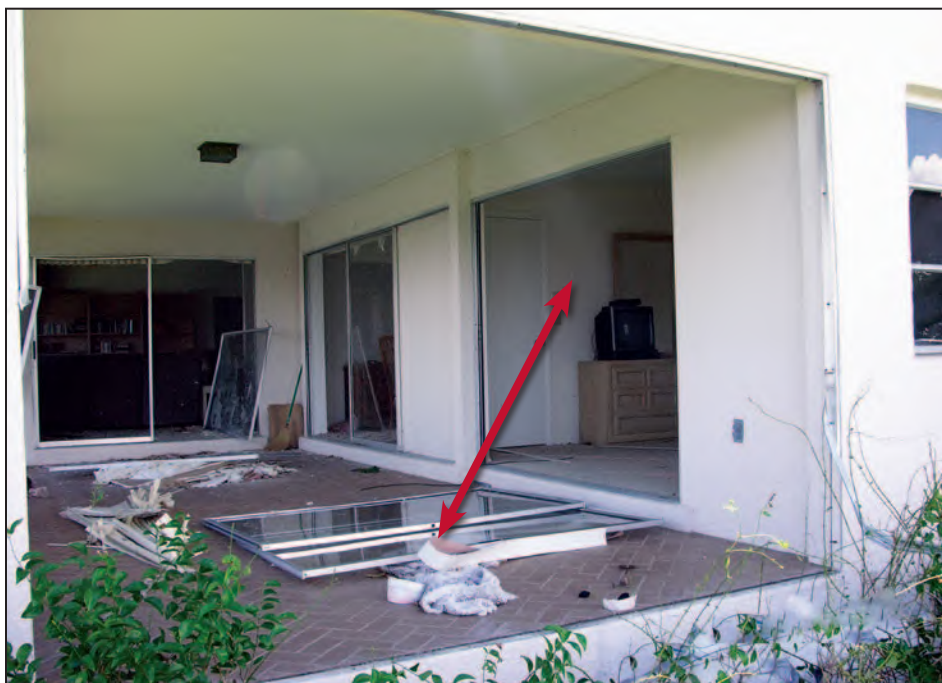
Figure 11-5. Sliding glass doors pulled out of their tracks by wind suction. Estimated wind speed: 140 to 160 mph. Hurricane Charley (Florida, 2004)

This section addresses exterior personnel doors and garage doors. The most common problems are entrance of wind-driven rain and breakage of glass vision panels and sliding glass doors by wind-borne debris. Blow-off of personnel doors is uncommon but as shown in Figure 11-5, it can occur. Personnel door blow-off is typically caused by inadequate attachment of the door frame to the wall. Garage door failure via negative (suction) or positive pressure was common before doors with high-wind resistance became available (see Figure 11-6). Garage door failure is typically caused by the use of door and track assemblies that have insufficient wind resistance or by inadequate attachment of the tracks to nailers or to the wall. Failures such as those shown in Figures 11-5 and 11-6 can result in a substantial increase in internal pressure and can allow entrance of a significant amount of wind-driven rain.

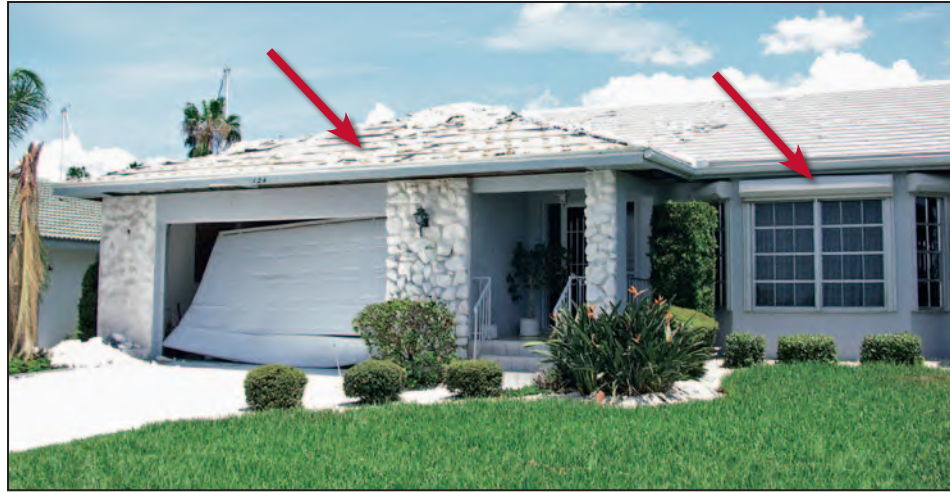
Figure 11-6. Garage door blown from its track as a result of positive pressure. Note the damage to the adhesive-set tiles (left arrow; see Section 11.5.4.1). This house was equipped with roll-up shutters (right arrow; see Section 11.3.1.2). Estimated wind speed: 140 to 160 mph. Hurricane Charley (Florida, 2004)

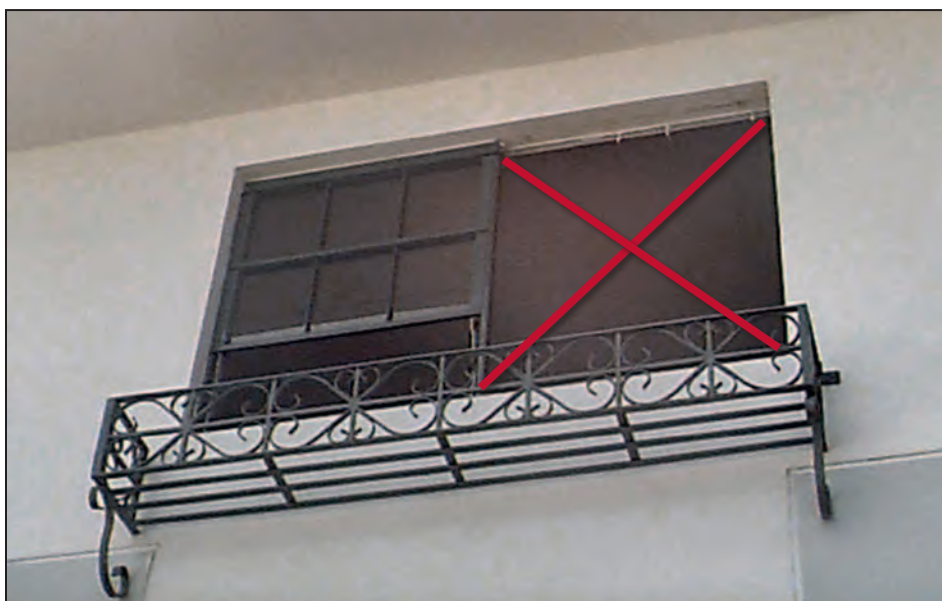
Figure 11-8. Window frame pulled out of the wall because of inadequate window frame attachment. Hurricane Georges (Puerto Rico, 1998)

This section addresses exterior windows (including door vision panels) and skylights. The most common problems in the coastal environment are entrance of wind-driven rain and glazing breakage by wind-borne debris. It is uncommon for windows to be blown-in or blown-out, but it does occur (see Figure 11-8). The type of damage shown in Figure 11-8 is typically caused by inadequate attachment of the window frame to the wall, but occasionally the glazing itself is blown out of the frame. Breakage of glazing from over-pressurization sometimes occurs with windows that were manufactured before windows with high-wind resistance became available. Strong seismic events can also damage windows although it is uncommon in residential construction. Hail can cause significant damage to skylights and occasionally cause window breakage.

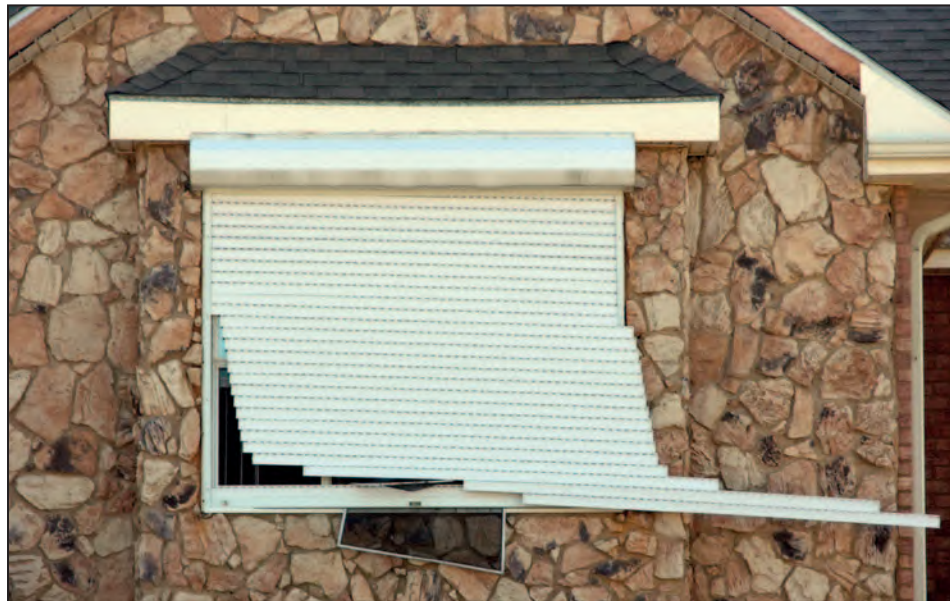
Figure 11-12.
Roll-up shutter slats that detached from the tracks. The lack of a label makes it unclear whether the shutter was tested in accordance with a recognized method. Estimated wind speed: 110 mph. Hurricane Katrina (Louisiana, 2005)

and test standards that were used to evaluate the pressure and impact resistance. Without a label, ascertaining whether a window or shutter has sufficient strength to meet pressure and wind-borne debris loads is difficult (see Figure 11-12). It is therefore recommended that design professionals specify that windows and shutters have permanently mounted labels that contain the type of information shown in Figure 11-11.

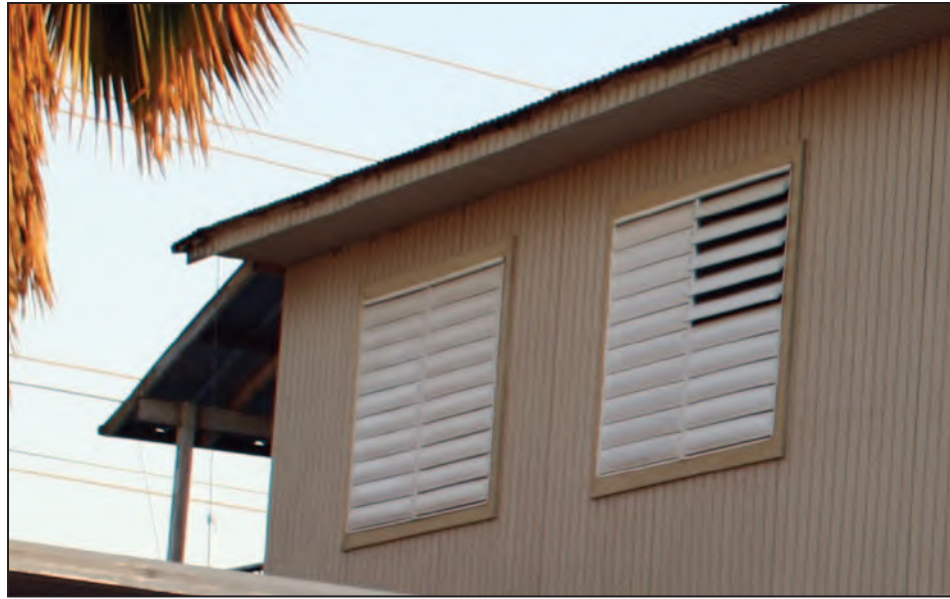
Figure 11-14.
House in Puerto Rico with
metal jalousie louvers

In tropical climates such as Puerto Rico, some houses have metal jalousie louvers in lieu of glazed window openings (see Figure 11-14). Metal jalousies have the appearance of a debris-resistant shutter, but they typically offer little debris resistance. Neither the UBC nor IRC require openings equipped with metal jalousie louvers to be debris resistant because glazing does not occur. However, the louvers are required to meet the design wind pressure.

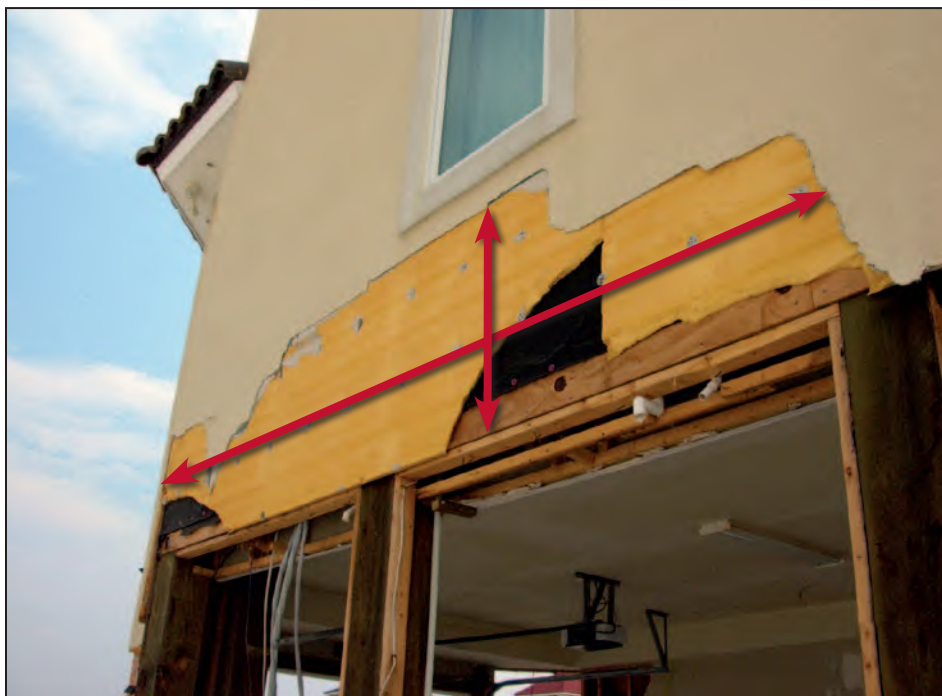
Figure 11-20. Collapse of the breakaway wall, resulting in EIFS peeling. A suitable transition detail at the top of breakaway walls avoids the type of peeling damage shown by the arrows. Estimated wind speed: 105 to 115 mph. Hurricane Ivan (Alabama, 2004)

At the house shown in Figure 11-20, floodwater collapsed the breakaway wall and initiated progressive peeling of the EIFS wall covering. A suitable flashing at the top of the breakaway wall would have avoided the progressive failure. When a wall covering progressively fails above the top of a breakaway wall, wave spray and/or wind-driven water may cause interior damage.

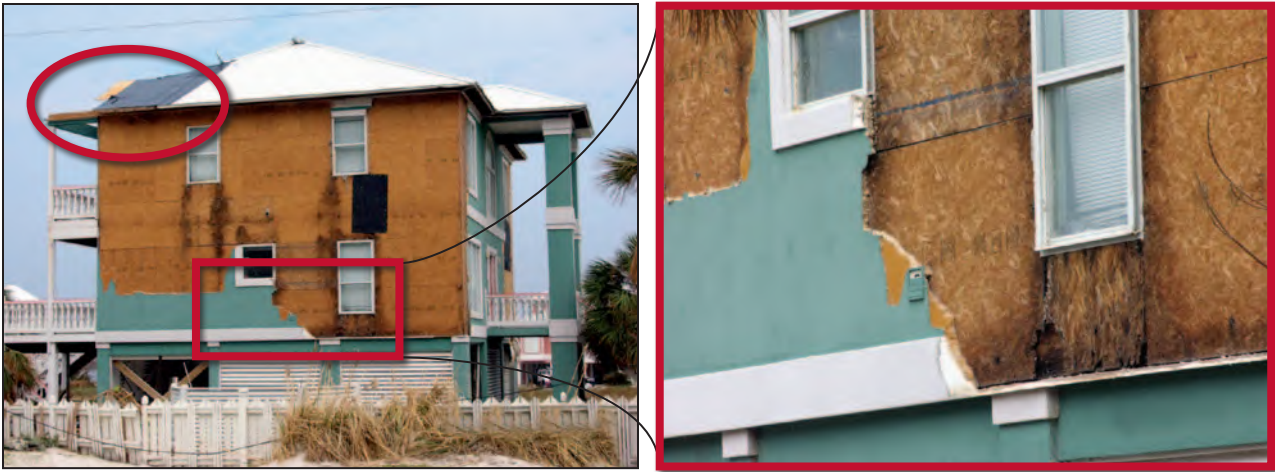
Figure 11-21.
EIFS with a barrier design: blown-off roof decking (top circle); severely rotted OSB due to leakage at windows (inset). Hurricane Ivan (2004)

Several of the studs shown in Figure 11-19 were severely rotted, indicating long-term moisture intrusion behind the MEPS insulation. The residence shown in Figure 11-19 had a barrier EIFS design, rather than the newer drainable EIFS design (for another example of a barrier EIFS design, see Figure 11-21). EIFS should be designed with a drainage system that allows for dissipation of water leaks.

Water infiltration at wall openings and wall transitions due to poor flashing design and/or installation is a common problem in many coastal homes (see Figure 11-21). In areas that experience frequent wind-driven rain and areas susceptible to high winds, enhanced flashing details and attention to their execution are recommended. Enhancements include flashings that have extra-long flanges, use of sealant, and use of self-adhering modified bitumen tape.

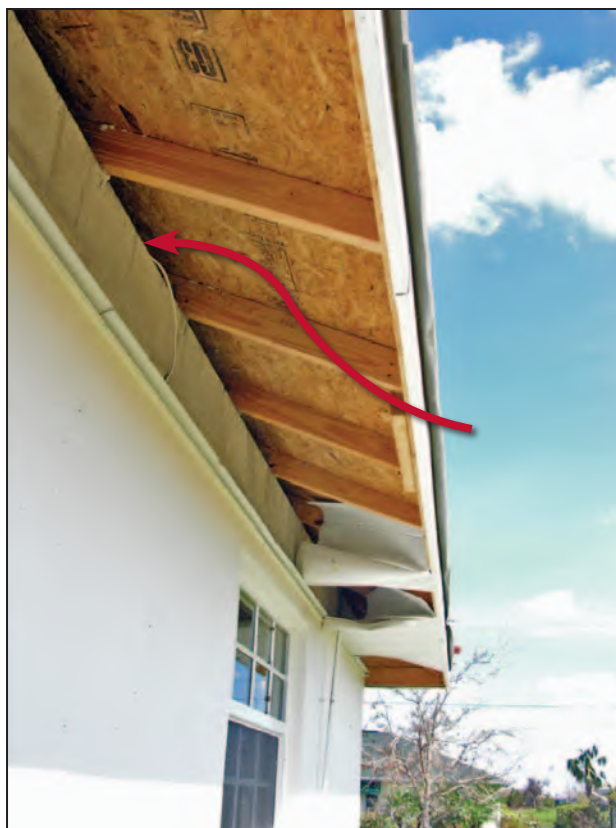
Figure 11-22. Blown-away soffit (arrow), which allowed wind-driven rain to enter the attic. Estimated wind speed: 140 to 160 mph. Hurricane Charley (Florida, 2004)

Depending on the wind direction, soffits can be subjected to either positive or negative pressure. Failed soffits may provide a convenient path for wind-driven rain to enter the building, as illustrated by Figure 11-22. This house had a steep-slope roof with a ventilated attic space. The exterior CMU/stucco wall stopped just above the vinyl soffit. Wind-driven rain entered the attic space where the soffit had blown away. This example and other storm-damage research have shown that water blown into attic spaces after the loss of soffits can cause significant damage and the collapse of ceilings. Even when soffits remain in place, water can penetrate through soffit vents and cause damage (see Section 11.6).

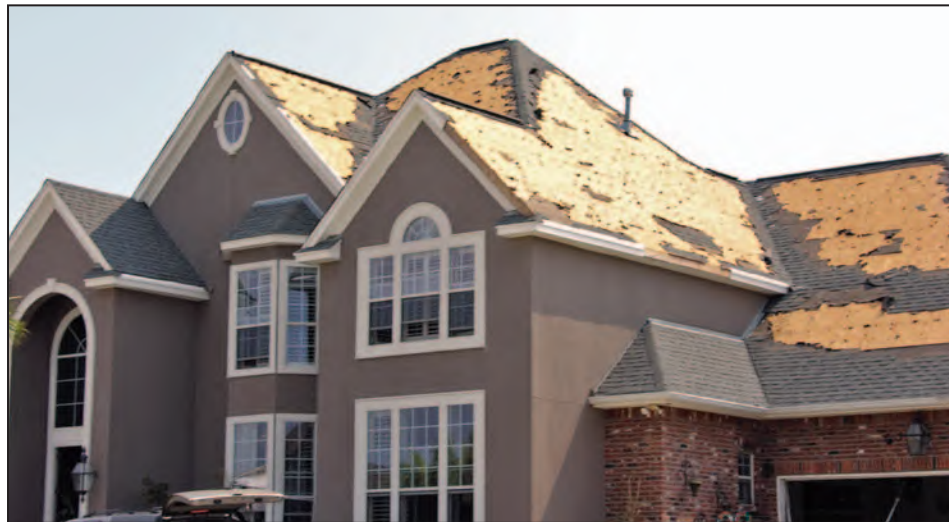
Figure 11-25.
Typical underlayment attachment; underlayment blow-off is common if the shingles are blown off, as shown. Estimated wind speed: 115 mph. Hurricane Katrina (Louisiana, 2005)

If shingles blow off, water infiltration damage can be avoided if the underlayment remains attached and is adequately sealed at penetrations. Figures 11-24 and 11-25 show houses with underlayment that was not effective in avoiding water leakage. Reliable

- **Enhanced Underlayment Option 3.** Option 3 is the typical underlayment scheme (i.e., a single layer of #15 felt tacked to the sheathing, as shown in Figure 11-25) with the added enhancement of self-adhering modified bitumen tape. This option provides limited protection against water infiltration if the shingles blow off. However, this option provides more protection than the typical underlayment scheme. Option 3 is illustrated in Fact Sheet 7.2 in FEMA P-499.

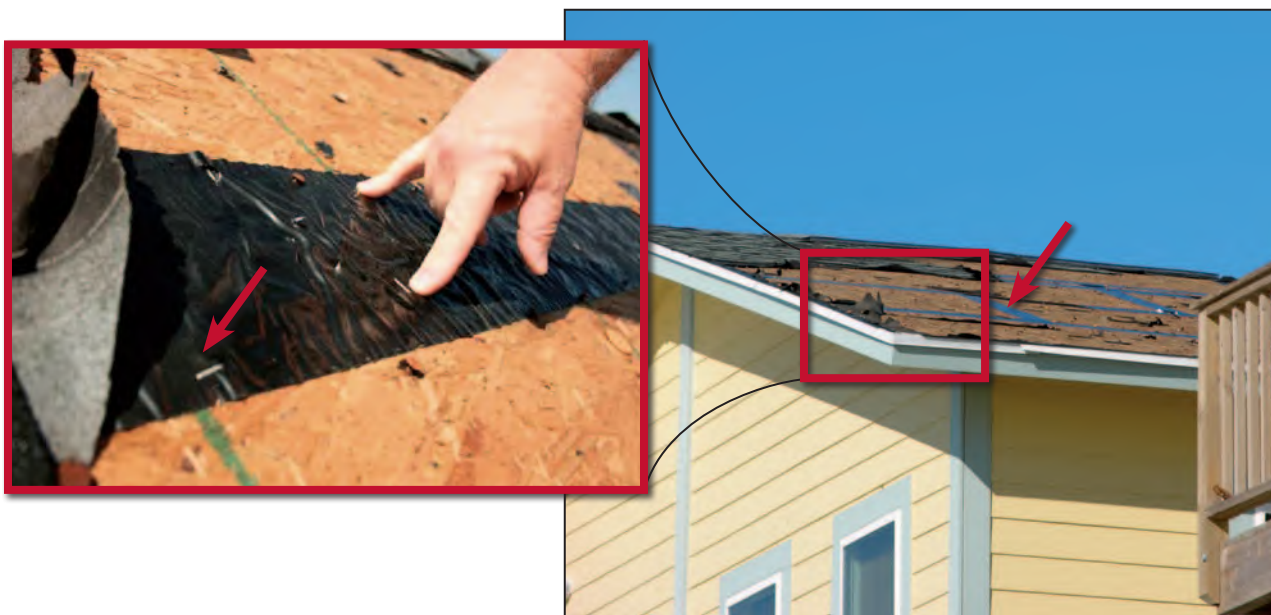
Figure 11-28. House that used enhanced underlayment Option 3 with taped sheathing joints (arrow). The self-adhering modified bitumen tape (inset) was stapled because of bonding problems. Estimated wind speed: 110 mph. Hurricane Ike (Texas, 2008)

Figure 11-28 shows a house that used Option 3. The self-adhering modified bitumen tape at the sheathing joints was intended to be a third line of defense against water leakage (with the shingles the first line and the felt the second line). However, as shown in the inset at Figure 11-28, the tape did not provide a watertight seal. A post-storm investigation revealed application problems with the tape. Staples (arrow, inset) were used to attach the tape because bonding problems were experienced during application. Apparently, the applicator did not realize the tape was intended to prevent water from leaking through the sheathing joints. With the tape in an unbonded and wrinkled condition, it was incapable of fulfilling its intended purpose.

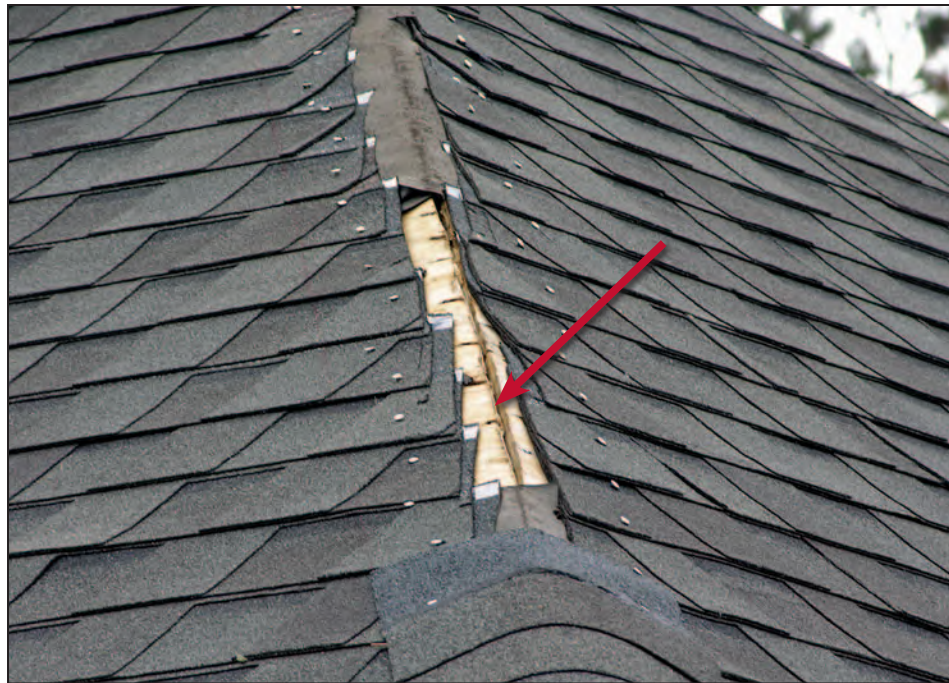
Figure 11-29.
Underlayment that was not lapped over the hip; water entry possible at the sheathing joint (arrow). Estimated wind speed: 130 mph. Hurricane Katrina (Mississippi, 2005)

In addition to taping the sheathing joints in the field of the roof, the hip and ridge lines should also be taped unless there is a continuous ridge vent, and the underlayment should be lapped over the hip and ridge. By doing so, leakage will be avoided if the hip or ridge shingles blow off (see Figure 11-29). See Section 11.6 for recommendations regarding leakage avoidance at ridge vents.

Shingle blow-off is commonly initiated at eaves (see Figure 11-30) and rakes (see Figure 11-31). Blow-off of ridge and hip shingles, as shown in Figure 11-29, is also common. For another example of blow-off of ridge

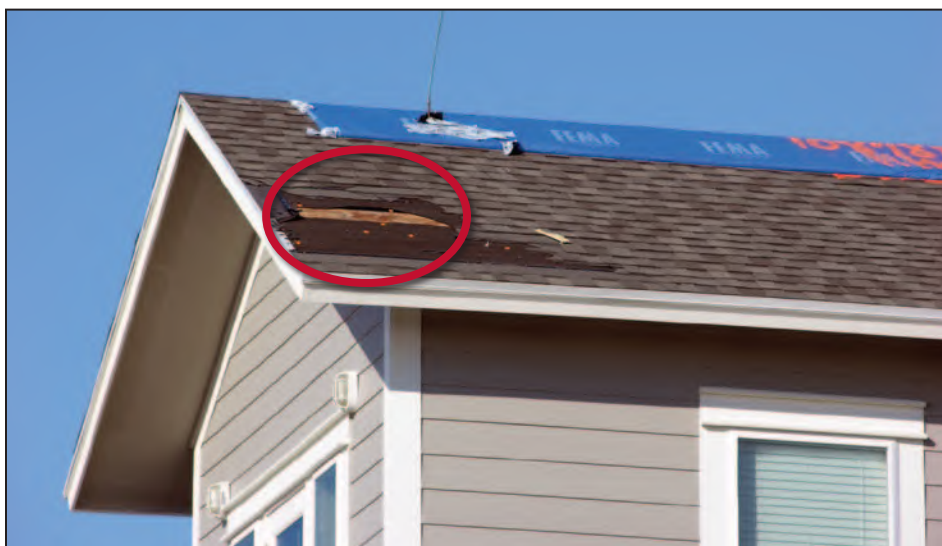
Figure 11-31. Loss of shingles and underlayment along the rake. Estimated wind speed: 110 mph. Hurricane Ike (Texas, 2008)

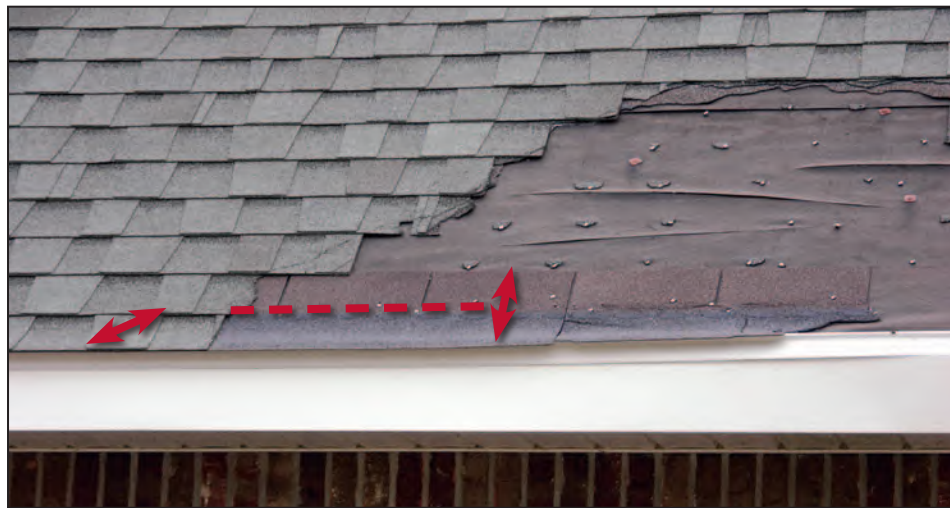
Figure 11-32.
Incorrect installation of the starter course (incorrectly rotated starter, right arrow, resulted in self-seal adhesive not near the eave, dashed line). Estimated wind speed: 130 mph. Hurricane Katrina (Mississippi, 2005)

Storm damage investigations have shown that when eave damage occurs, the starter strip was typically incorrectly installed, as shown in Figure 11-32. Rather than cutting off the tabs of the starter, the starter was rotated 180 degrees (right arrow). The exposed portion of the first course of shingles (left arrow) was unbounded because the self-seal adhesive (dashed line) on the starter was not near the eave. Even when the starter is correctly installed (as shown on shingle bundle wrappers), the first course may not bond to the starter because of substrate variation. Fact Sheet 7.3 in FEMA P-499 provides information about enhanced attachment along the eave, including special recommendations regarding nailing, use of asphalt roof cement, and overhang of the shingle at the eave.

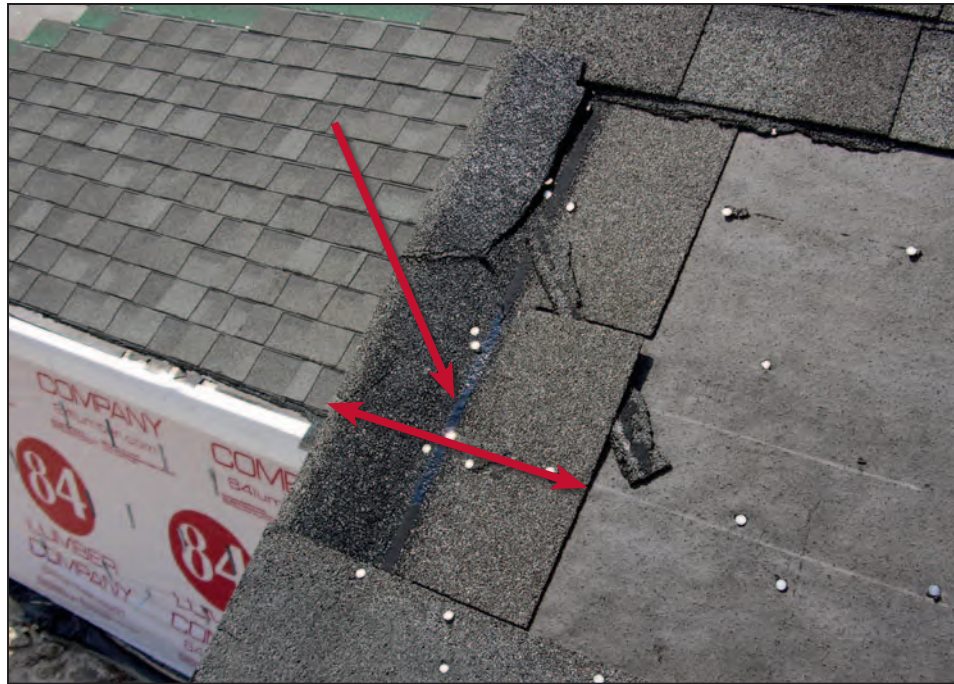
Figure 11-34.
A bleeder strip (double-arrow) that was used at a rake blow-off; lack of contact between the tab of the overlying shingle and the bleeder's self-seal adhesive (upper arrow). Estimated wind speed: 125 mph. Hurricane Katrina (Mississippi, 2005)

Storm damage investigations have shown that on several damaged roofs, bleeder strips had been installed. Bleeder strips are shingles that are applied along the rake, similar to the starter course at the eave, as shown at Figure 11-34. A bleeder provides an extended straight edge that can be used as a guide for terminating the rake shingles. At first glance, it might be believed that a bleeder enhances wind resistance along the rake. However, a bleeder does not significantly enhance resistance because the concealed portion of the overlying rake shingle is the only portion that makes contact with the self-seal adhesive on the bleeder. As can be seen in Figure 11-34, the tab does not make contact with the bleeder. Hence, if the tab lifts, the shingle is placed in peel mode, which can easily break the bond with the bleeder. Also, if the tabs are not cut from the bleeder and the cut edge is placed along the rake edge, the bleeder's adhesive is too far inward to be of value.

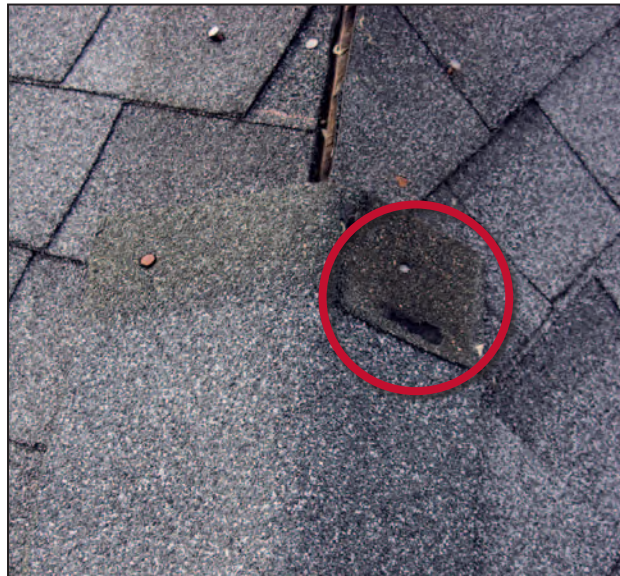
Figure 11-35.
Inadequate sealing of the self-sealing adhesive at a hip as a result of the typical hip installation procedure. Estimated wind speed: 105 mph. Hurricane Katrina (Mississippi, 2005)

Storm damage investigations have shown that when hip and ridge shingles are blown off, there was a lack of bonding of the self-seal adhesive. Sometimes some bonding occurred, but frequently none of the adhesive had bonded. At the hip shown in Figure 11-35, the self-seal adhesive made contact only at a small area on the right side of the hip (circle). Also, at this hip, the nails were above, rather than below, the adhesive line. Lack of bonding of the hip and ridge shingles is common and is caused by substrate irregularity along the hip/ridge line. Fact Sheet 7.3 in FEMA P-499 provides recommendations regarding the use of asphalt roof cement to ensure bonding in order to enhance the attachment of hip and ridge shingles.

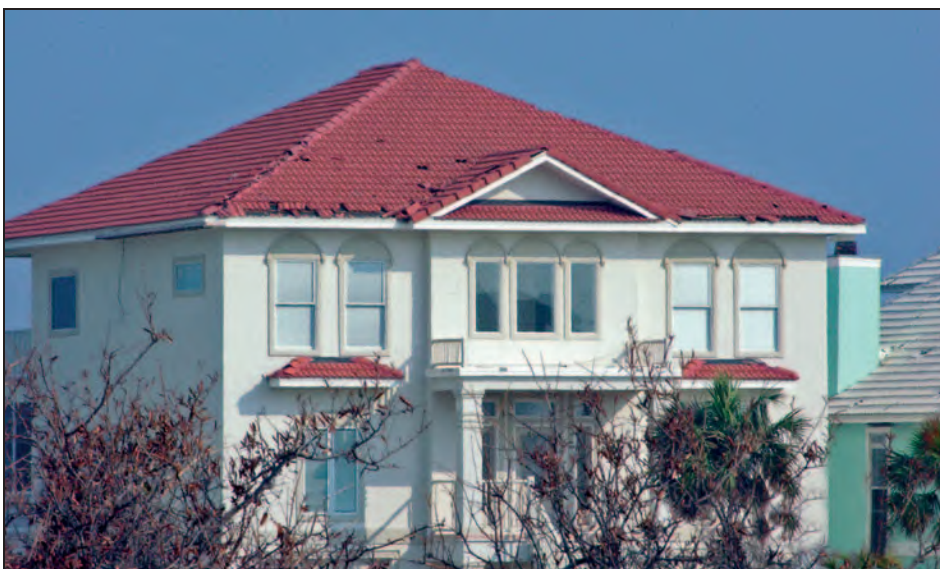
Figure 11-39.
Blow-off of eave and hip tiles and some broken tiles in the field of the roof. Hurricane Ivan (Alabama, 2004)

Figure 11-39 illustrates the type of damage that has often occurred during moderately high winds. Blow-off of hip, ridge, or eave tiles is caused by inadequate attachment. Damage to field tiles is typically caused by wind-borne debris (which is often tile debris from the eaves and hips/ridges). Many tile roofs occur over waterproof (rather than water-shedding) underlayment. Waterproof underlayments have typically been well-attached and therefore have not normally blown off after tile blow-off. Hence, many residences with tile roofs have experienced significant tile damage, but little, if any water infiltration from the roof. Figure 11-40 shows an atypical underlayment blow-off, which resulted in substantial water leakage into the house.

Damage investigations have revealed that blow off of hip and ridge failures are common (see Figures 11-39, 11-45, and 11-46). Some of the failed hip/ridge tiles were attached with mortar (see Figure 11-45), while others were mortared and mechanically attached to a ridge board. At the roof shown in Figure 11-46, the hip tiles were set in mortar and attached to a ridge board with a single nail near the head of the hip tile.

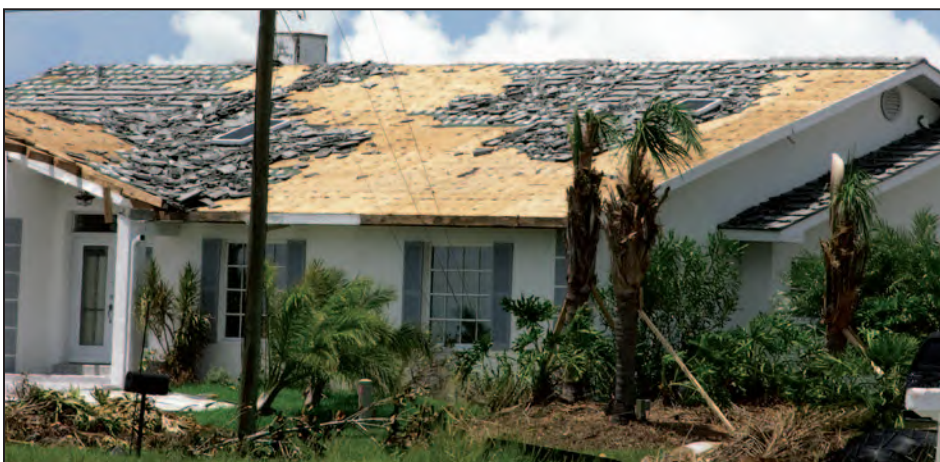
Figure 11-40.
Large area of blown-off underlayment on a mortar-set tile roof. The atypical loss of waterproofing tile underlayment resulted in substantial water leakage into the house. Estimated wind speed: 140 to 160 mph. Hurricane Charley (Florida, 2004)

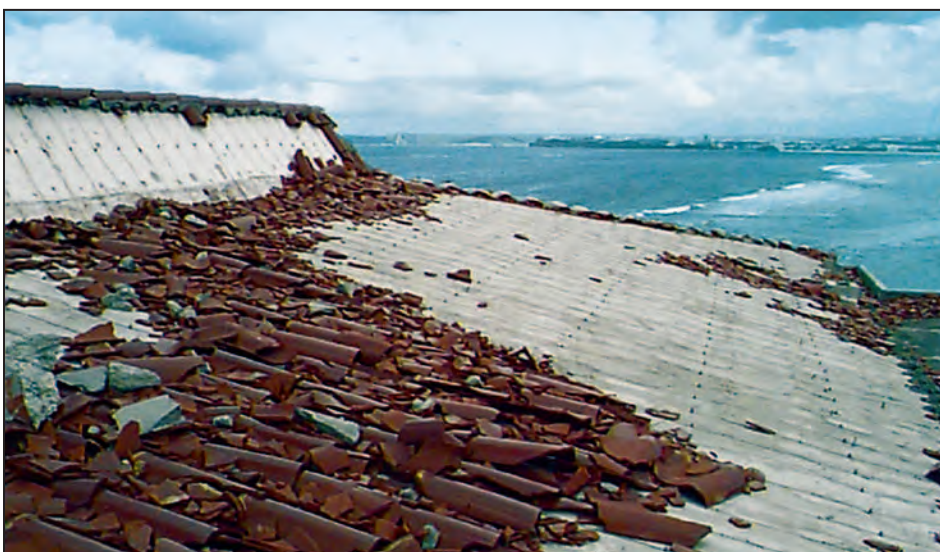
Figure 11-41.
Blow-off of wire-tied tiles installed over a concrete deck. Typhoon Paka (Guam, 1997)

The four methods of attaching tile are wire-tied, mortar-set, mechanical attachment, and foam-adhesive (adhesive-set). Wire-tied systems are not commonly used in high-wind regions of the continental United States. On the roof shown in Figure 11-41, wire-tied tiles were installed over a concrete deck. Nose hooks occurred at the nose. In addition, a bead of adhesive occurred between the tiles at the headlap. Tiles at the first three perimeter rows were also attached with wind clips. The clips prevented the perimeter tiles from lifting. However, at the field of the roof, the tiles were repeatedly lifted and slammed against deck, which caused the tiles to break and blow away.

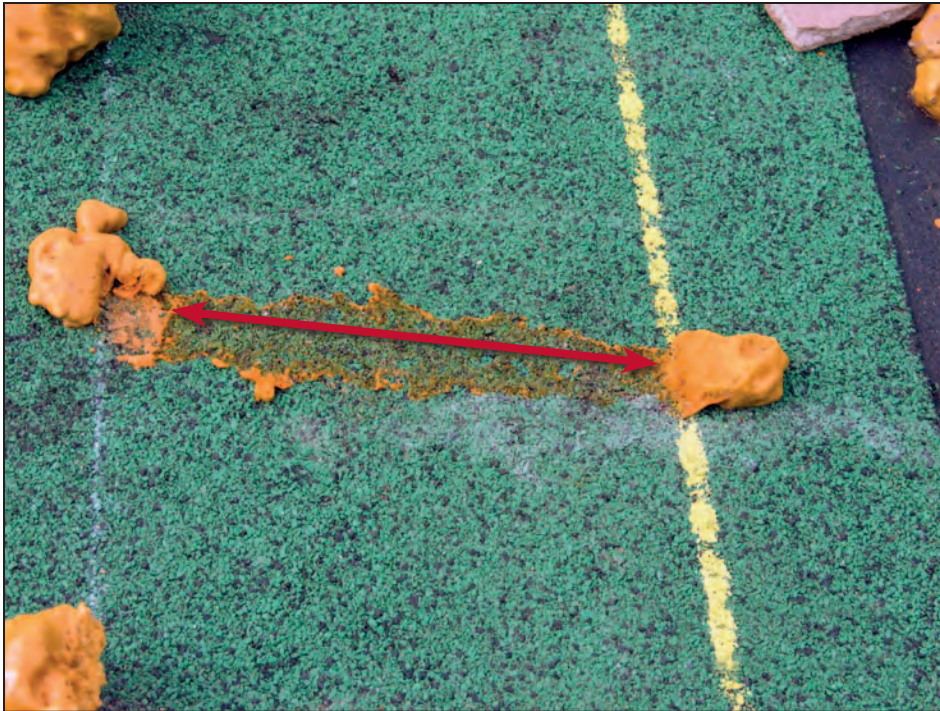
Figure 11-44.
Adhesive that debonded
from the cap sheet

Figure 11-43 shows a house with adhesive-set tile. There were significant installation problems with the foam paddies, including insufficient contact area between the patty and the tile. As can be seen in Figure 11-43, most of the foam failed to make contact with the tile. Some of the foam also debonded from the mineral surface cap sheet underlayment (see Figure 11-44).

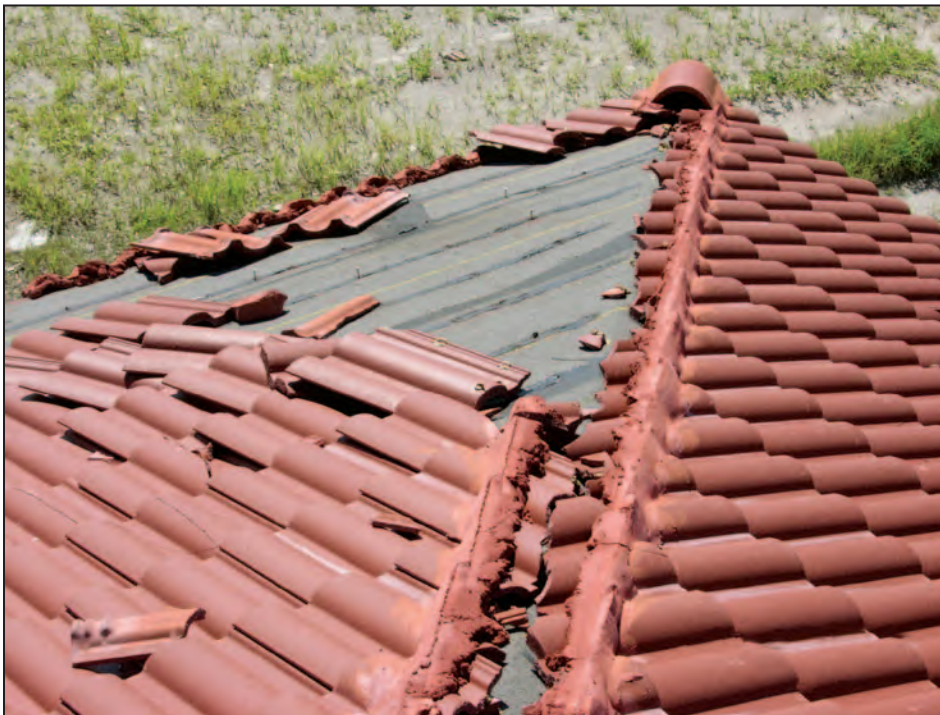
Figure 11-45.
Blow-off of mechanically
attached tiles. Estimated
wind speed: 140 to 160
mph. Hurricane Charley
(Florida, 2004)

Figure 11-45 shows tiles that were mechanically attached with screws. At the blow-off area, some of the screws remained in the deck, while others were pulled out. The ridge tiles were set in mortar.

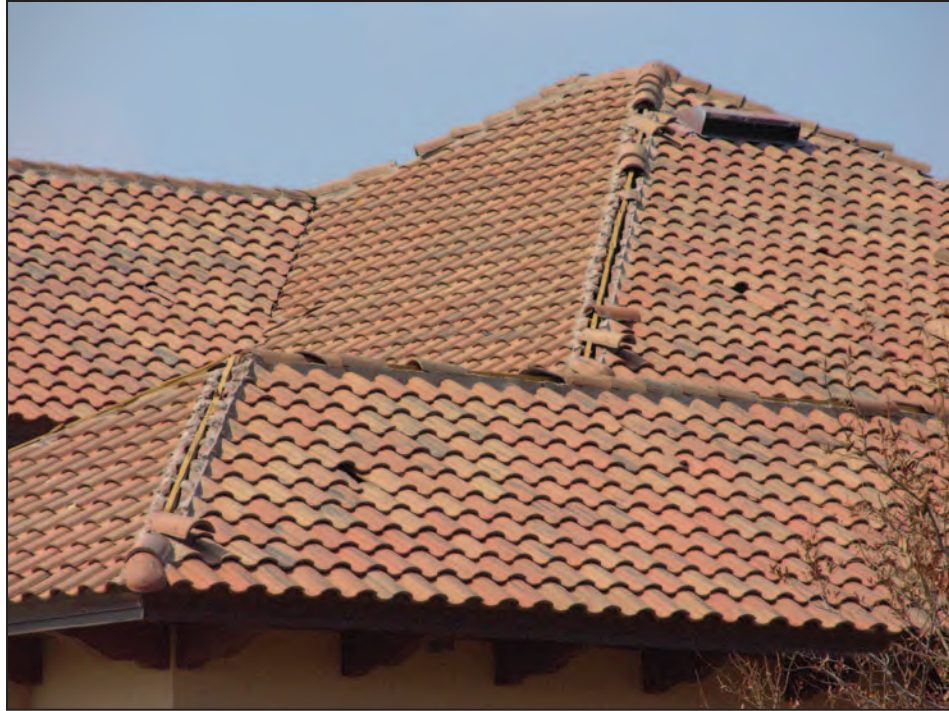
Figure 11-46.
Blow-off of hip tiles that
were nailed to a ridge
board and set in mortar.
Hurricane Ivan (Florida,
2004)

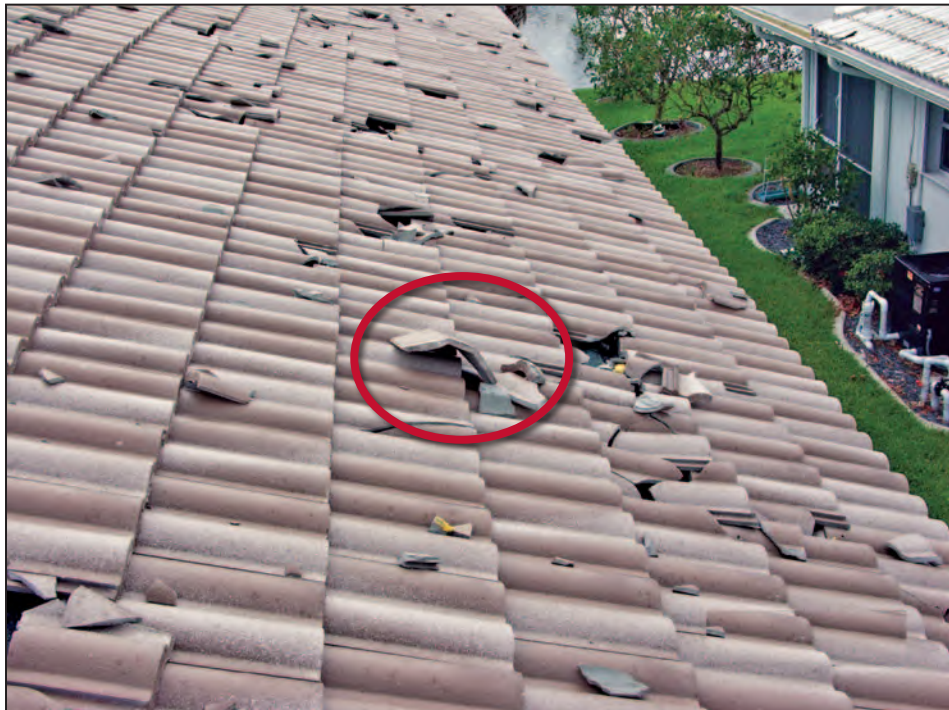
Figure 11-47.
Damage to field tiles
caused by tiles from
another area of the
roof, including a hip
tile (circle). Estimated
wind speed: 140 to 160
mph. Hurricane Charley
(Florida, 2004)

Because of the brittle nature of tile, tile is often damaged by wind-borne debris, including tile from nearby buildings or tile from the same building (see Figure 11-47).

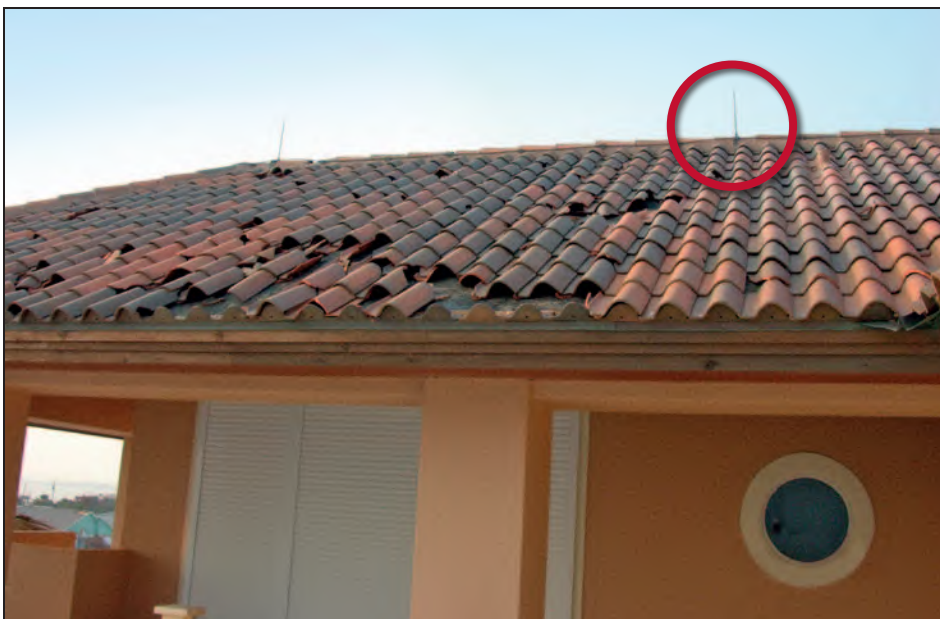
The house in Figure 11-48 had a lightning protection system (LPS), and the LPS conductors were placed under the ridge tile. Conductors are not susceptible to wind damage if they are placed under the tile and the air terminals (lightning rods) are extended through the ridge.

Figure 11-48. The fastener heads on this mechanically attached tile roof had corroded; air terminals (lightning rods) in a lightning protection system (circle). Hurricane Ivan (Alabama, 2004)

At houses on the coast, fasteners and clips that are used to attach tiles are susceptible to corrosion unless they are stainless steel. Figure 11-48 shows a 6-year-old tile roof on a house very close to the ocean that failed because the heads of the screws attaching the tile had corroded off. Stainless steel straps, fasteners, and clips are recommended for roofs within 3,000 feet of an ocean shoreline (including sounds and back bays).

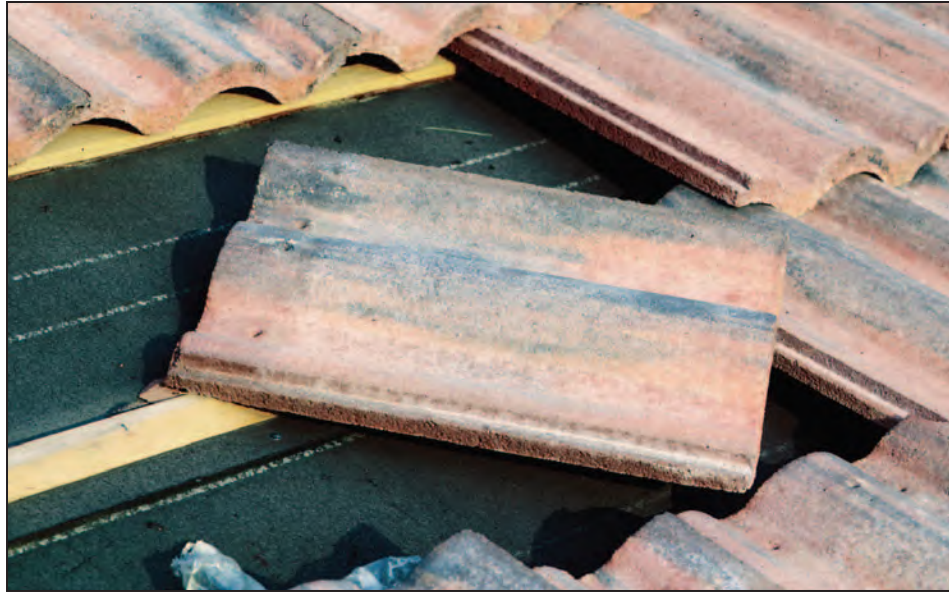
Figure 11-49.
Area of the roof where
tiles were not nailed to
batten strips. Northridge
Earthquake (California,
1994)

- If tiles are laid on battens, supplemental mechanical attachment is recommended. When tiles are only loose laid on battens, they can be shaken off, as shown in Figure 11-49 where most of the tiles on the roof were nailed to batten strips. However, in one area, several tiles were not nailed. Because of the lack of nails, the tiles were shaken off the battens.

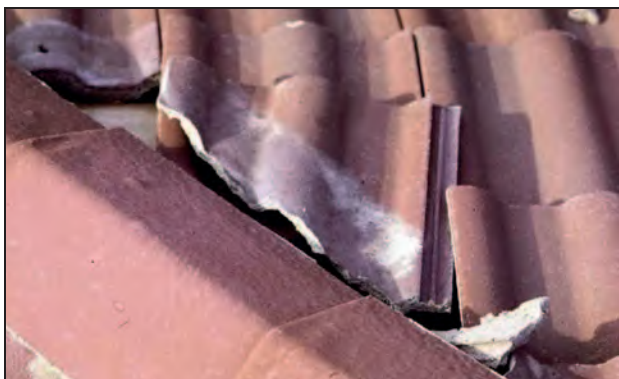
Figure 11-51.
Tile that slipped out from under the hip tiles.
Northridge Earthquake (California, 1994)

- When tiles are cut to fit near hips and valleys, the portion of the tile with the nail hole(s) is often cut away. Figure 11-51 shows a tile that slipped out from under the hip tiles. The tile that slipped was trimmed to fit at the hip. The trimming eliminated the nail holes, and no other attachment was provided. The friction fit was inadequate to resist the seismic forces. Tiles must have supplemental securing to avoid displacement of these loose tiles.
