Coastal Construction: Designing the Building Envelope

Course No: S04-018
Credit: 4 PDH

11 Designing the Building Envelope

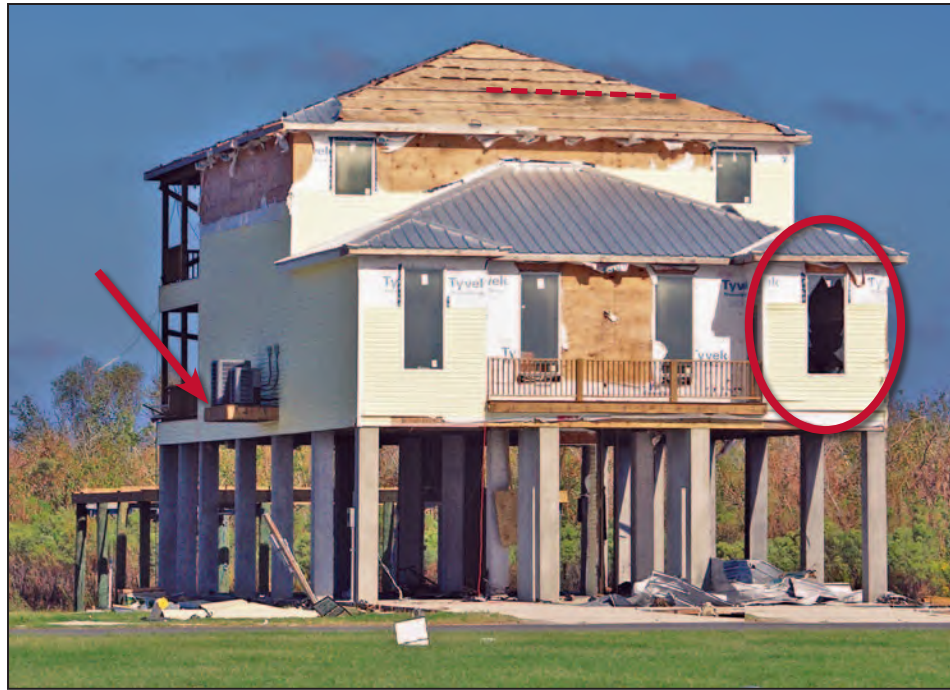
Figure 11-52.
Blow-off of one of the nailers (dashed line on roof) caused panels to progressively fail; cantilevered condenser platform (arrow); broken window (circle). Estimated wind speed: 130 mph. Hurricane Katrina (Louisiana, 2005)

Figure 11-52 illustrates the importance of load path. The metal roof panels were screwed to wood nailers that were attached to the roof deck. The panels were well attached to the nailers. However, one of the nailers was inadequately attached. This nailer lifted and caused a progressive lifting and peeling of the metal panels. Note the cantilevered condenser platform (arrow), a good practice, and the broken window (circle).

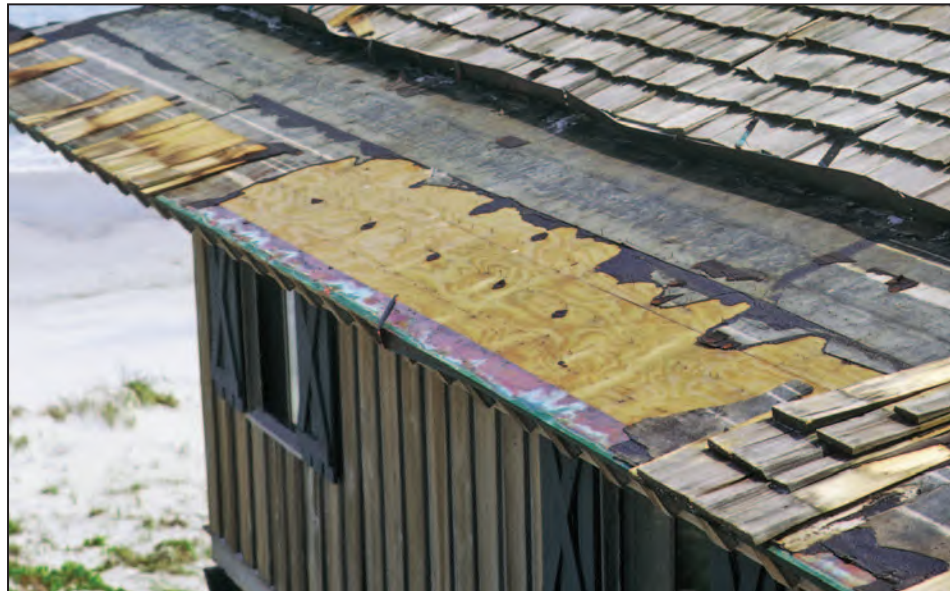
Figure 11-54.
Loss of wood shingles
due to fastener corrosion.
Hurricane Bertha (North
Carolina, 1996)

For enhanced durability, preservative-treated wood is recommended for shingle or shake roofs on coastal buildings. Stainless steel fasteners are recommended for roofs within 3,000 feet of an ocean shoreline (including sounds and back bays). See Figure 11-54 for an example of shingle loss due to corrosion of the nails.
