## **Ethical Issues from the St. Francis Dam Failure**

Course No: LE2-004  
Credit: 2 PDH

J. Paul Guyer, P.E., R.A., Fellow ASCE, Fellow AEI

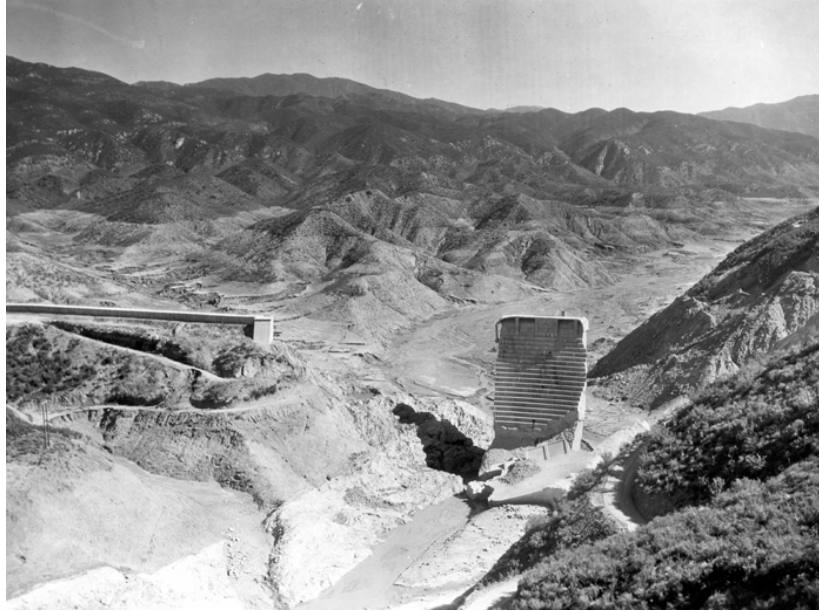
St. Francis Dam, March 17, 1928  
(Attribution: U.S. Geological Survey Photographic Library)  
Figure 3

The dam broke into several large concrete blocks, some of which were carried almost 1/2 mile downstream, while the center section of the dam remained standing. The upright center section was subsequently demolished. The St. Francis Dam was not rebuilt, although Bouquet Reservoir in nearby Bouquet Canyon and Castaic Dam in the town of Castaic were subsequently built as replacements for the St. Francis Dam.

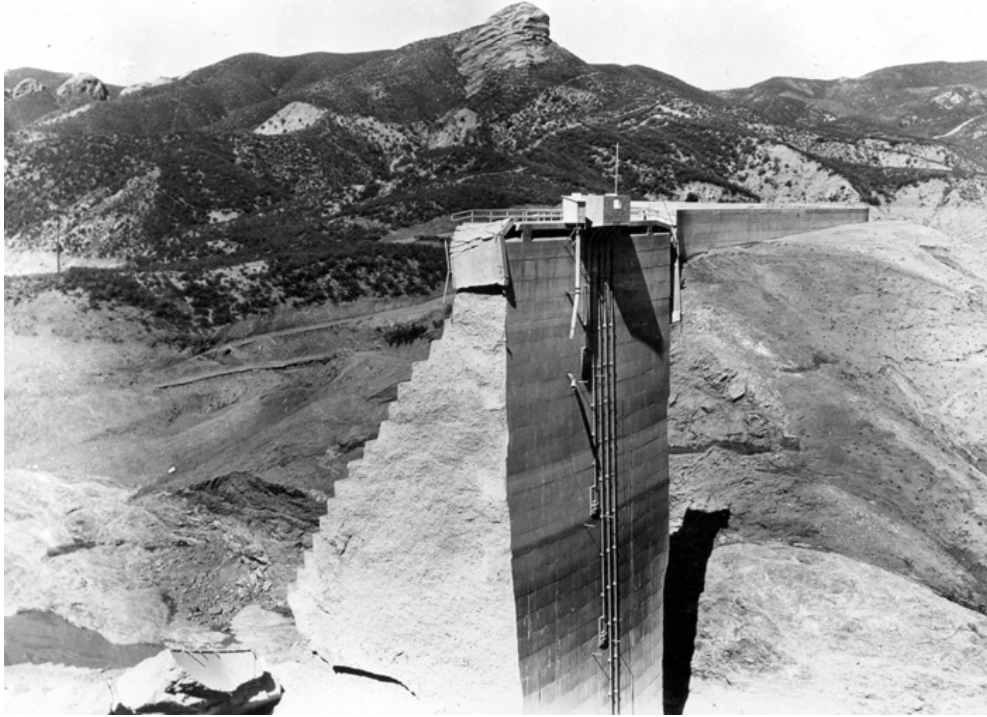
**St. Francis Dam, March 17, 1928**  
(Attribution: U.S. Geological Survey Photographic Library)  
**Figure 4**

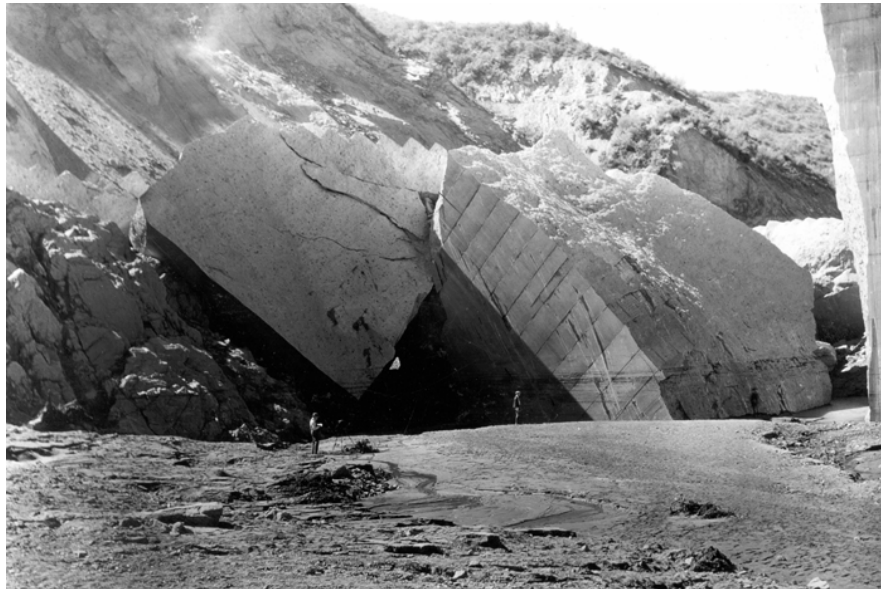
**St. Francis Dam, Concrete Debris Blocks**  
(Attribution: U.S. Geological Survey Photographic Library)  
**Figure 5**

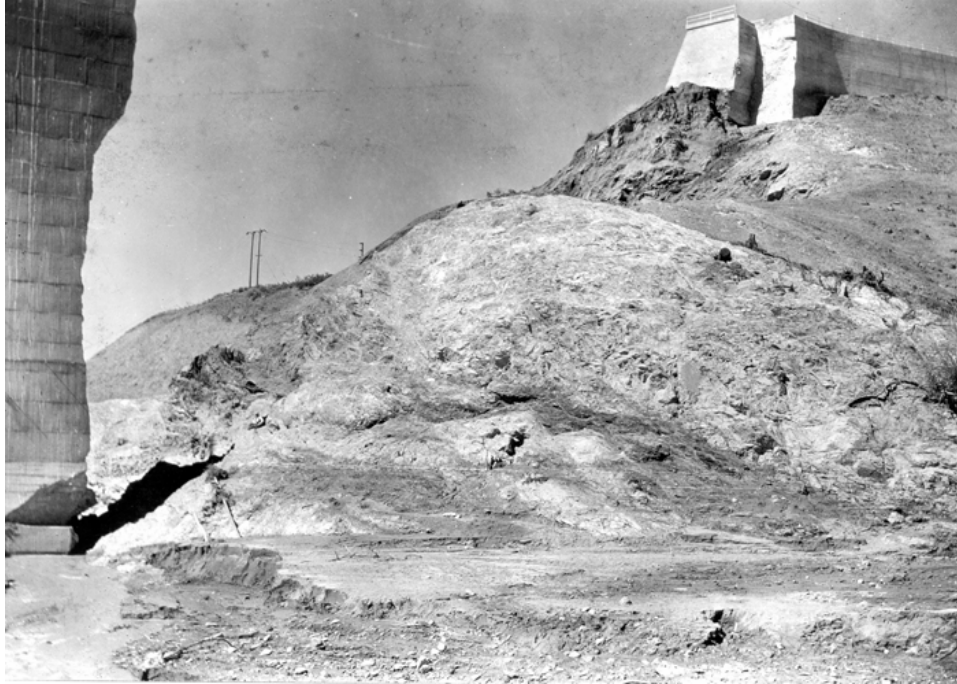
**St. Francis Dam, Former West Abutment**  
(Attribution: U.S. Geological Survey Photographic Library)  
**Figure 6**

The Los Angeles Coroner's Inquest concluded the disaster was primarily caused by the unsuitable soil conditions on which the eastern abutment of the dam was built, but which would have been impossible for the geologists of the 1920s to detect. Therefore, the inquest determined responsibility for the disaster lay with the governmental organizations which oversaw the dam's construction and the dam's designer and engineer, William Mulholland. Mulholland, however, was cleared of any charges since it was determined that neither he nor anyone at the time could have known of the instability of the rock formations on which the dam was built. The hearings also recommended, "the construction and operation of a great dam should never be left to the sole judgment of one man, no matter how eminent." It has also been suggested that raising the height of the dam 20 feet (as described above) during construction failed to recognize that accompanying design changes might be needed (such as increasing the width of the base of the dam).

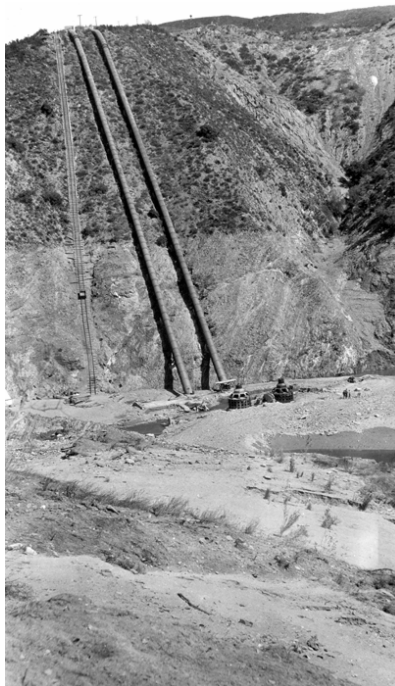
**Remains of downstream powerhouse**  
(Attribution: U.S. Geological Survey Photographic Library)  
**Figure 7**

Studies concluded that water behind the dam took about five minutes to travel 1.5 miles to Powerhouse No. 2 located below the dam. The height of the wall of water for the first few miles was 100 to 140 feet, and huge pieces of the dam, some weighing ten thousand tons, were washed one-half mile or more down the canyon.

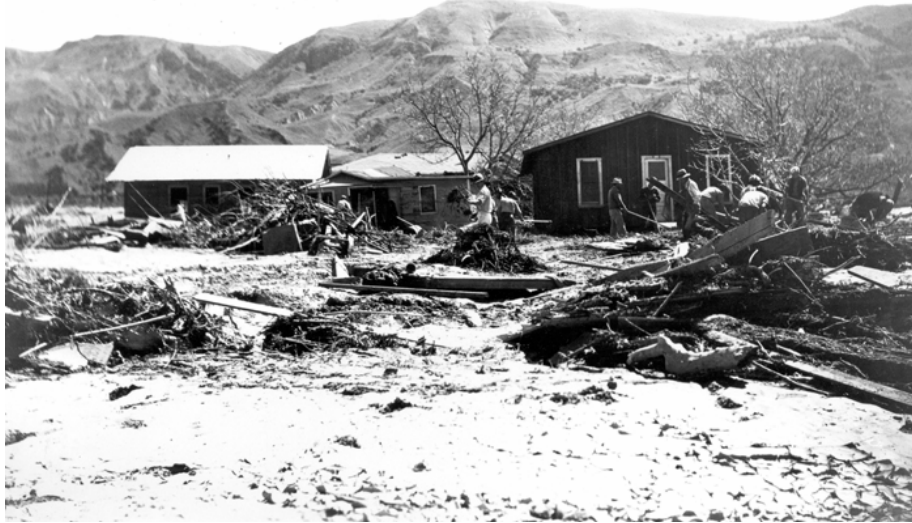
**Flood damage at Santa Paula**  
(Attribution: U.S. Geological Survey Photographic Library)  
**Figure 8**

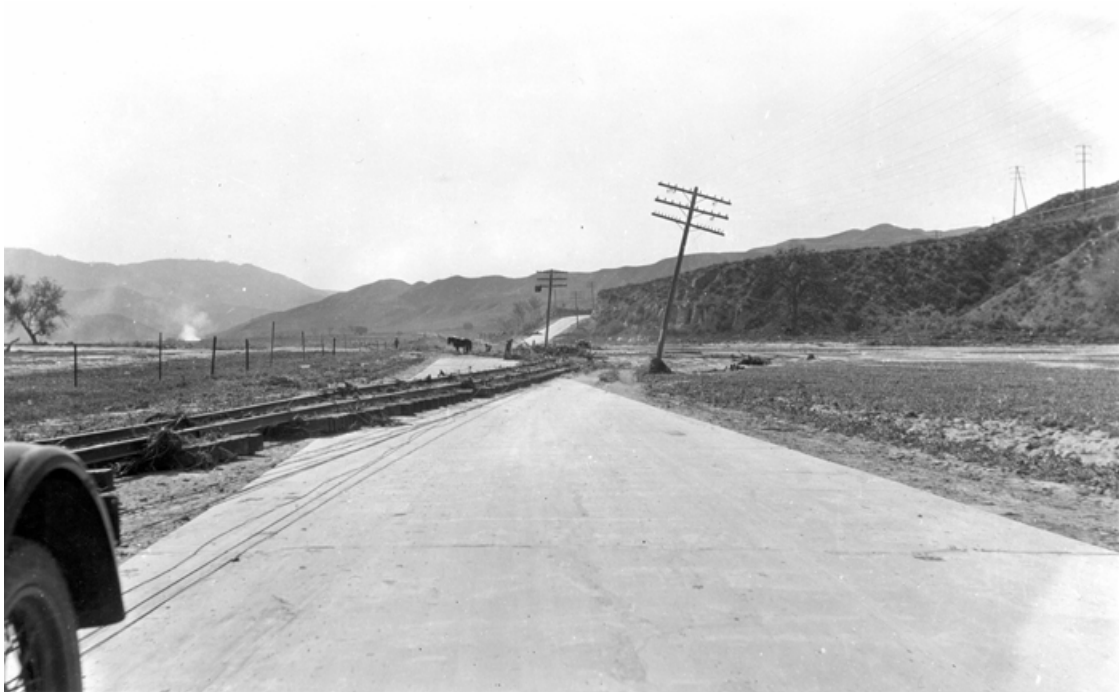
**Figure 10**

**Dislocated railroad tracks**  
(Attribution: U.S. Geological Survey Photographic Library)  
**Figure 9**

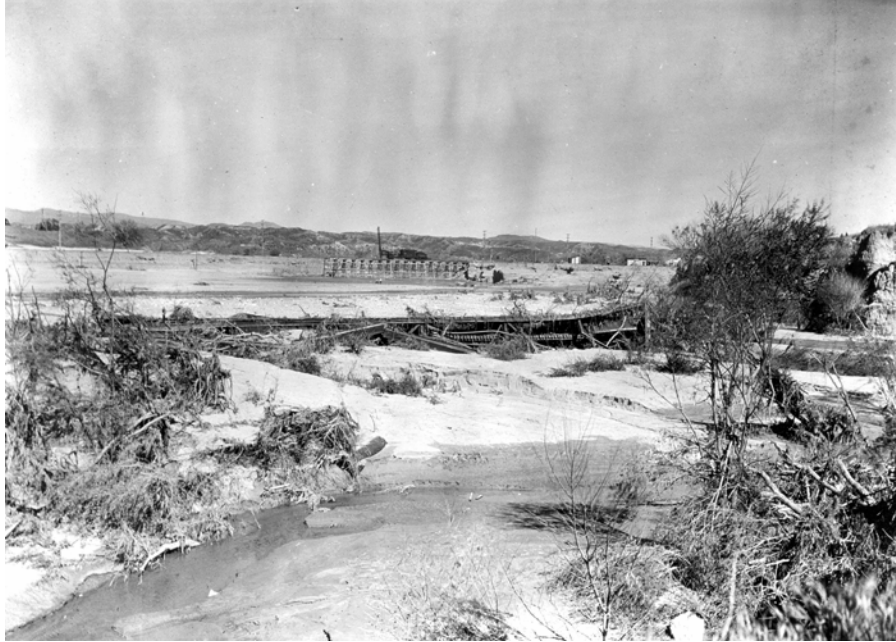
**Highway damage**

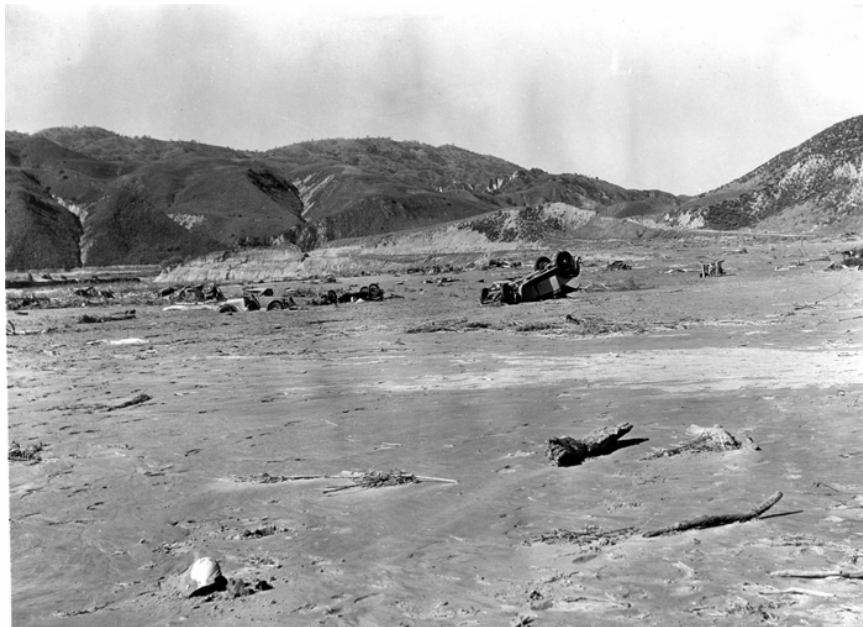
**Figure 11**

**Flood damage**
