## **Coastal Construction: Maintaining the Building**

Course No: S01-007  
Credit: 1 PDH

# 14 Maintaining the Building

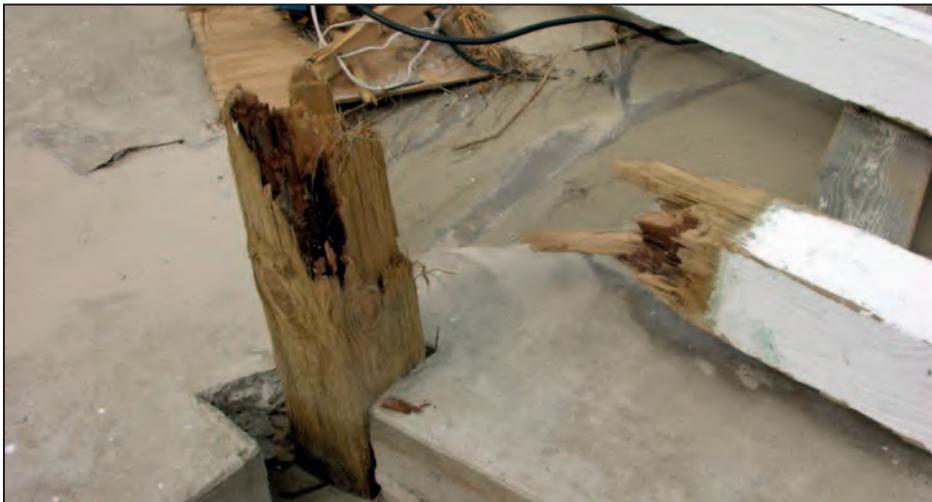
**Figure 14-1.**  
Pile that appears acceptable from the exterior but has interior decay

acceptable condition but is weakened by interior decay, which can be determined only through a detailed inspection. This post failed under the loads imposed by a natural hazard event.

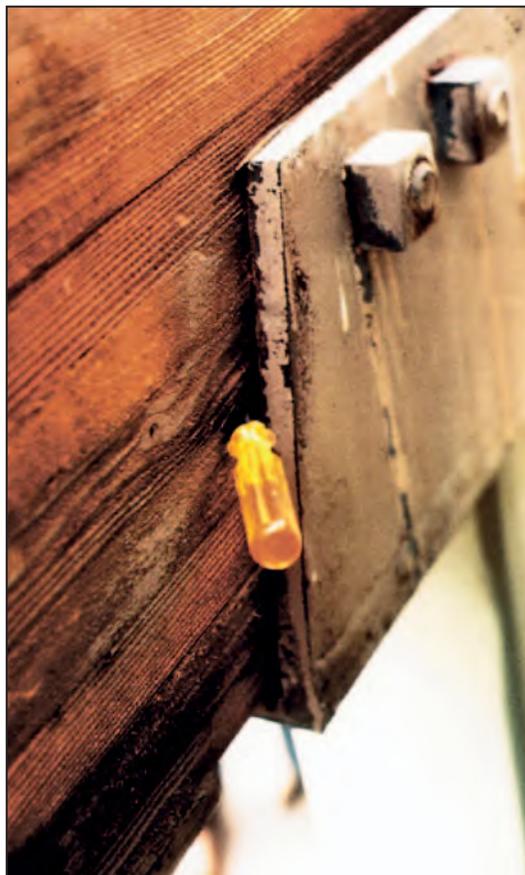
There are many sources of exterior moisture from outside the home in the coastal environment. Whenever an object absorbs and retains moisture, the object may decay, mildew, or deteriorate in other ways. Figure 14-2 shows decay behind the connection plate on a beam.

Figure 14-2.  
Wood decay behind a  
metal beam connector

Connectors should be designed to shed water to prevent water from accumulating between the connector and the material the connector is attached to. Trapped moisture increases the moisture content of the material and potentially leads to decay. Moisture is most likely to enter at intersections of materials where there is a hole in the building envelope (e.g., window, door) or where two surfaces are joined (e.g., roof to wall intersection). If properly installed, the flashings for the openings and intersections should not require maintenance for many years. However, flashings are frequently not properly installed or installed at all, creating an ongoing moisture intrusion problem.

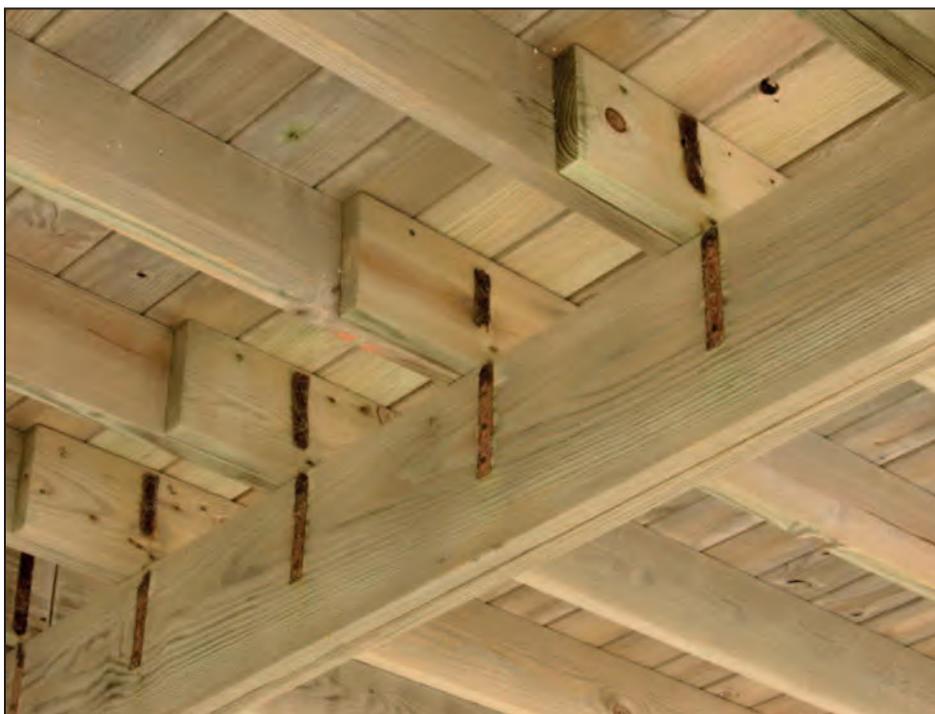
been consumed and the corrosion rate of the unprotected steel can be expected to accelerate by up to a factor of 50 times. Figure 14-3 illustrates severe corrosion under an exterior deck.

Figure 14-3.  
Severely corroded deck connectors

- Sheet-metal connectors can be susceptible to rapid corrosion and are frequently without reserve strength. During routine inspections, any sheet-metal connectors found to have turned rust red or to show severe, localized rusting sufficient to compromise their structural capacity should be replaced immediately. However, the replacement of sheet metal connectors is usually difficult for a number of reasons: the connection may be under load, the nails or bolts used to secure connectors are usually hard to remove, and the location of a connector often makes removal awkward.
- Salt-laden air can increase corrosion rates in building materials. Covering exposed connectors with a sheathing material reduces their exposure and therefore increases their life expectancy.

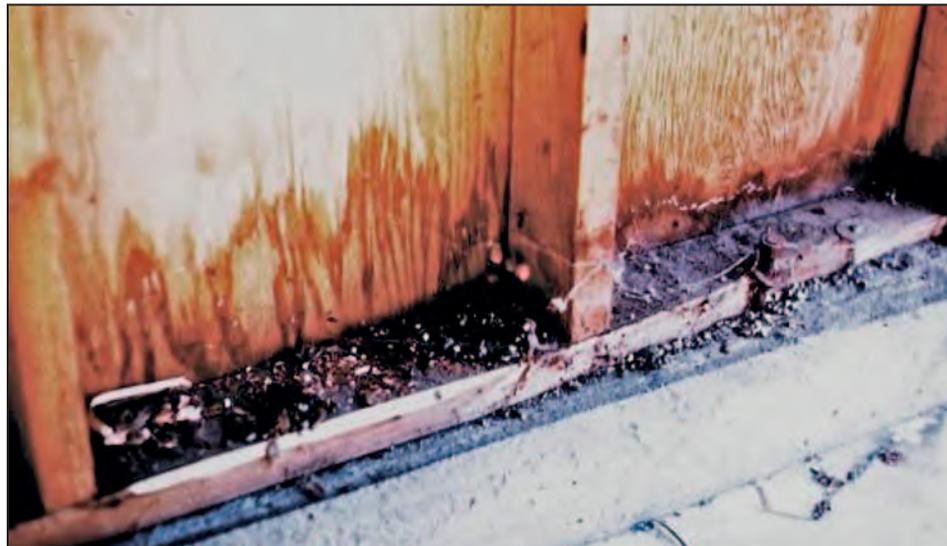
Shearwall sill plates bearing directly on continuous footings or concrete slabs-on-grade, if used in coastal construction, are particularly susceptible to decay in moist conditions. Figure 14-4 shows a deteriorated sill plate. Even if the decay of the preservative-treated sill plate is retarded, the attached untreated plywood can easily decay and the shearwall will lose strength. Conditions that promote sill and plywood decay include an outside soil grade above the sill, stucco without a weep screed at the sill plate, and sources of excessive interior water vapor. Correcting these conditions helps maintain the strength of the shearwalls.

**Figure 14-4.**  
Deteriorated wood sill  
plate
