# Engineering Principles of Microbially Induced Corrosion

Course No: T04-010

Donald Parnell, P.E.

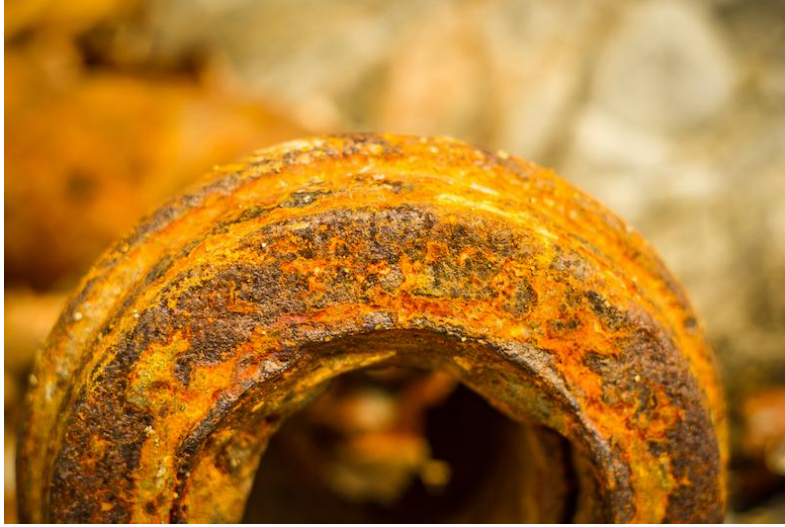
Figure 1: A schematic of microbiologically induced corrosion (MIC).

Microbially Induced Corrosion (MIC) refers to corrosion processes in which microorganisms, principally bacteria and archaea, modify the local chemical environment at a metallic surface in ways that increase the rate or severity of electrochemical degradation. The term coexists in the literature with Microbiologically Influenced Corrosion (abbreviated as MIC in both cases), and both expressions describe the same phenomenon (see Figure 1).

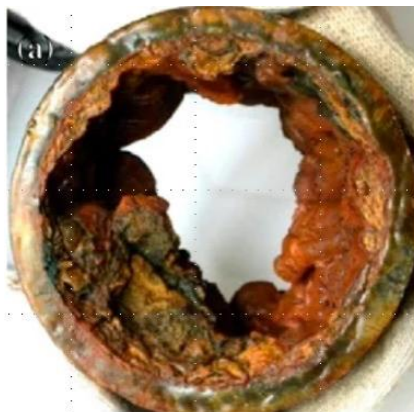
*Figure 2: Cross Section of Pipe with Electrochemical Corrosion.  
Credit: Mi et al., 2015.*

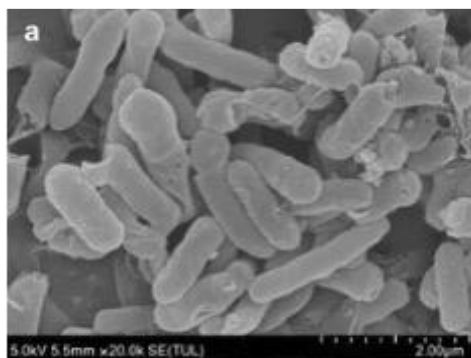
Figure 3: Scanning electron microscopy (SEM) images of the sulfate-reducing bacteria (SRB).  
*Credit: Xia et al., 2024*

Sulfate-reducing bacteria (SRB) are the most widely studied and arguably the most economically significant MIC organisms (Figure 3). They are obligate anaerobes that use sulfate as a terminal electron acceptor in their metabolism, producing hydrogen sulfide as a byproduct. Hydrogen sulfide is corrosive to iron and many alloy systems through multiple mechanisms, including direct chemical attack, cathodic depolarization, and hydrogen embrittlement in high-strength steels (see Figure 4). SRB thrive in oxygen-depleted environments, such as buried pipelines, the interior of biofilms, sedimented tank bottoms, and anaerobic wastewater zones.

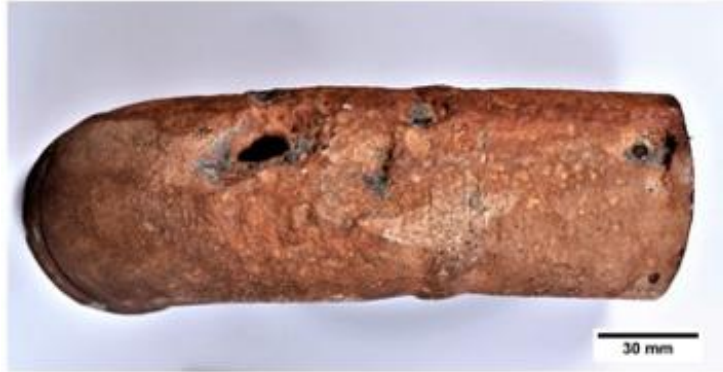
*Figure 8: Large pits and perforations were seen on the surface of a steel pipe elbow.  
Credit: Kiani et al., 2019.*

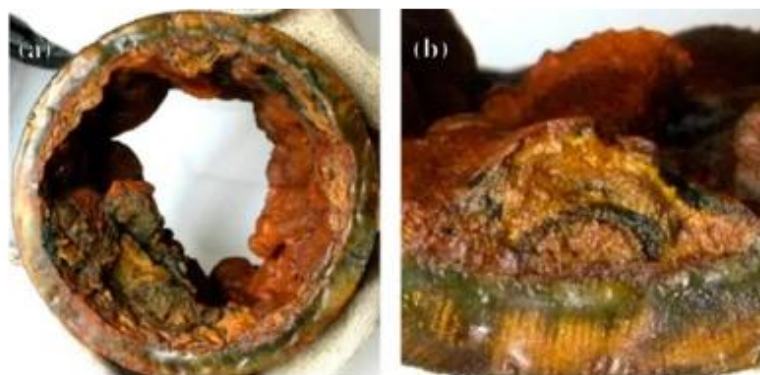
*Figure 9: Heavily corroded internal surface of cast iron pipe used in drinking water distribution systems. (a) Pipe cross section, (b) tubercle. Credit: Mi et al., 2015*

Municipal water distribution systems are often assumed to be relatively clean environments because treated water contains chlorine or chloramine disinfectants. In practice, most distribution systems still harbor some level of microbial activity, and under the right conditions, biofilm communities capable of driving MIC develop even in compliant systems. As water travels through an extensive distribution network, residual disinfectant decays, temperatures rise during warm months, and organic carbon accumulates. In hydraulic dead zones, oversized pipe sections, and storage tank inlets, water age can become high enough to allow substantial biofilm growth before water reaches the end user. The resulting biofilm communities on iron or ductile iron pipe walls can produce tuberculation, a characteristic mound-like corrosion deposit that contains iron oxides, iron bacteria, and embedded anaerobic organisms (American Water Works Association, 2012; see Figure 9).

Tuberculation illustrates how infrastructure geometry interacts with microbial activity. As tubercles grow, they restrict flow area and increase head loss (see Figure 9 (b)). More significantly, the oxygen-depleted zone directly beneath each tubercle becomes anodic, concentrating corrosion at exactly the points where the deposit has formed. Older cast iron mains in many US cities exhibit severe tuberculation that has measurably reduced hydraulic capacity and produced localized pipe wall losses far exceeding the original corrosion allowance. The corrosion is not always immediately visible from the outside because the external pipe surface may remain intact while the internal wall progressively thins.

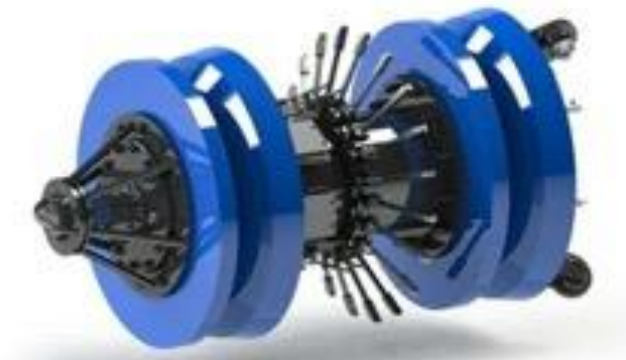
*Figure 10: Smart Pipe Inspection Gauge (PIG).*

Internal pipe inspection tools, commonly called inline inspection tools or smart pipe inspection gauges (PIGs), use magnetic flux leakage or ultrasonic measurement to detect wall thinning and pitting from within a flowing pipeline (see Figure 10). These tools can identify localized pitting consistent with MIC, but they cannot distinguish biologically driven pitting from abiotic localized corrosion based on geometry alone. The distribution pattern of pitting, its location relative to low points where water might accumulate, and the morphology of the pit interior during excavation and visual examination provide additional diagnostic context.
